# CRASH INJURY INVESTIGATION

U. S. ARMY H-21C

SHAWNEE HELICOPTER ACCIDENT

2 December 1959

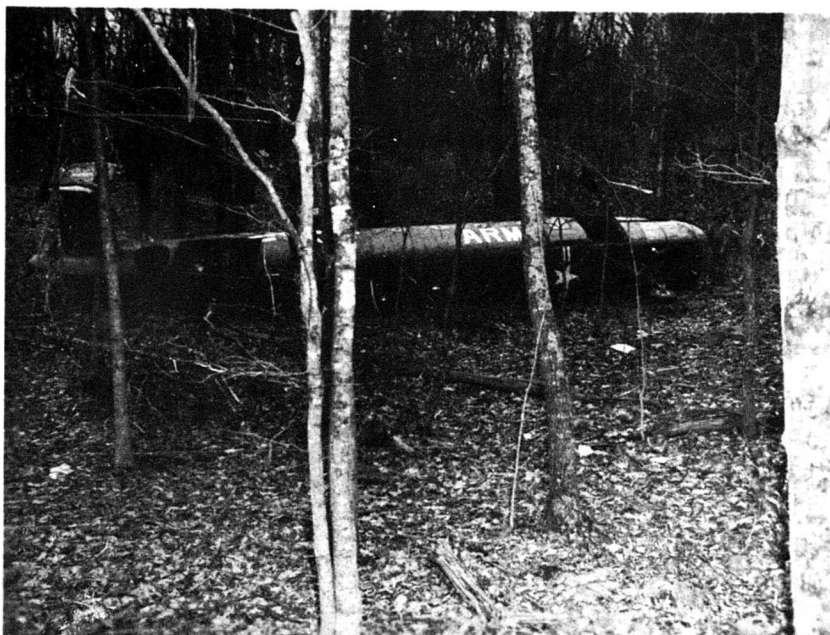
Figure 5. A side view of subject aircraft as it came to rest on its left side. The engine covers were removed after the accident.

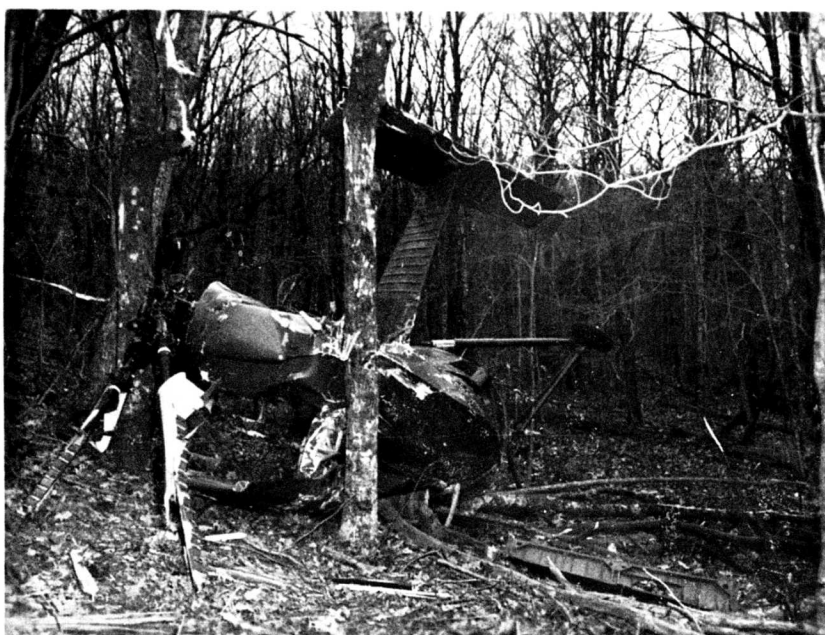
Figure 6. The nose-down attitude was caused by the aft end of the aircraft being wedged between several large trees as shown in the above photograph.

In addition, the left cabin door was torn free, the left rear landing gear was bent and the drag strut broken and pushed into the engine area. Some distortion occurred on the left side of the engine area and fire wall. The fuselage skin aft of the forward rotor along the left side was wrinkled as the nose struck the ground (Figure 9). The tail assembly was damaged by sliding down the 40 foot trees (Figure 6).

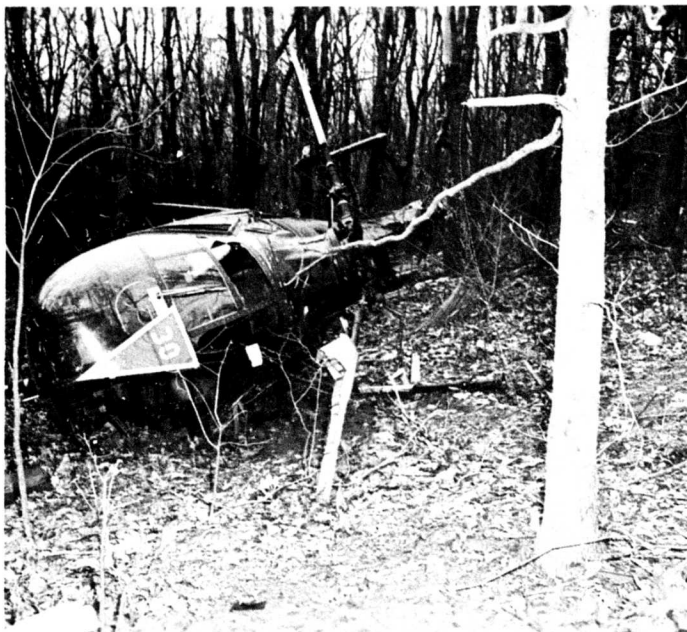
Figure 7. Front view of the helicopter showing the broken nose bubble on the left side.

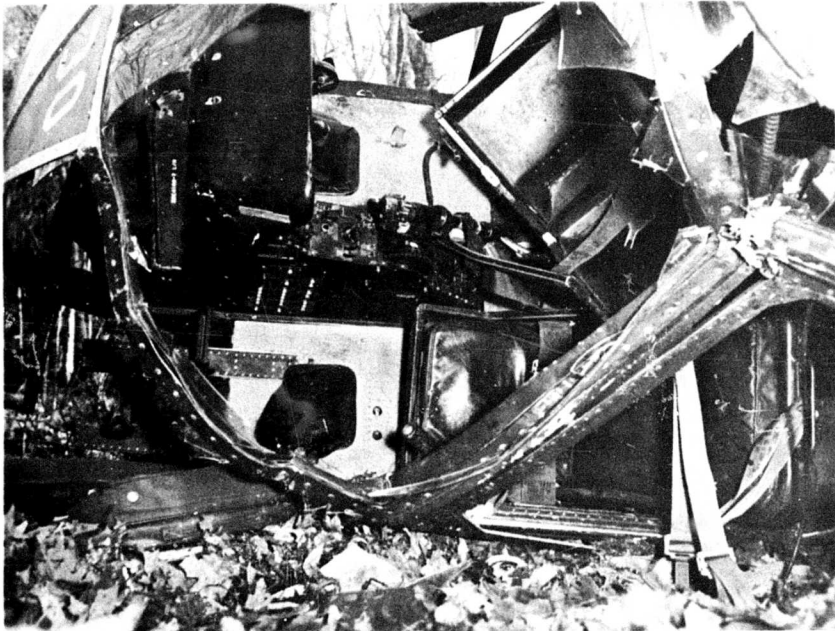
Figure 8. View looking down into the cockpit showing the final position of the two pilots' seats and the opening in the cockpit through which the pilot evacuated the aircraft.

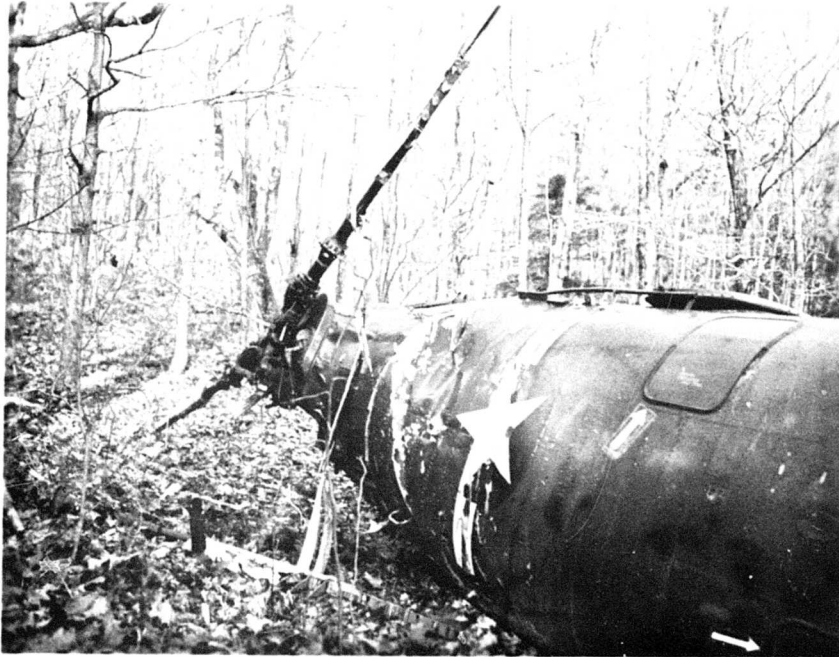
Although adequate emergency exits are provided in this aircraft, they were not utilized. Figures 9 and 10 show the location of two ceiling exits, which were operable but were not utilized, probably as a result of inadequate emergency evacuation briefing prior to the flight or the incapacitation of the crew chief.

↑ Figure 9. A view of the aircraft looking toward the forward rotor. The arrows indicate the operable, but unused, ceiling emergency exits.

The time required to evacuate all personnel from the aircraft including those requiring assistance indicates that more emphasis should be placed on briefing occupants of military aircraft on evacuation procedures and the location and use of emergency exits prior to the flight.

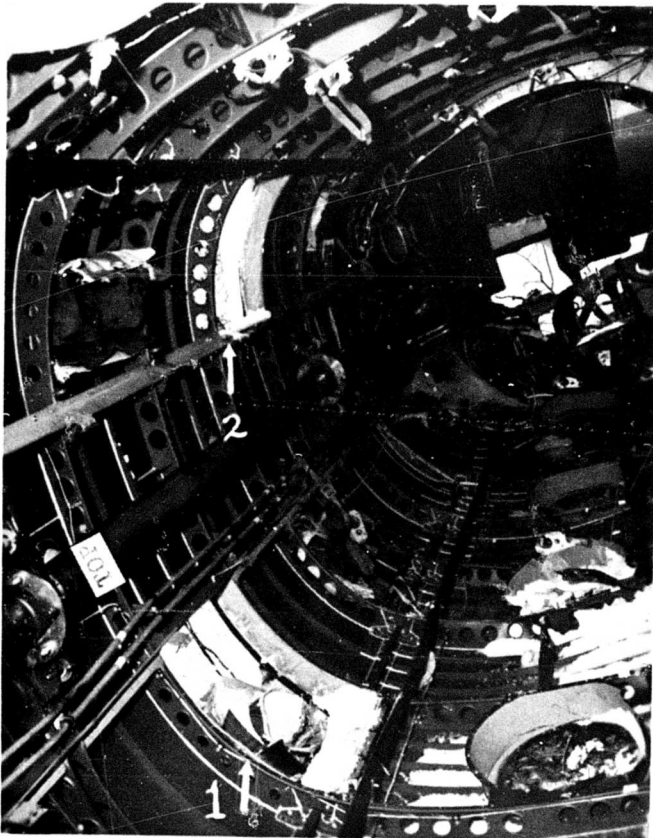
← Figure 10. Interior view of the operable but unused ceiling emergency exits (arrows 1 and 2). Both exits were opened by the accident investigators.

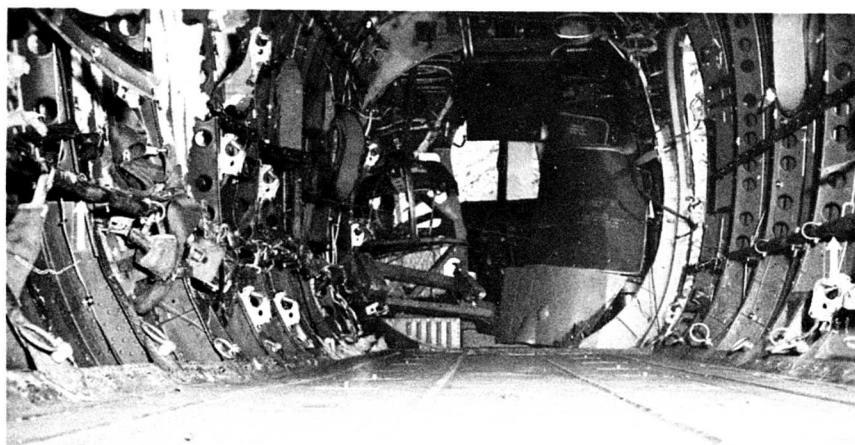
Figure 11. View looking forward to show intactness of the helicopter. The floor showed no distortion. Arrows denote the rear-seat supporting structure.

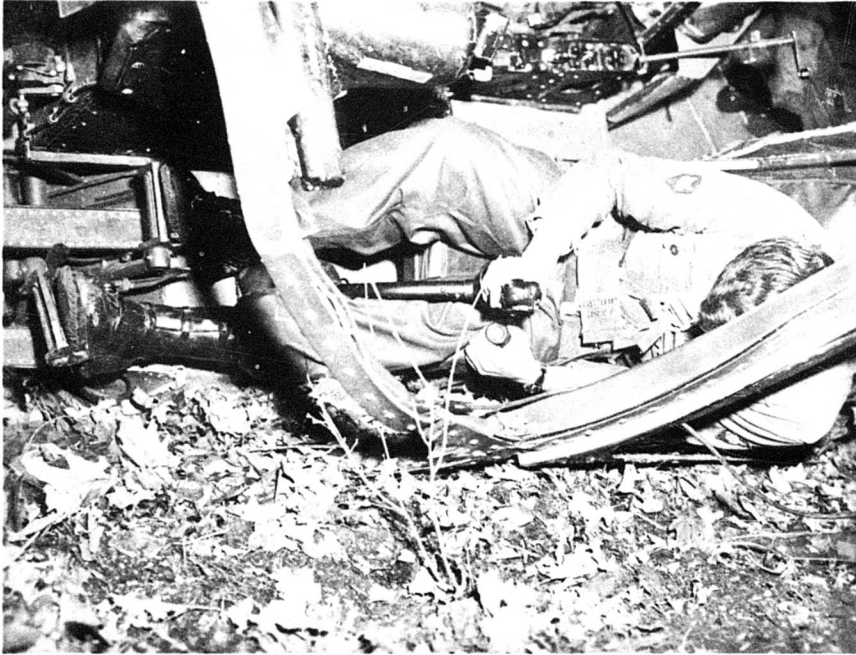
Figure 12. Posed photograph shows position of the copilot when the helicopter came to rest. Note the position of the copilot's head against the cockpit support member.

4. Cockpit support members within striking range of either the pilot or copilot be padded with high energy absorption material, such as ensolite.
5. The three-man troop seat used in this aircraft be re-designed or a new design be developed which will prevent structural failures under survivable conditions.

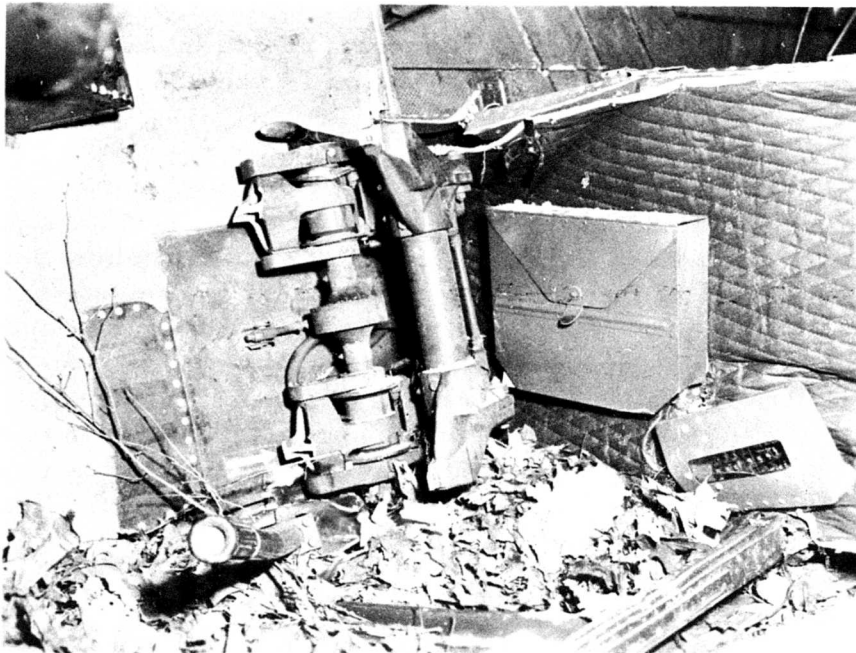
The most significant damage in the entire cockpit area was the failure of both pilot and copilot's seats during the lateral deceleration. Both seat supporting structures failed, permitting the pilot and the copilot to be thrown violently to the left. This movement caused the copilot to strike the left vertical support member, as shown in posed photograph (Figure 12). Figures 13 and 14 show the seat supporting structures and the failure points.

Figure 13. The four seat support members (arrows) of the copilot's seat failed due to side load.

1. The seat supporting structure of the pilot and copilot seats in the H-21 be re-designed to prevent failures due to lateral forces under survivable conditions. A more ductile material, which will absorb energy through progressive collapse, is suggested.

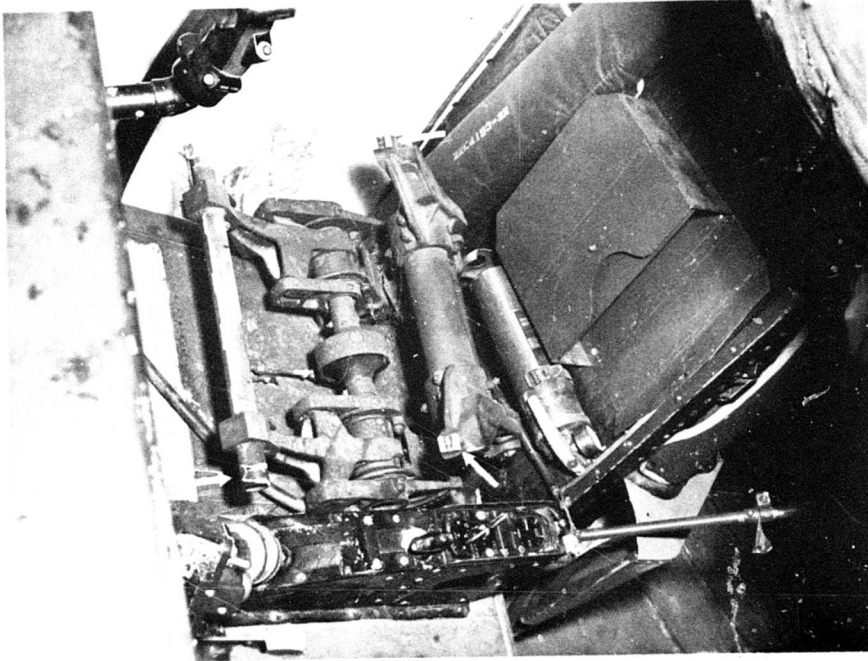
Figure 14. The four arrows in the photo depict points of failure of the seat support members on the pilot's seat. The failures are almost identical with those of the copilot's seat.

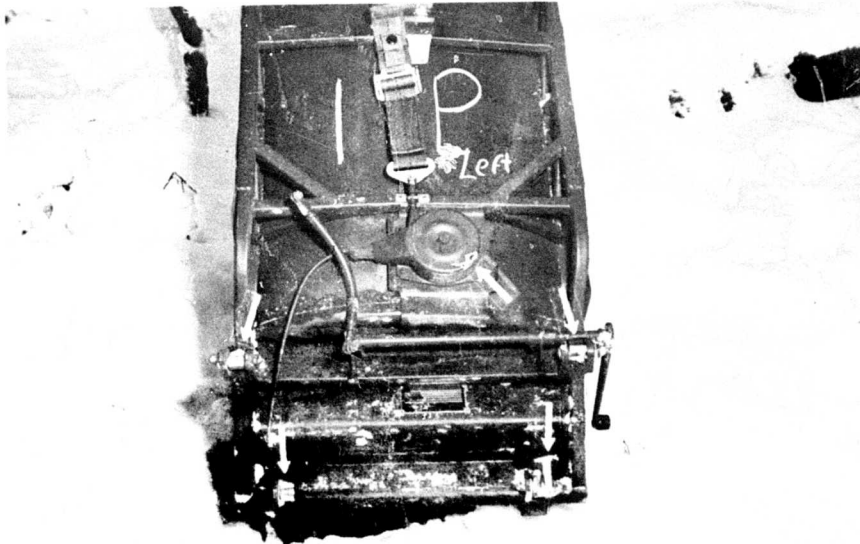
Figure 15. A rear view of the copilot's seat. Arrows depict points of failure of the support members. Location of inertia reel mounted on the seat back is also indicated.

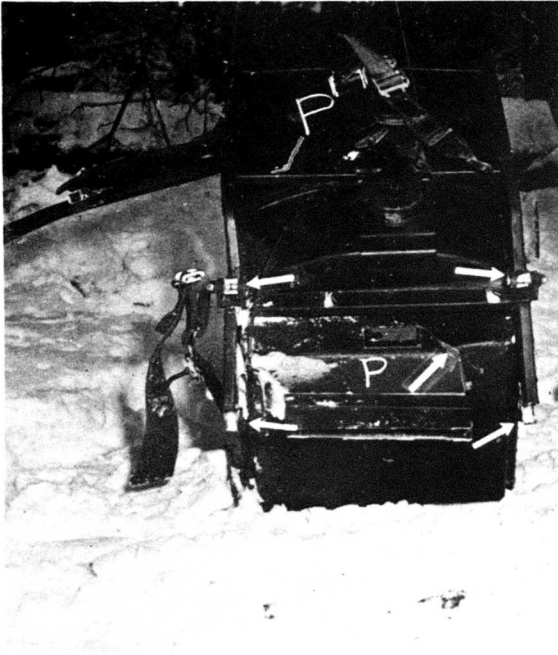
Figure 16. The failures of the seat-support members are depicted by the arrows. The inertia reel locked but due to the seat failure the shoulder harness was ineffective. There are indications that the seat structure offered the pilot some protection when he struck the console.

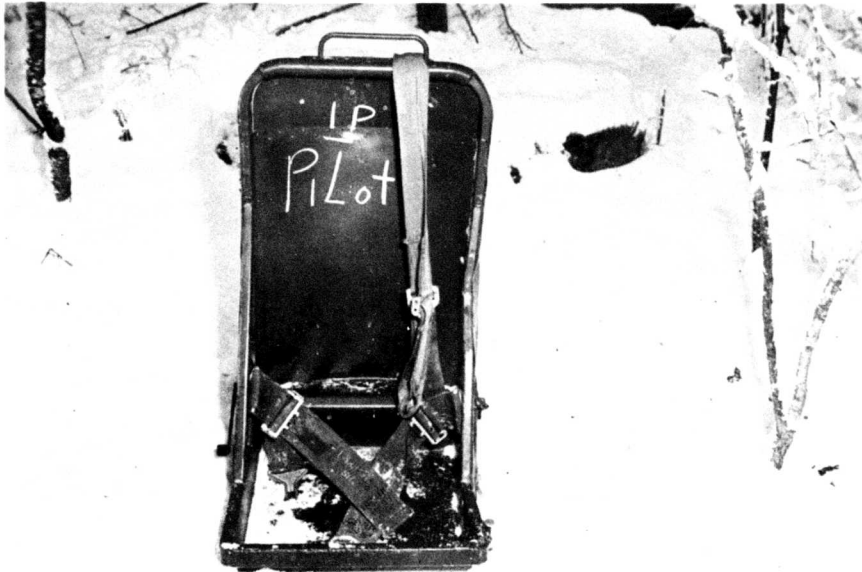
The complete failure of the seats from their supporting assemblies rendered the shoulder harnesses and the seat belts of both the pilot and the copilot ineffective. Figures 15 and 16 show the inertia reels, which are of the impact type, mounted on the seat backs. The copilot's inertia reel did not lock during this crash, apparently as a result of predominant side loads. Had the inertia reels been anchored to primary structures of the aircraft, the occupants would have been partially restrained by the shoulder harnesses even though the seats failed. An additional item of interest is the excessive width of the shoulder harness guide at the top of the seat (Fig. 17). Under seat load conditions as experienced in this accident, the occupant is permitted to move laterally several inches before the harness becomes effective.

Figure 17. The wide shoulder harness guide at the top of the seat permits considerable lateral movement under side load conditions.

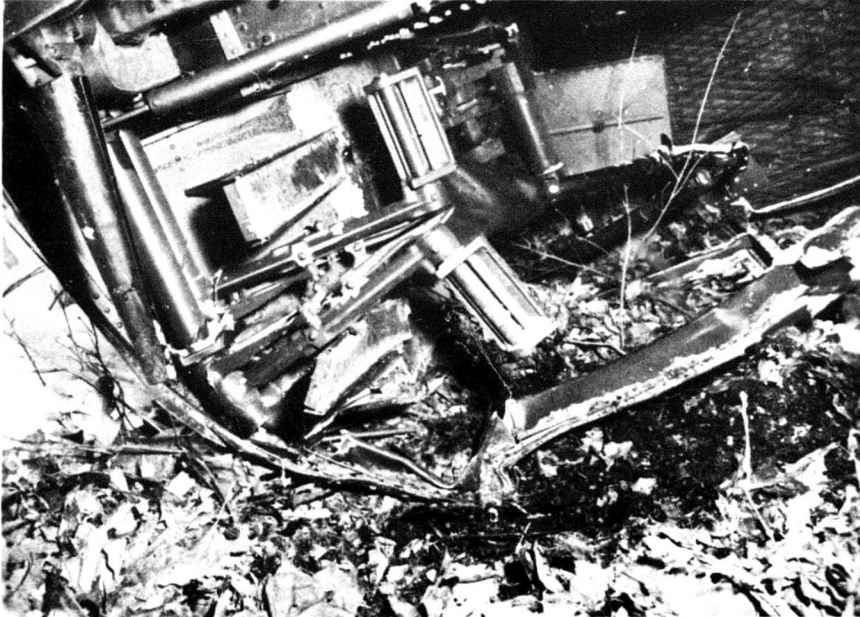
In addition to the seat failures, the instructor's left pedal was pushed inward and rearward; the right pedal was distorted; the copilot's cyclic control stick was broken; his collective pitch control was bent inward against the stick, and the pilot's collective pitch control was broken to the left (Figures 18 and 19).

Figure 18. Front view of the left cockpit area after removal of the copilot's seat.

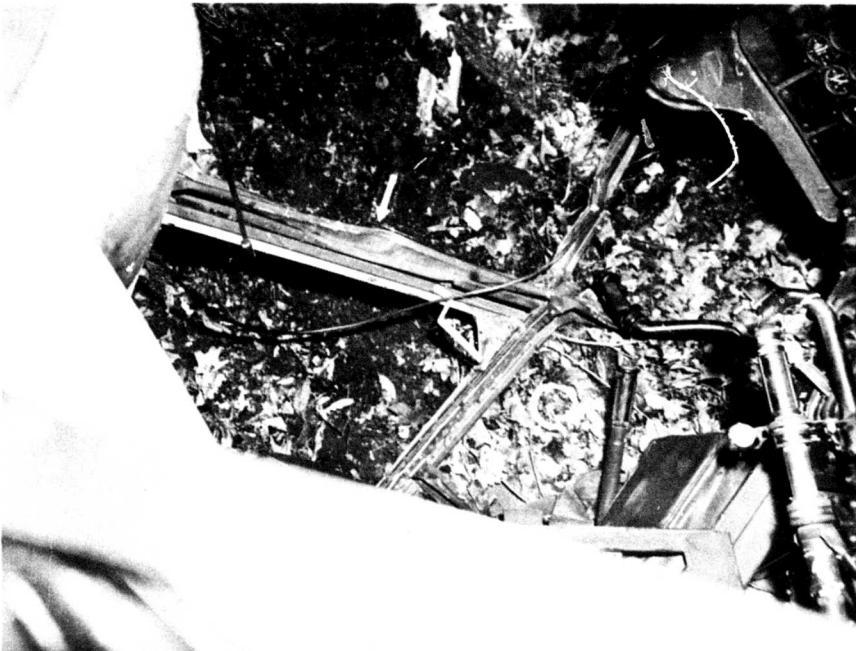
Figure 19. The arrow denotes the point where the copilot's helmet contacted the support member. The copilot's seat is visible in the lower right.

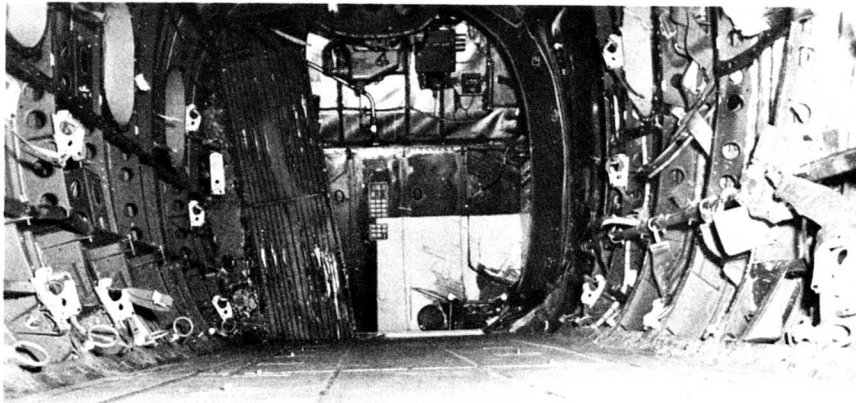
2. MAIN CABIN—The basic structure in the main cabin area remained completely intact, as illustrated in Figure 20. In spite of the intact condition of this basic structure (indicating moderate crash forces), a number of the seats and seat belts failed, resulting in numerous injuries to the occupants of the main cabin. Figure 21 is a chart showing the seating arrangement of all occupants at the time of the accident, seat and seat belt damage, and a summary of the injuries sustained by each occupant.

Figure 20. View looking aft at floor level. Note the tie-down rings (floor level) designed for cargo. Each ring is tied into primary structure and stressed for 2,000 lb. Similar tie-downs for the safety belts would prevent some of the failures that occurred in this accident.

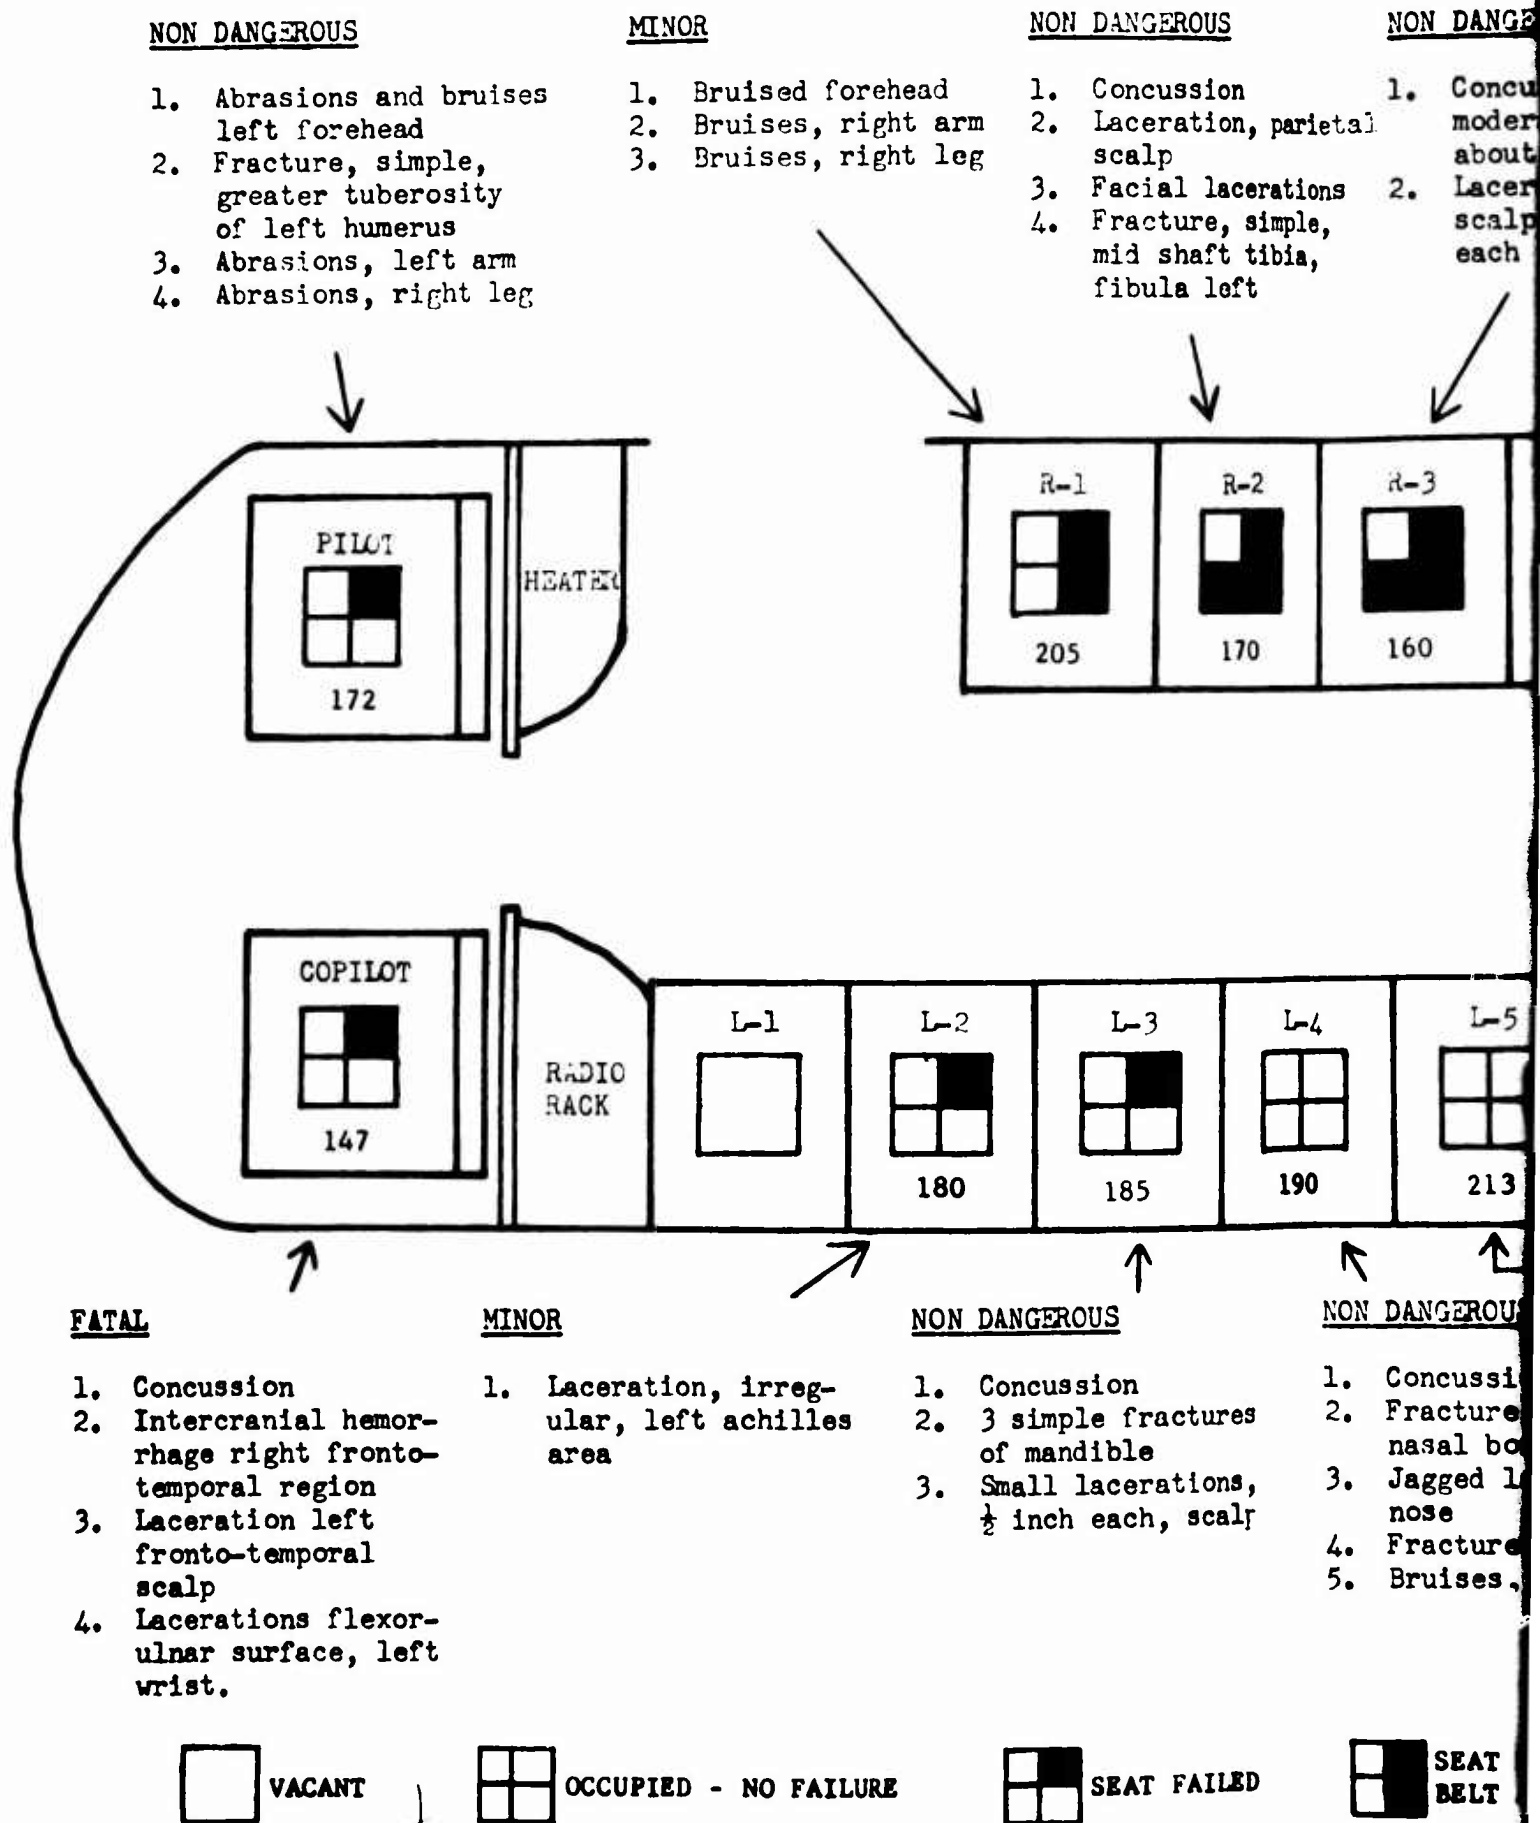
FIGURE 21.

An examination of the chart reveals that six seats failed, two on the left, or low side, of the aircraft and four on the right, or high side. The two failures on the left side of the cabin consisted of failure of the vertical seat supports. These failures probably occurred when the occupants from the right side were thrown against them. The four seat failures on the right side resulted mainly from a number of breaks in the rear seat supporting structure. These failures occurred at the points where the seat supporting structure is drilled to accommodate either a seat belt

Further examination of Figure 21 also reveals six seat belt anchorage failures on the right, or high side, of the cabin. These failures also resulted from failure of the rear seat supporting member. The safety belts are attached to this rear seat supporting member in the following manner: A D-ring is attached to the rear seat support member through one of the drill holes cited above. The safety belts are then snapped to this D-ring. Two safety belts are frequently attached on one D-ring; that is, the left safety belt of one occupant and the right safety belt for another occupant are both attached to the same ring. This is illustrated by Arrow 5 in Figure 27. A single failure, under such conditions, permits two occupants to be thrown free in the cabin area. Attachment of the seat belts in this manner, combined with the forces generated by the occupant in the seat, contributed to the numerous failures of the rear seat supporting structure in the accident.

Figure 21 also reveals that two seat belt webbing failures occurred during the accident (Seats R-2 and R-3.) These failures are illustrated in Figures 28 and 29. The failures were probably caused by the occupants wearing the seat belts loosely fastened, resulting in amplification of the impact forces or jolt loads on the belts.

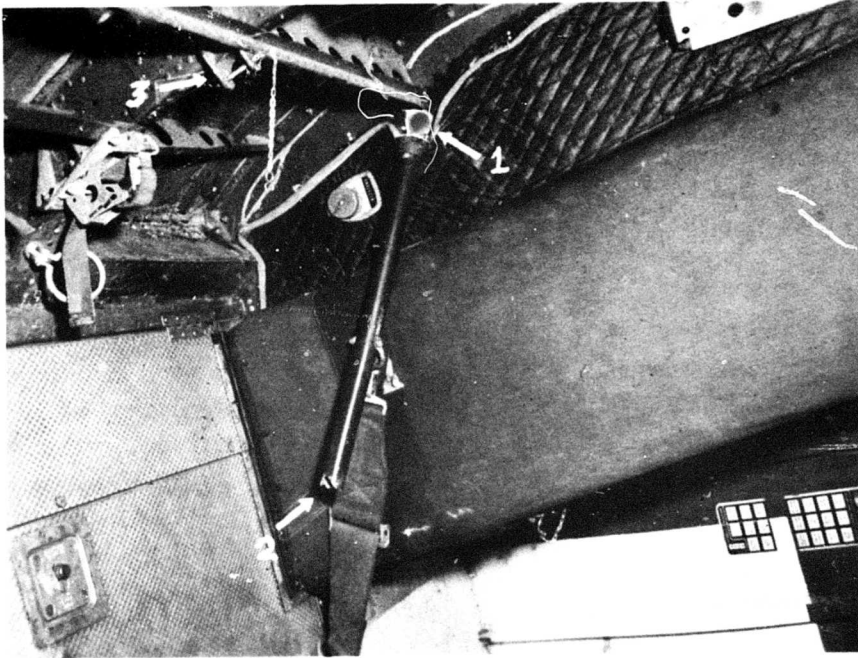
Figure 22. The rear support member, in addition to failing, was nearly torn free from the rear bulkhead (arrow 1). Arrow 2 shows a failure in the rear support member which is normally attached at arrow 3.

attachment (D-ring) or a wall anchorage. The drill holes are located approximately every 18 inches along the length of the support member. In addition to the rear seat support member failures, there were also numerous vertical and diagonal support member failures of the seats on the right, or high side. Illustrations of seat failures are contained in Figures 22 through 27.

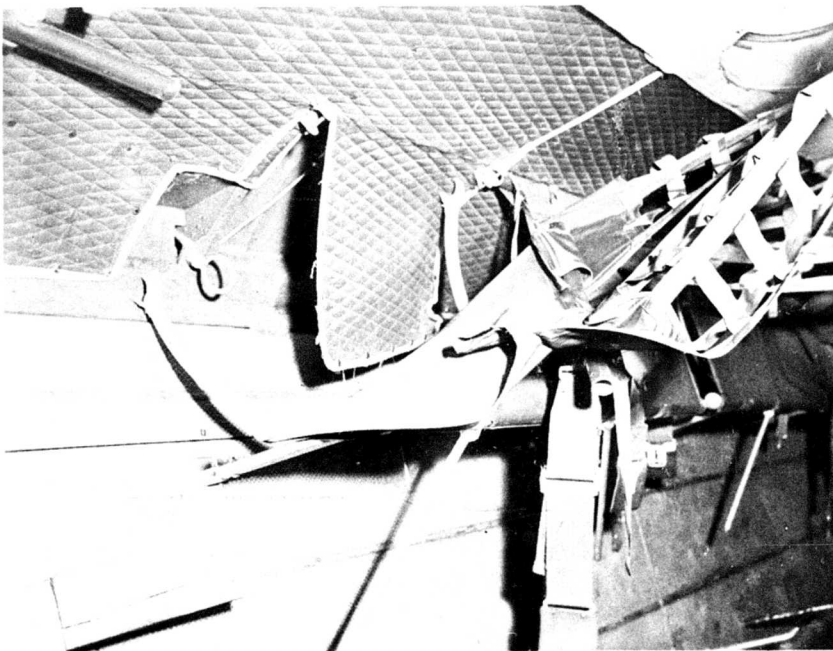
Figure 23. The first group of seats (forward) on the right or "high" side. The rear support failure plus belt and tie-down failures allowed the occupants to become projectiles.

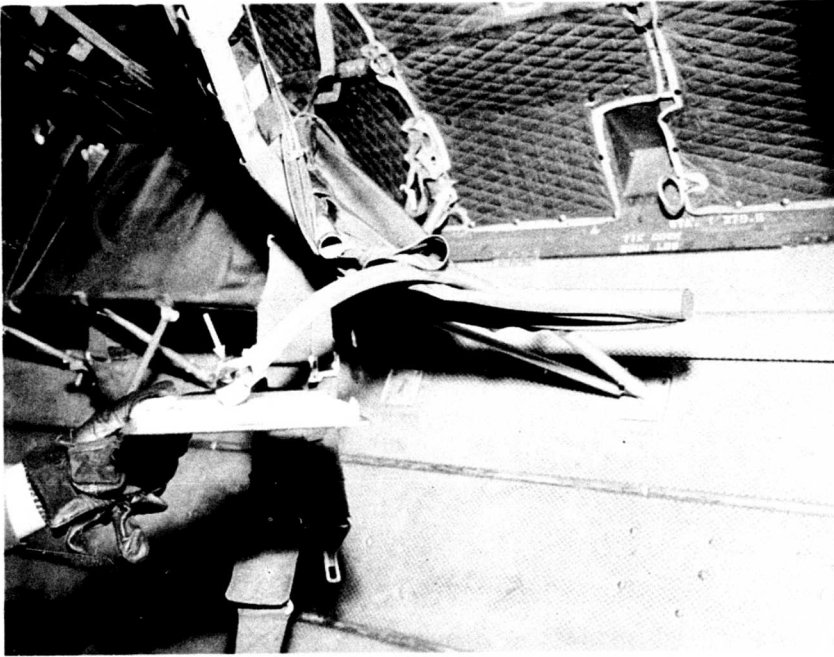
Figure 24. The seat spreader (arrow) was torn from the rear support member.

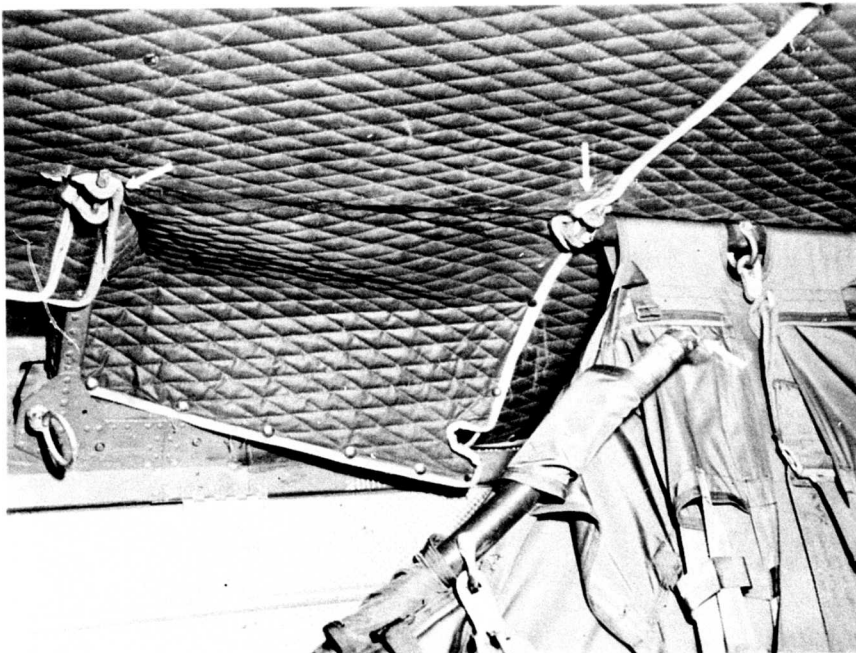
Figure 25. Rear longitudinal support failures (arrows). Snap load conditions frequently tear the support member from its attachment points.

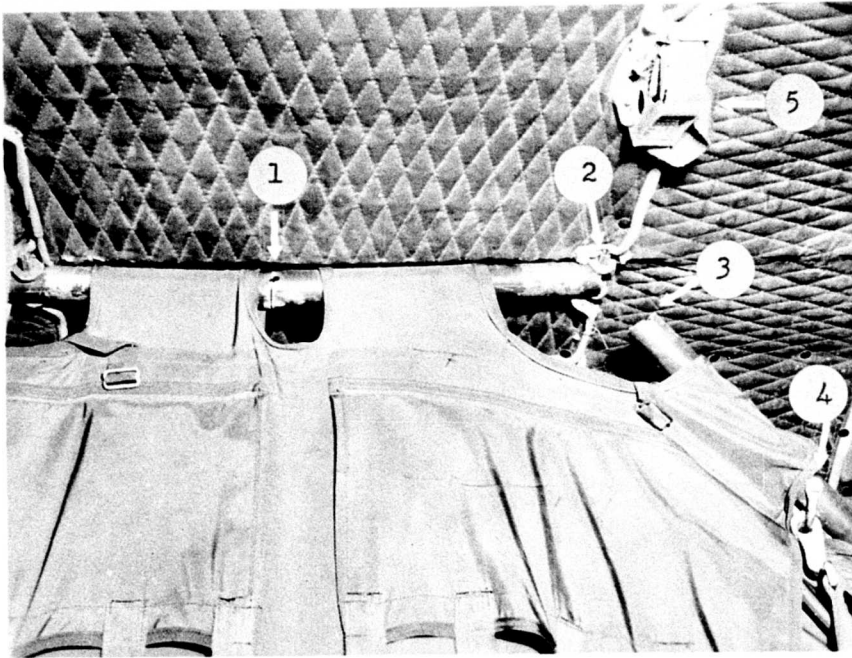
Figure 26. Arrow 1 depicts the manner in which some of the "D" rings failed. Arrows 2 and 3 depict typical seat support failures. This occupant's safety belt, arrow 4, became ineffective due to failure of the rear support member. A litter bracket, arrow 5, which is located directly behind an occupant's back, is a potential injury-producing item.

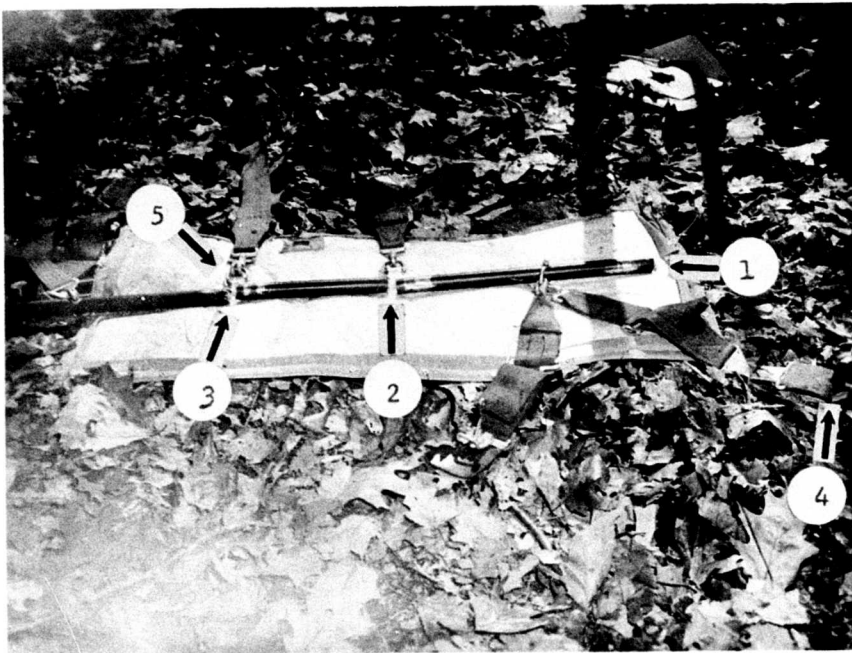
Figure 27. View showing the failures of the rear-seat supporting structure (arrows 1, 2 and 3) due to the seat belt anchorages' tearing free. Notice the failure of the seat belt webbing (arrow 4). Arrow 5 indicates the manner in which two belts are anchored to the same "D" ring.

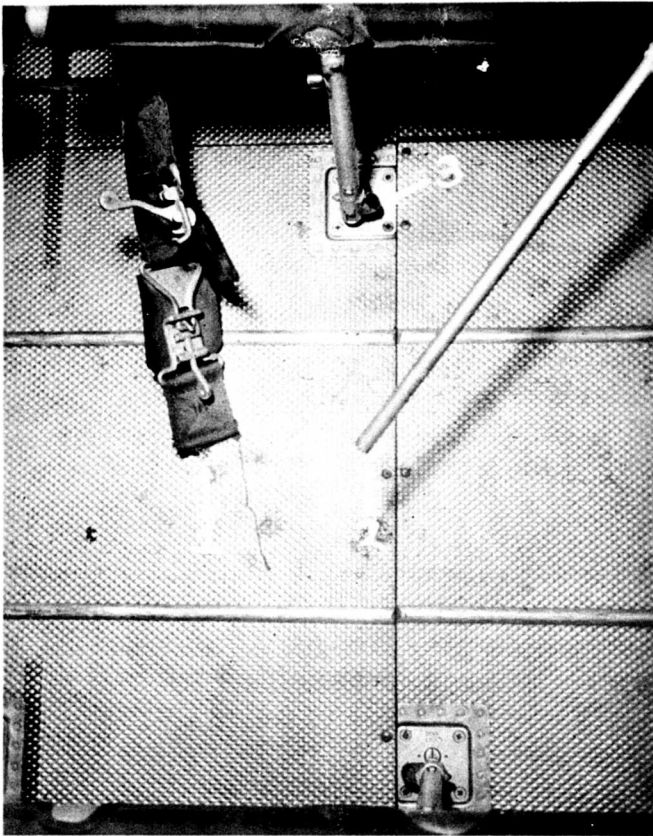
Figure 28. Seat belt webbing failed at the aft end of the overlap (arrow 1). The diagonal seat support (arrow 2) was pulled out of its attachment (arrow 3). It should also be noted that the vertical seat support is straddled by the occupant and usually fails under vertical loads leaving exposed jagged ends, which are a potential cause of injury.

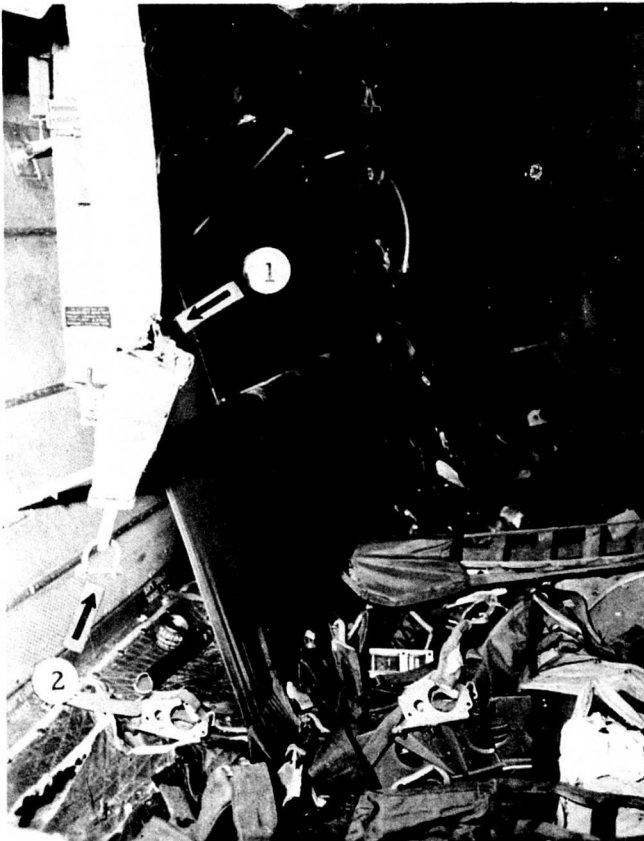
Figure 29. Particular attention should be paid to arrows 1 and 2. Arrow 1 indicates webbing failures. Arrow 2 shows the "D" ring that was pulled out of the rear-seat support structure. This was actually a double failure at a single restraint attachment point.

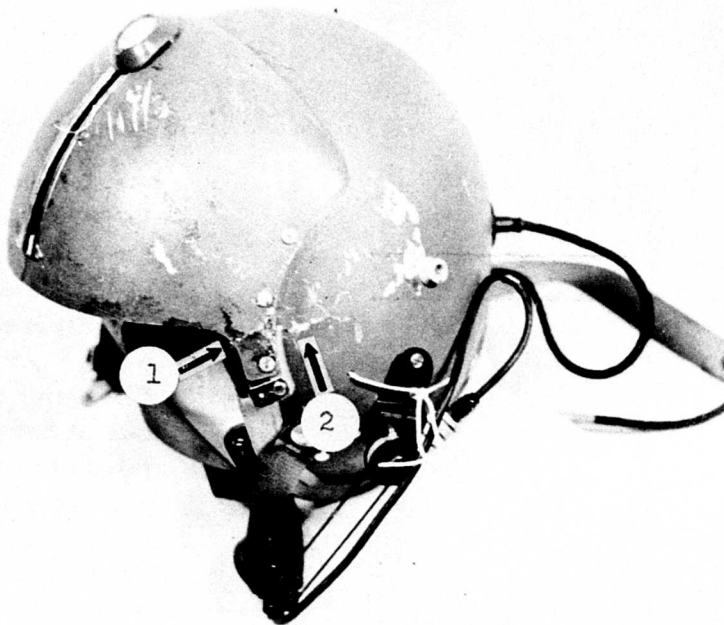
Figure 30. Impact marks were found on the left temple area and also on the visor housing. The arrows point out the area of impact.

1. COPILOT—At impact, both cockpit seats failed and permitted the seats and their occupants to be thrown violently to the left. The copilot, who occupied the left cockpit seat, nearest the point of impact, struck the left vertical cockpit support member with the left side of his helmet, just above the keeper on the eye shield housing. The impact marks on the helmet are indicated in Figures 30 and 31. A detailed examination of the helmet revealed that the blow was absorbed by the shield housing at the point indicated by Arrow 1 in Figure 30. The shield housing broke at this point, permitting inward bending of the outer shell, resulting in a fracture approximately one inch in length at the point indicated by Arrow 2. Removal and examination of the inner liner revealed that the total force was absorbed over an area of approximately 2 to 3 square inches.

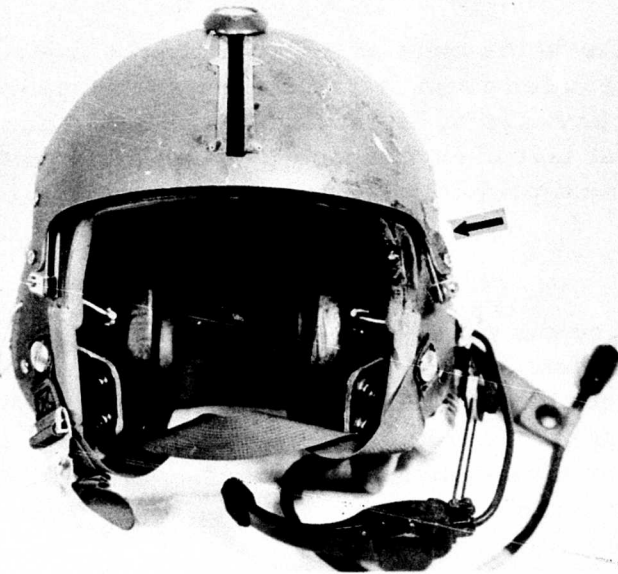
Figure 31. Front view of the copilot's helmet. The arrow denotes the impact area.

lesion (an inter-cerebral hematoma in the right fronto-temporal region). This brain injury was of the contrecoup type, the result of transmission of impact force from the point of impact to the opposite side of the brain. The copilot was hospitalized, underwent neuro-surgery, suffered a cardiac arrest and died about 20 hours after the accident. In addition to the brain injury, the copilot also sustained a laceration to the left wrist, apparently as his wrist struck the window handles.
