## FEDERAL CIVIL AERONAUTICS BOARD

## AIRCRAFT ACCIDENT REPORT

IMPERIAL AIRLINES, INC., LOCKHEED CONSTELLATION L-049,  
N 2737A, BYRD FIELD, RICHMOND, VIRGINIA,  
NOVEMBER 8, 1961

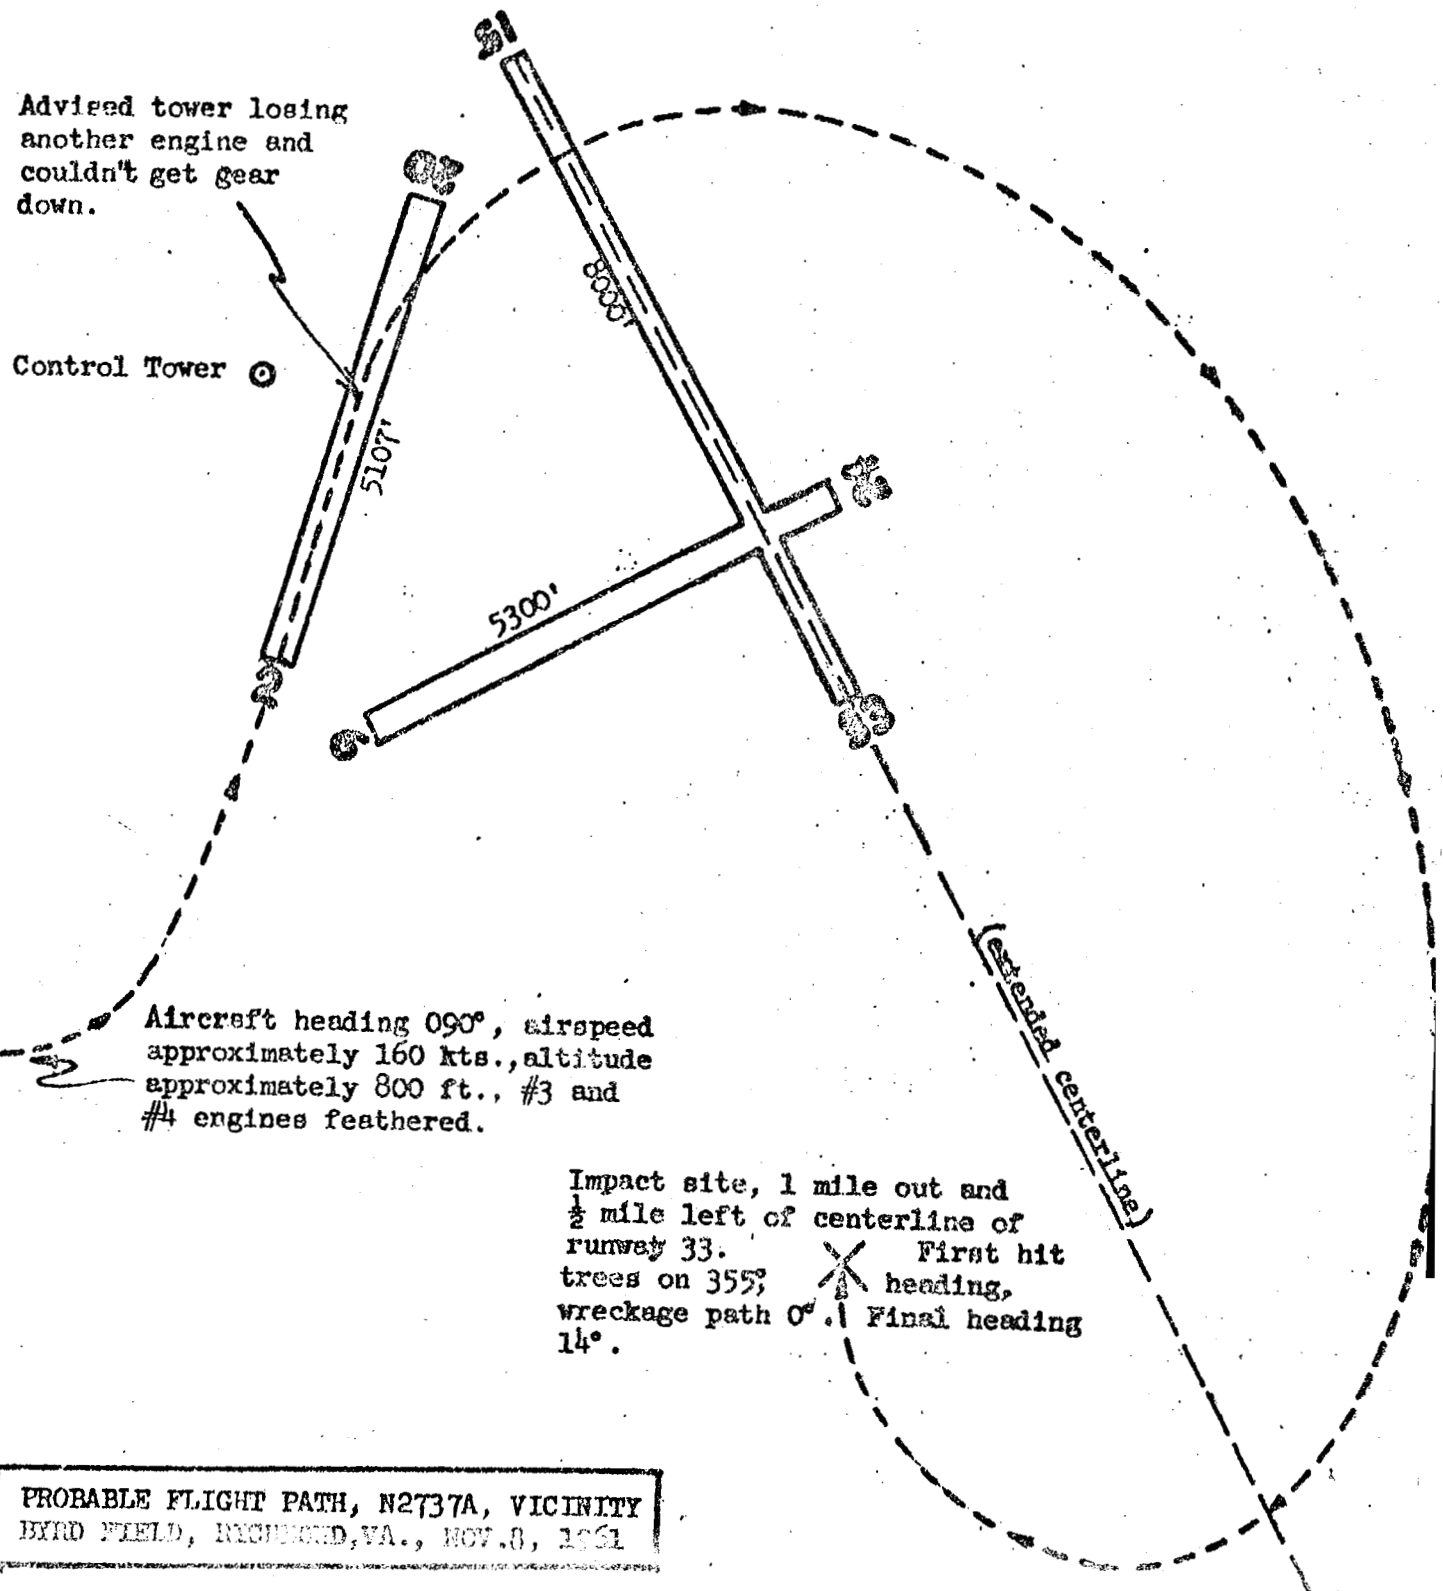
Advised tower losing another engine and couldn't get gear down.
