Report of the Commission of Inquiry appointed by His Excellency the President to inquire into the causes and circumstances in which Loftleider Icelandic Airways Aircraft DC-8-63F TF-FLA met with an accident in the vicinity of the Katunayake Airport on 15th November, 1978

REPORT OF THE COMMISSION OF INQUIRY APPOINTED BY  
HIS EXCELLENCY THE PRESIDENT TO INQUIRE INTO THE CAUSES  
AND CIRCUMSTANCES IN WHICH LOFTLEIDER ICELANDIC  
AIRWAYS AIRCRAFT DC-8-63F TF-FLA MET WITH AN ACCIDENT  
IN THE VICINITY OF THE KATUNAYAKE AIRPORT ON  
15TH NOVEMBER, 1978

COMMISSIONER :  
V. SIVA SUPRAMANIAM

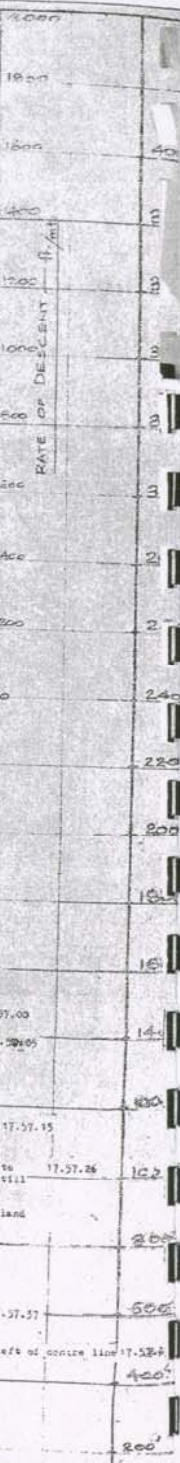
APPROACH PROFILE

13.4.3. The nominal glide slope is 3 degrees and the lower broken line on the drawing is the worst assumed glide slope at 1.48 degrees to the horizon. The curve at the top of the drawing is the descent rate. The text appearing above the nominal glide slope in cages is from the CVR transcript and the text below the glide slope in cages is from the Control Tower tapes. The figure in the cages alongside the conversation is local time.

The failure to monitor the sink rate was a grave lapse which was a contributory factor to the accident. Considering the average ground speed of the aircraft and its gross weight during descent, the appropriate rate of descent would have been 850/900' per minute. The rate of descent appearing on the top of the Approach Profile (Annex VII) indicates that the rate of descent whilst being on the high side for most of the approach has been well above 1,000'/min. on five peak value excursions, the maximum rate of descent being as high as 2,000'/min. and 1,800'/min. in the final phase of descent. *G.P.L.S. - call out not*

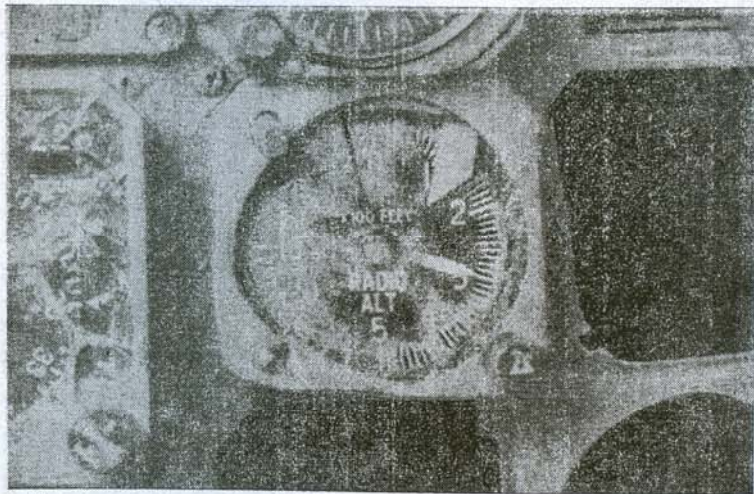
## PHOTOGRAPH OF THE RADIO ALTIMETER

16  
 Captain's side  
 Instruments:  
 Settings:  
 18.1 The obstruction clearance limit (OCL) for an ILS approach to runway 22 at Katunayake is 200' (vide Annex IX). Consistent with this height was the instruction of the Captain to set the Radio Altimeter bug at 250' as seen at 23.26.45 on the transcript (Annex VII). Whilst no call-outs had been made approaching the MDH, the Radio Altimeter (RA) found on the Captain's panel of instruments recovered from the wreckage showed the bug set at 150' —vide the photograph, Annex X. It is not possible to determine at what stage the bug on the RA had been set to 150'.

18.4. On the other hand, if the Captain had correctly set his radio altimeter bug at 250', the warning light would have come on when the aircraft came down to that height. If he was scanning his instruments, he could not have failed to notice that fact. In that event, one cannot understand why he did not overshoot if the runway was not within view.

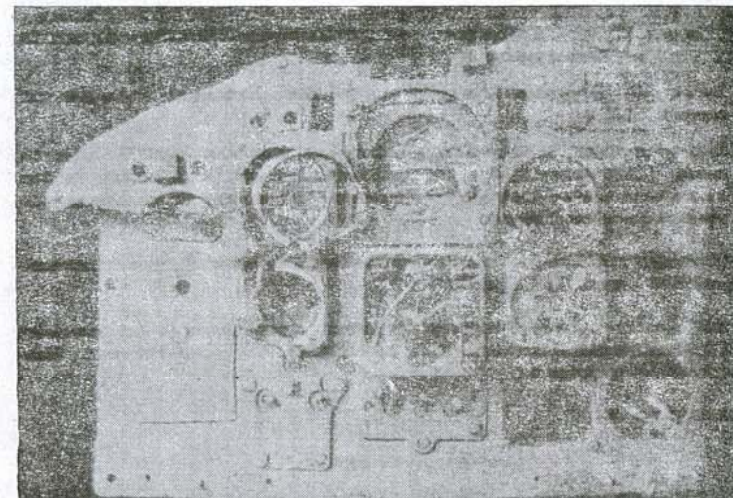
PHOTOGRAPH OF THE PILOTS INSTRUMENT PANEL RECOVERED  
FROM THE WRECKAGE

22.8. Captain Wickramanayake was also questioned about the readings found on the Flight Director of the Captain's panel which was recovered from the wreckage. He stated that the Flight Director was type 109 and that he had himself used Flight Directors of that type.

22.10. The glass of the Course Indicator was only partly broken but there were small pebbles and mud under the glass. The Glide Slope Pointer was not embedded but was movable. In these circumstances, it is not possible to state with any reasonable degree of certainty that the position of the Glide Slope Pointer as shown in the photograph (Annex XIV) was the self-same position at the time of the crash. The position may well have altered as a result of the force of the impact and, in considering the evidence, therefore, much importance cannot be attached to the fact that the photograph shows the indicator to be only about half a dot above.
