AIRCRAFT ACCIDENT REPORT 1/97

**ACCIDENTS INVESTIGATION DIVISION**

Report on the Incident to  
Airbus A320-231 VR-HYU  
at Hong Kong International Airport  
on 6 June 1994

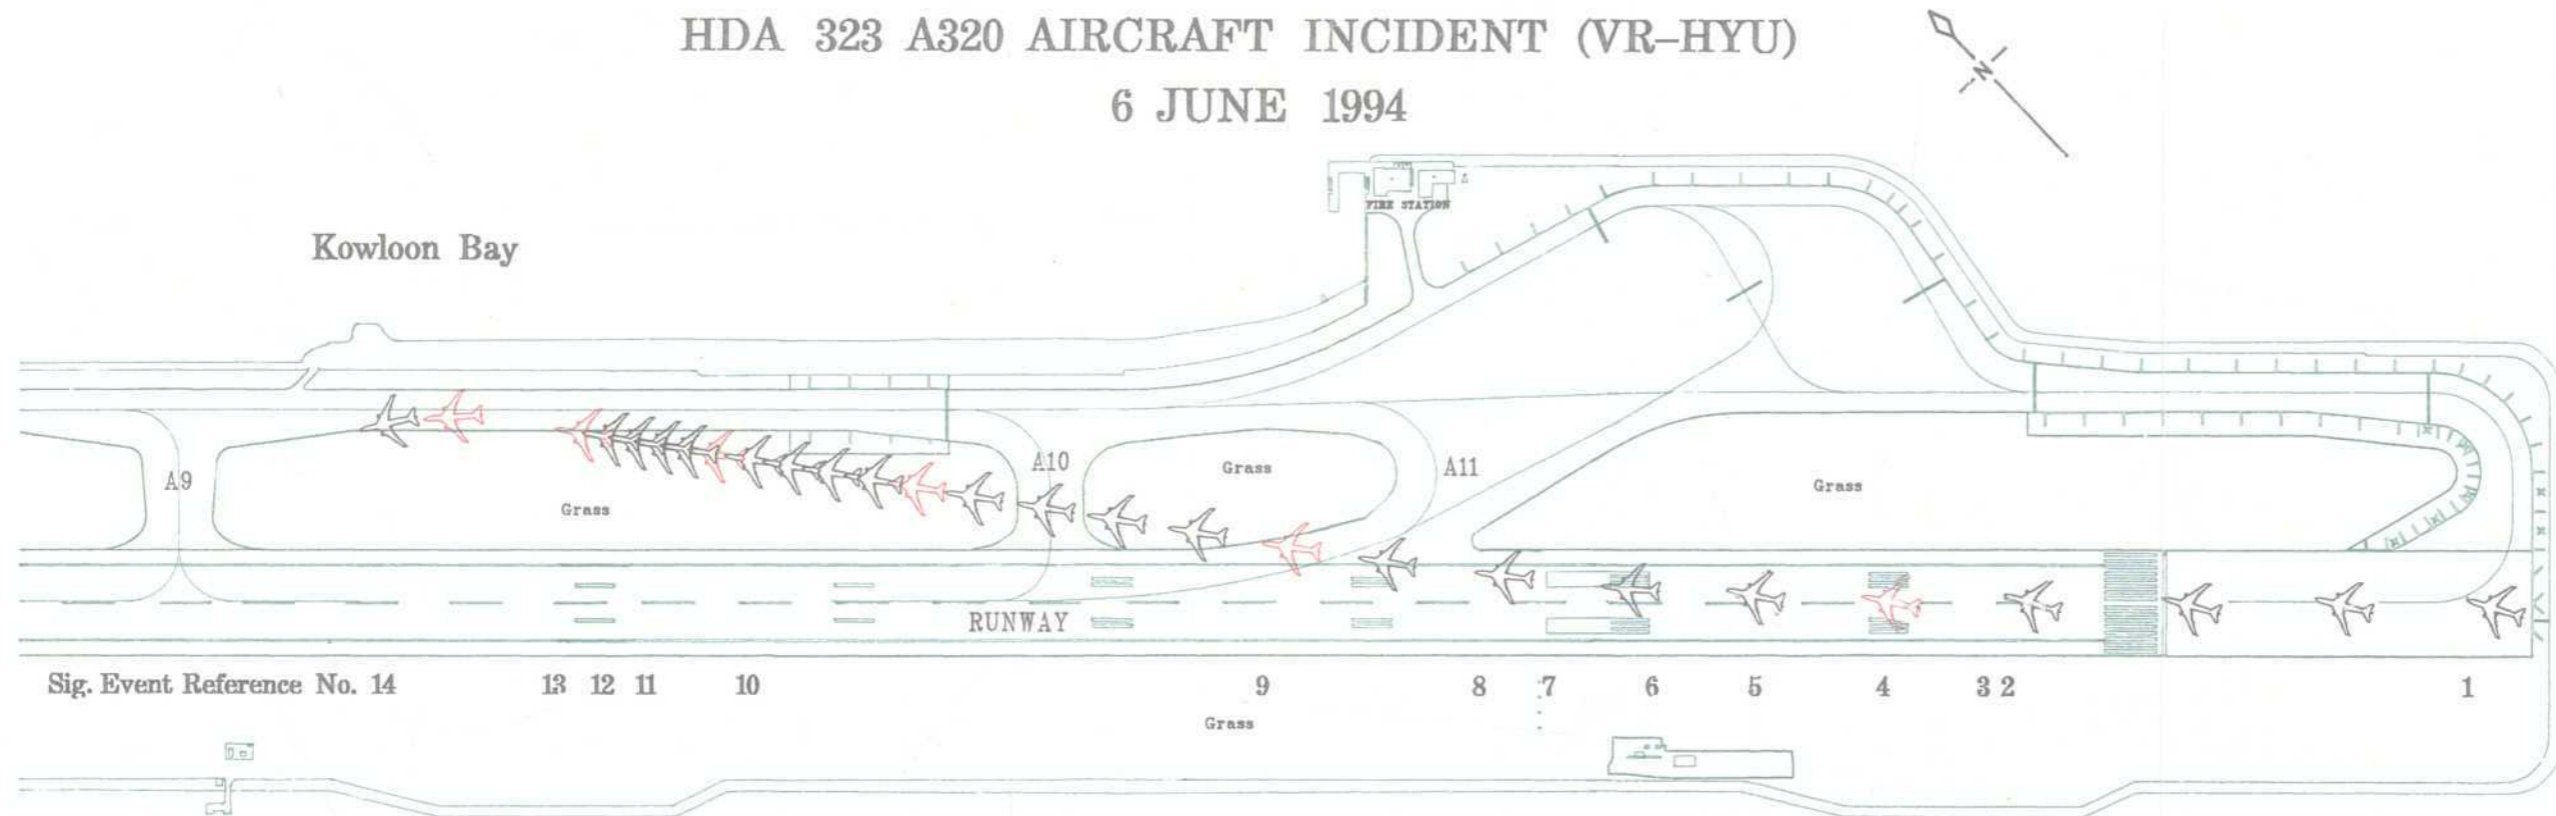
## HDA 323 A320 AIRCRAFT INCIDENT (VR-HYU)

At 0917 hr, the aircraft landed within the normal touchdown zone close to the runway centre-line at a ground speed of 161 kt and tracking 319°T (Runway direction is 314°T). DFDR data showed that the aircraft changed track to 324°T within 5 seconds of touchdown. The aircraft then departed the runway paved surface to the right on to the grass area and headed towards the northern edge of the runway promontory. However, towards the end of the landing roll, the Captain managed to steer the aircraft on to taxiway B1. The outer tyre of the left main gear was punctured and smoke was observed coming from the main landing gear by the Airport Fire Contingent (AFC) who signalled the Captain to initiate an emergency evacuation on the port side. Seven passengers received minor injuries or suffered from shock and were taken to hospital for observation and treatment. A plot showing the events of the aircraft after landing is at Appendix 4.

At the end of the incident sequence the aircraft came to rest by the western side of the parallel taxiway B1 near the grass area close to runway exit A9 (Appendix 4). The aircraft was not structurally damaged. At that time, the wind was quite strong, 15 to 20 kt from the east. There was no fire but smoke was seen coming from the main landing gear due to overheated brakes. The Captain, after checking that there was no fire, initiated an emergency evacuation from the port side of the aircraft when prompted by the AFC personnel. The entire evacuation took about 3 minutes to complete and was carried out in a satisfactory and expeditious manner. Seven passengers received minor injuries and/or suffered from shock and were taken to hospital for observation and medical treatment. Three of these passengers were classified as having suffered minor injuries.

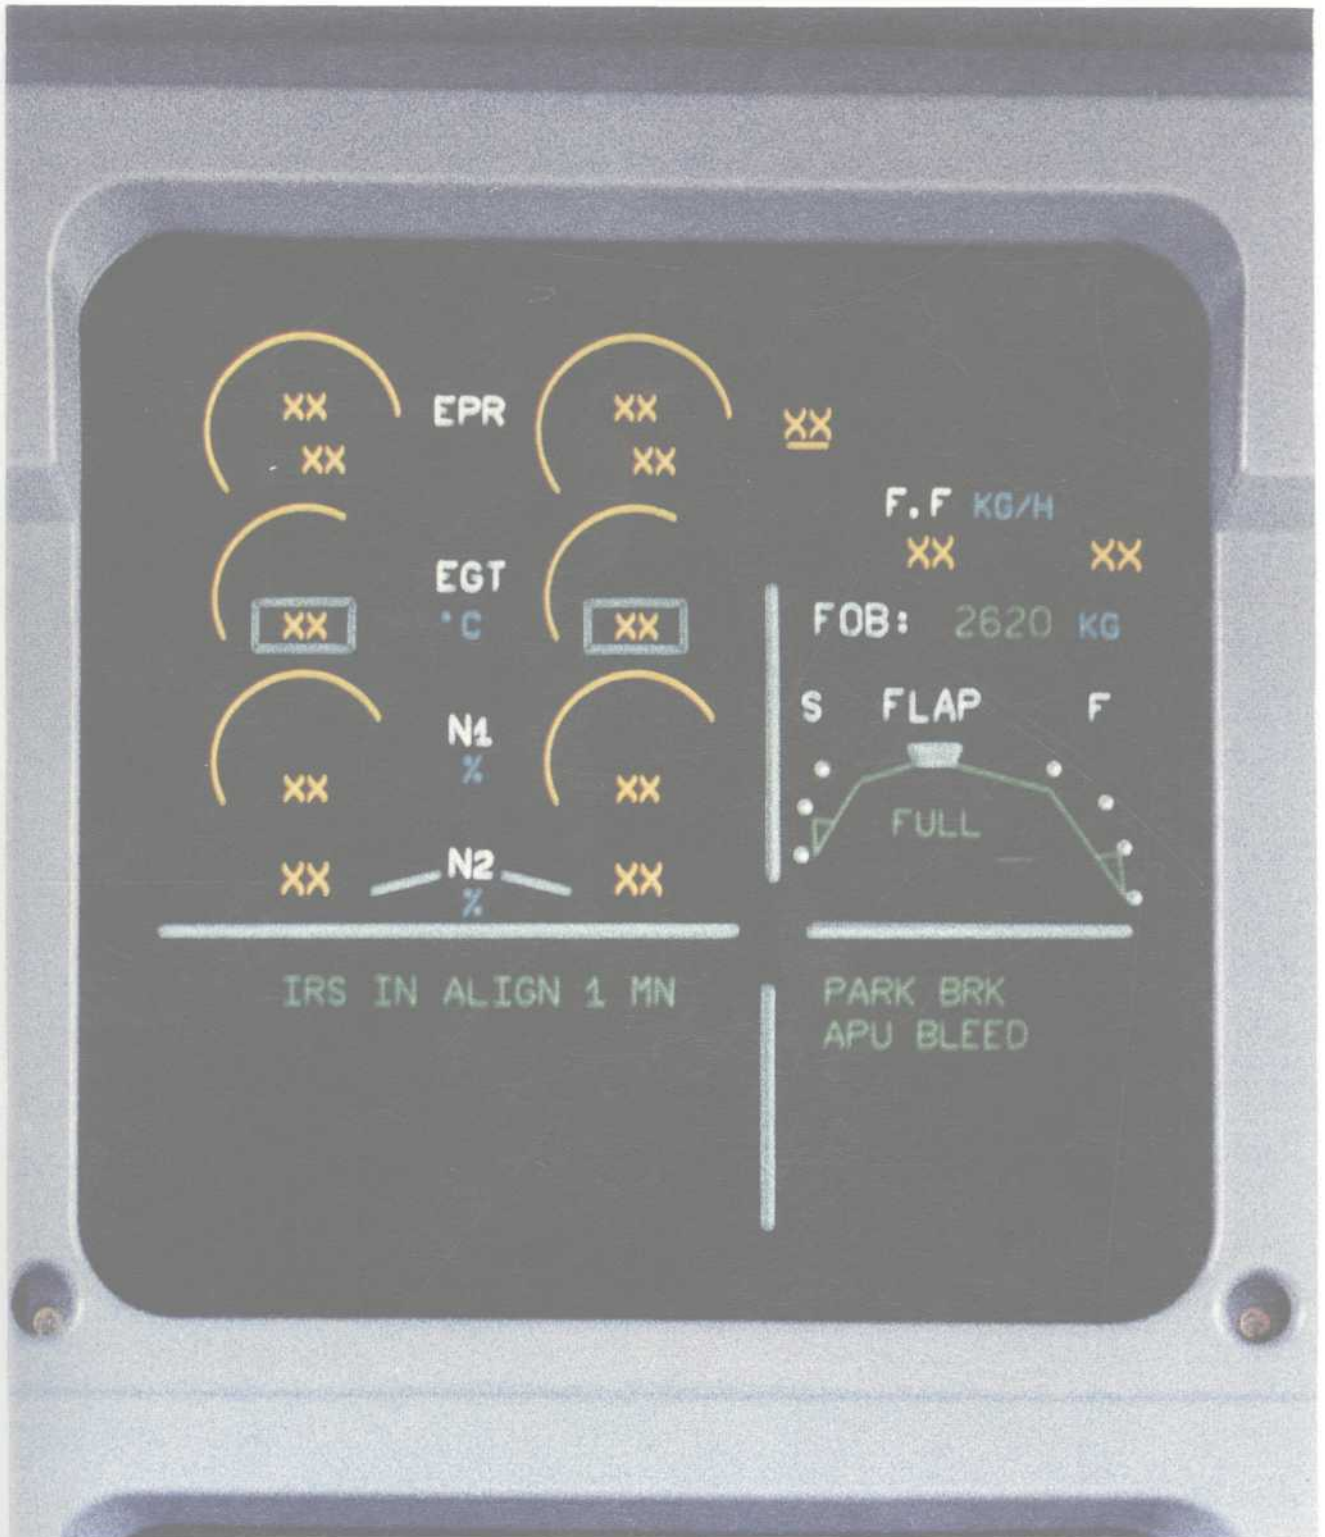
ECAM Indications with CONFIG FULL selected

The ECAM indication of the slats/flaps positions in normal 'FULL' configuration is shown at Appendix 6A. The indication of a flap lock at 'FULL' is shown at Appendix 6B. The symbol "FLAP" and the flap position line have changed to an amber colour. The indications on flap locked at full while the FLAPS lever is moved to Config 3 and 2 are shown at Appendices 6C and 6D respectively. It should be noted that the amber "flap" symbol and position line do not change but the selected positions (indicated by the green slats position line, a blue small triangular flap symbol and a blue position figure) do. It appears that the crew repeatedly ignored the amber indications and mistook the selected position indications as the flap lock position.

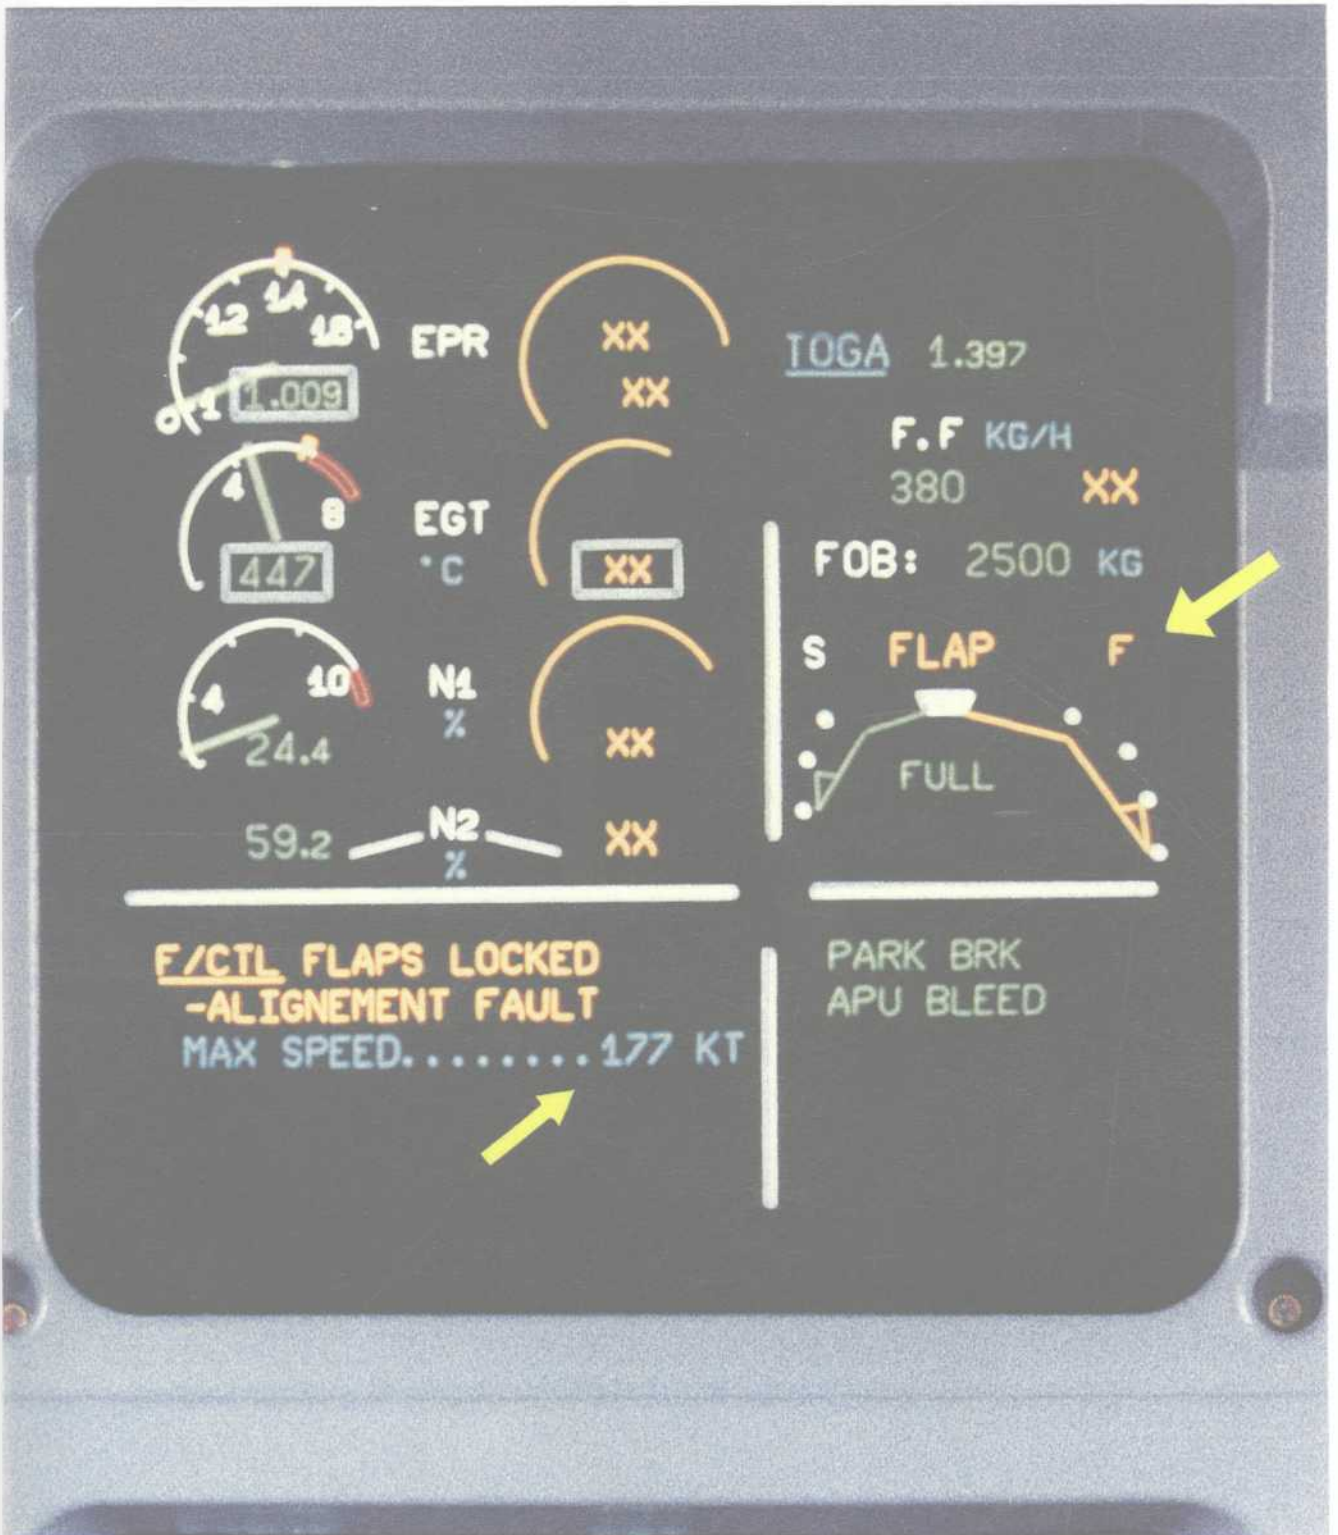
FLAPS lever set at CONFIG FULL  
Flap locked at FULL Indications

Immediately following the gust encounter, the master caution triggered an audio warning together with the ECAM F/CTL FLAPS LOCKED warning as shown at Appendix 6B. Something unusual had obviously occurred and the Captain had to make an immediate decision to land or go around. The primary concern was whether the approach could be continued to a safe landing and to evaluate this required an appreciation of the nature of the problem which caused the warnings. As the aircraft was on short final and was being flown visually, the crew had very limited spare capacity to evaluate the situation. An immediate evaluation of the ECAM indication required the crew to be totally familiar with the ECAM display. Instead of continuing the approach to land with the flap lock, the Captain decided to carry out a go around and resolve the problem later. The decision was probably affected by the violence of the gust encounter immediately preceding the ECAM warning, which could have engendered the expectation of a serious problem. In addition, unfamiliarity with the fault displayed may have predisposed the crew towards a "safe" decision, i.e. one that allowed time for analysis.
