FINAL REPORT

96-12/A-5

G-JTCA, Piper PA23 Aztec

Final Report of the investigation into the probable cause of the accident with the Piper PA23 Aztec, G-JTCA at De Kooy Airport, Den Helder, The Netherlands on 11 march 1996.

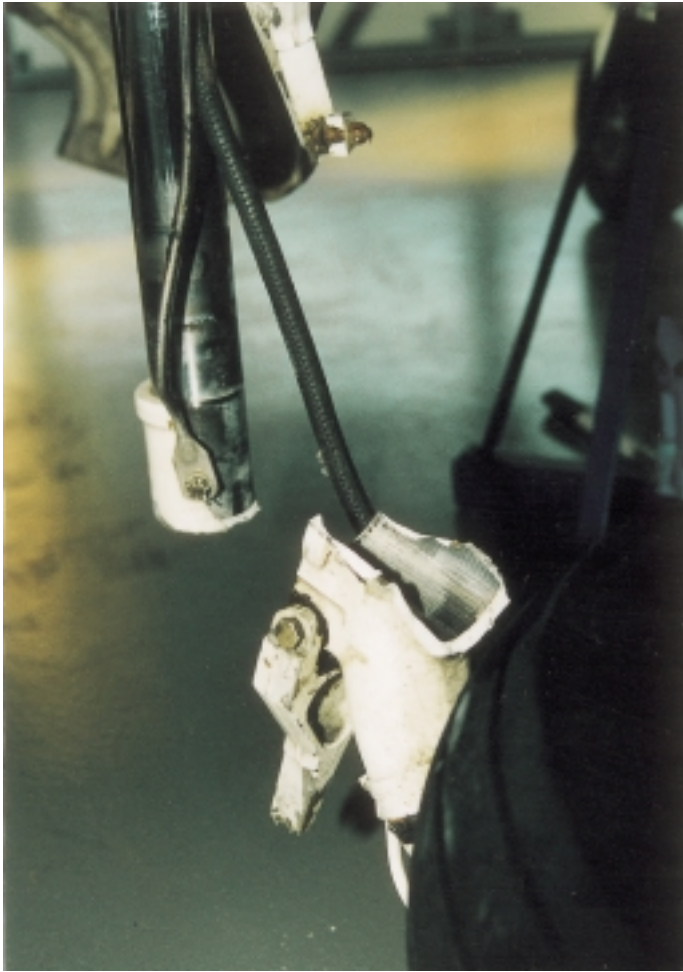
Figure 1
General View of Damage

A part of the fork assembly from the left main landing gear from A/C G-JTCA (Piper Aztec) was submitted for investigation. The landing gear failed after arrival of the airplane at De Kooy airport (11 march 1996). Figure 1 shows a general view of the damage. Figure 2 presents a close-up of the submitted part.

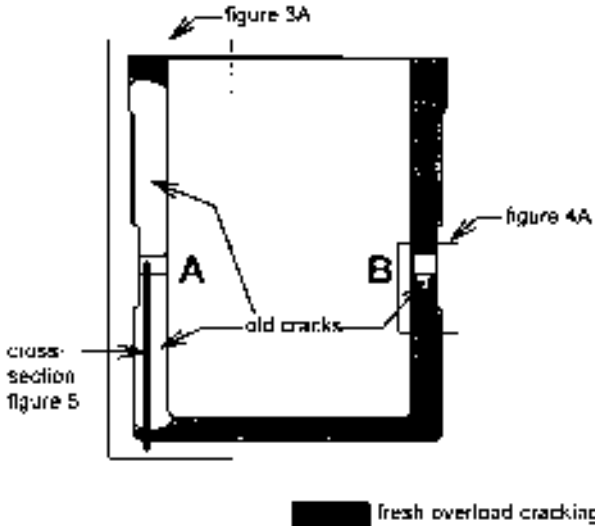
Figure 2 presents also a sketch of the broken part. Old cracks are present around both bolt holes. The old crack around bolt hole A (figure 3) covers nearly the full length of the part. This crack is covered by white corrosion products (typical for corroded aluminum). Bolt hole A itself shows strong corrosion pitting, with some brown deposits (most likely corrosion products from the steel bolt).

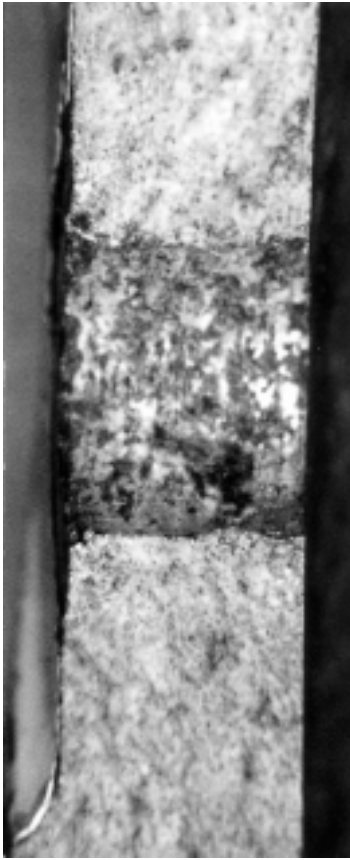
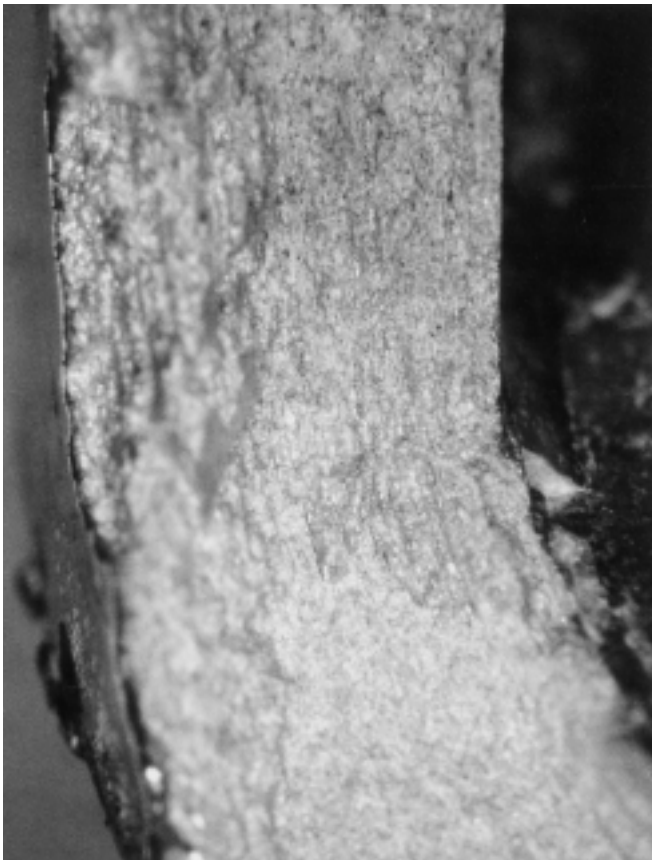
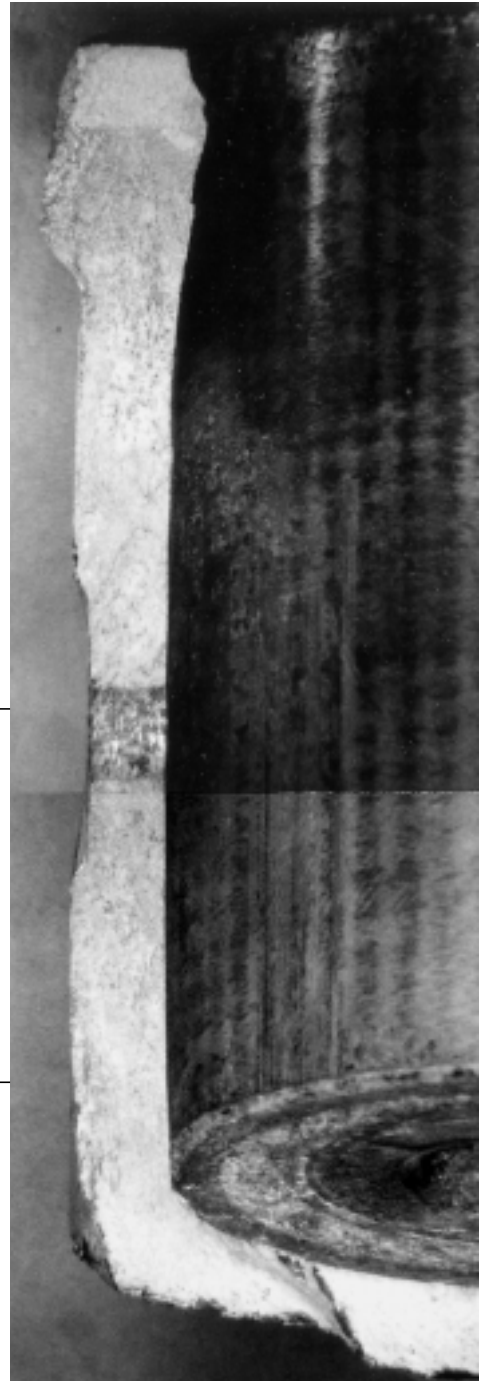
Figure 3 Crack around Hole A

Figure 3B; magn. 6,5x

Figure 3C; magn. 10x

Detail at end of
old crack

Detail around hole:
note the heavy
pitting in the bore.

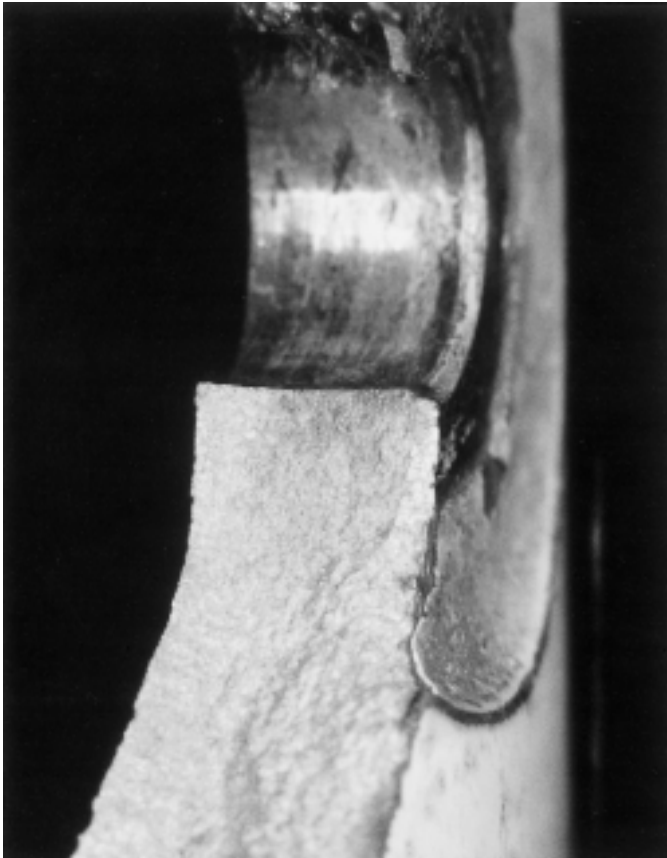
The old crack around bolt hole B (figure 4) is much smaller. Bolt hole B is relatively free of corrosion.

Figure 4A; magn. 6,5x
The hole itself shows only minor corrosion

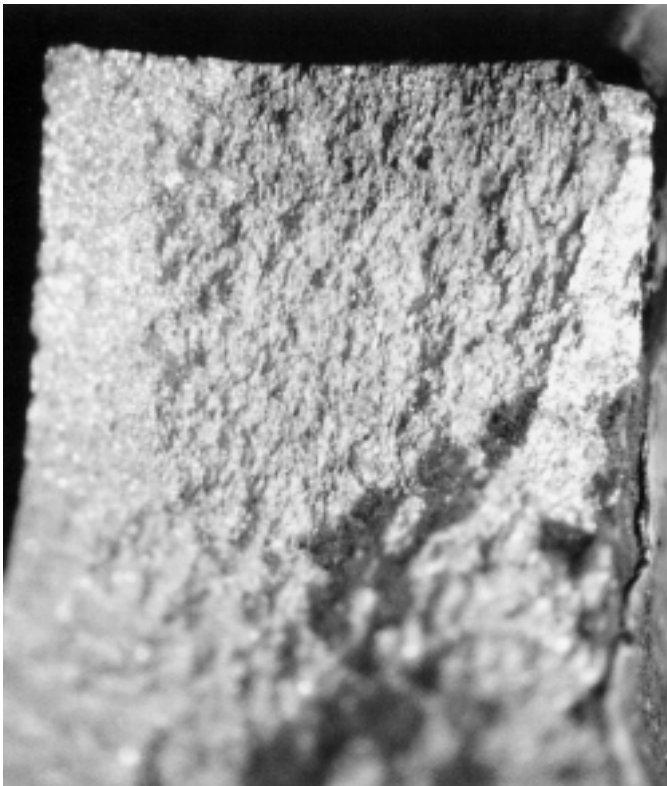
Figure 4B; magn. 16x
Detail from figure 4A.
The old "thumb-nail" shaped crack is surrounded by fresh overload cracking. The texture of the old crack reflects the forging material flow.

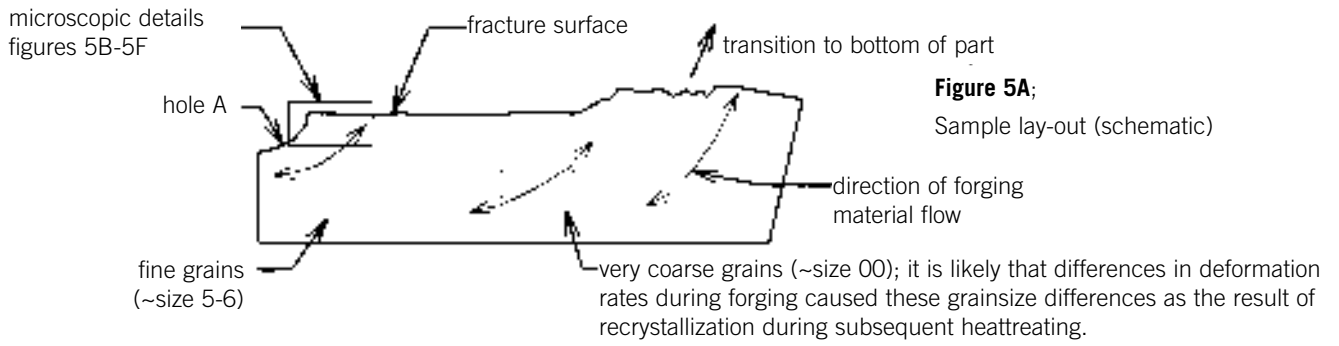
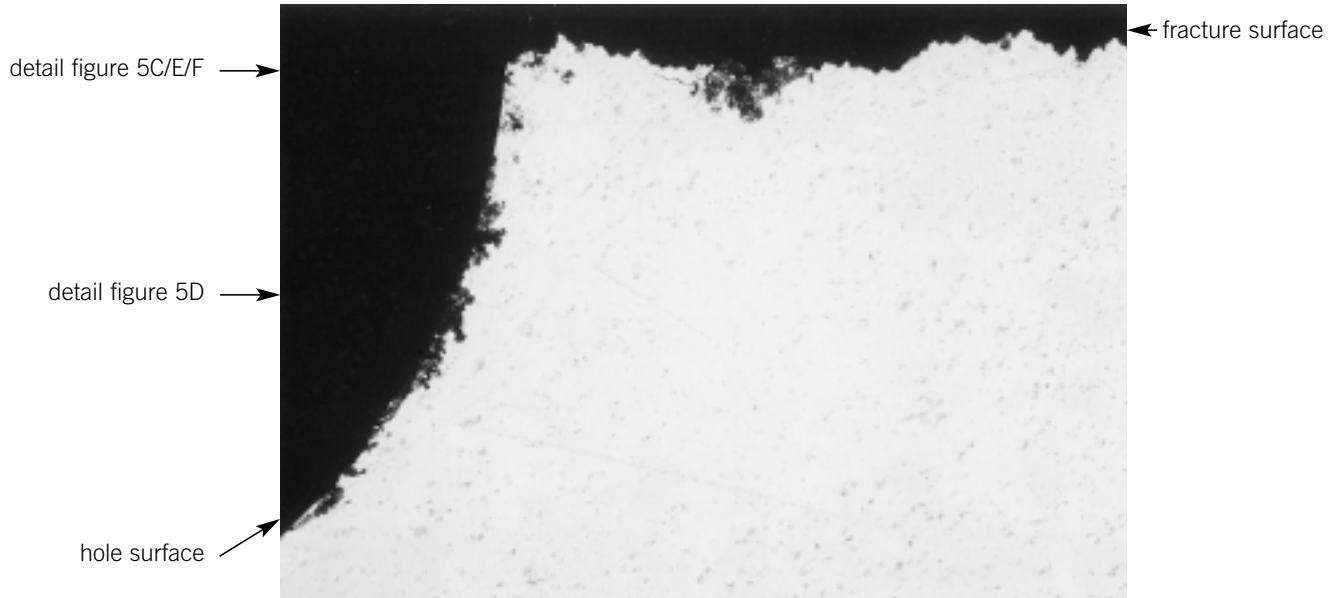
A metallographic sample was prepared passing a part of the crack around hole A (in a tangential plane; see figure 2 for orientation). Figure 5 shows a sketch and several details. Heavy corrosion pitting is evident at the bolt hole. The corrosion along the fracture surface has an intergranular character. This corrosion mode can be classified as stress corrosion.

Figure 3B; magn. 31x; unetched
 Note the corrosion pitting at the hole surface.

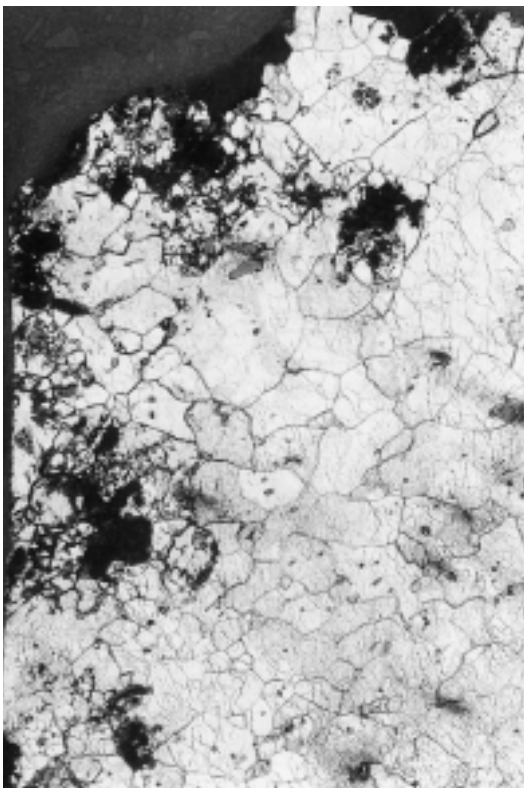
Figure 5C; magn. 200x; unetched
 Detail from figure 5B (intersection of hole surface and fracture surface)

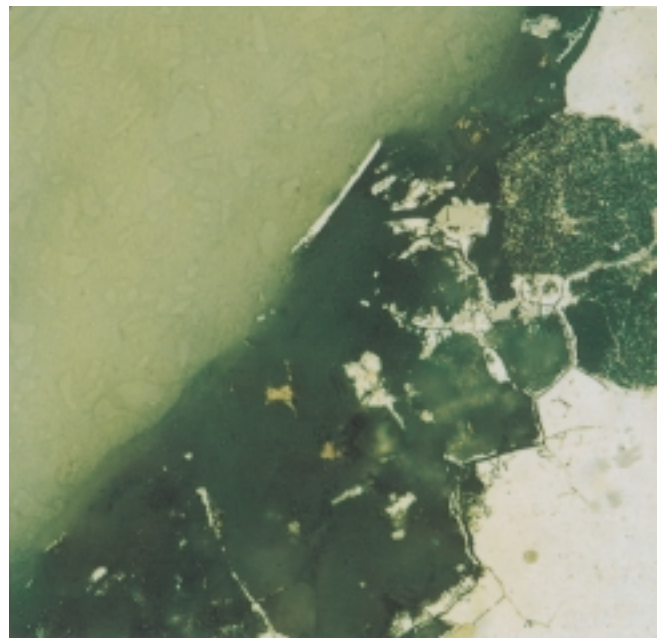
Figure 5D; magn. 500x; unetched
 Detail from figure 5B
 This detail shows one of the corrosion pits at the hole surface at higher magnification. Galvanic corrosion attacked the aluminum alloy was "saved" and concentrated in copper particles. These copper particles were found at several locations where pitting occurred (both at the hole surface and at the fracture surface).

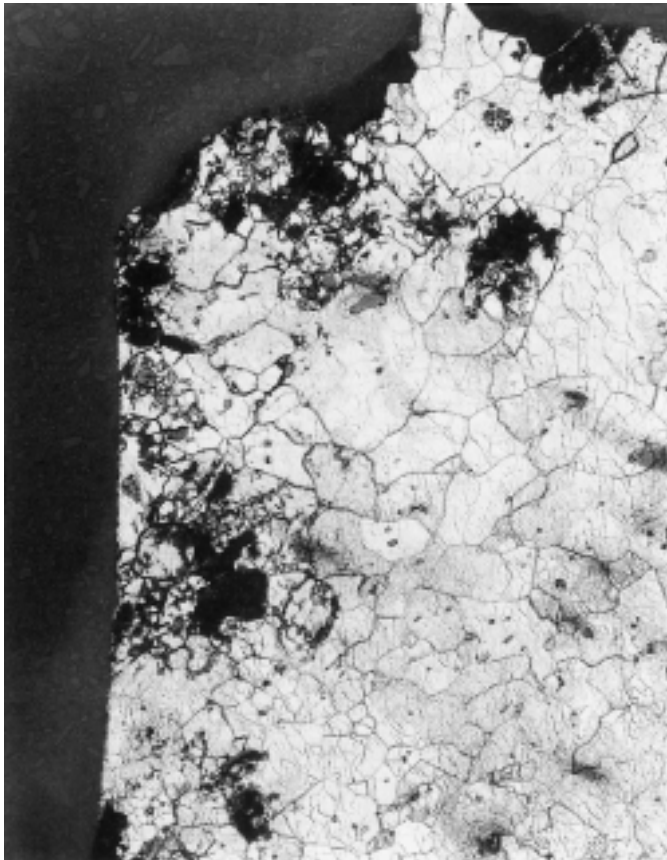
Figure 5E; magn. 200x; Keller's etch
same area as figure 5C
