Air Accidents Investigation Branch

**Report by the Dominican Republic Authorities
into the accident to Boeing 757-200, G-WJAN
at Puerto Plata Airfield, Dominican Republic
on 1 January 1998**

Air Accident Report No 3/99

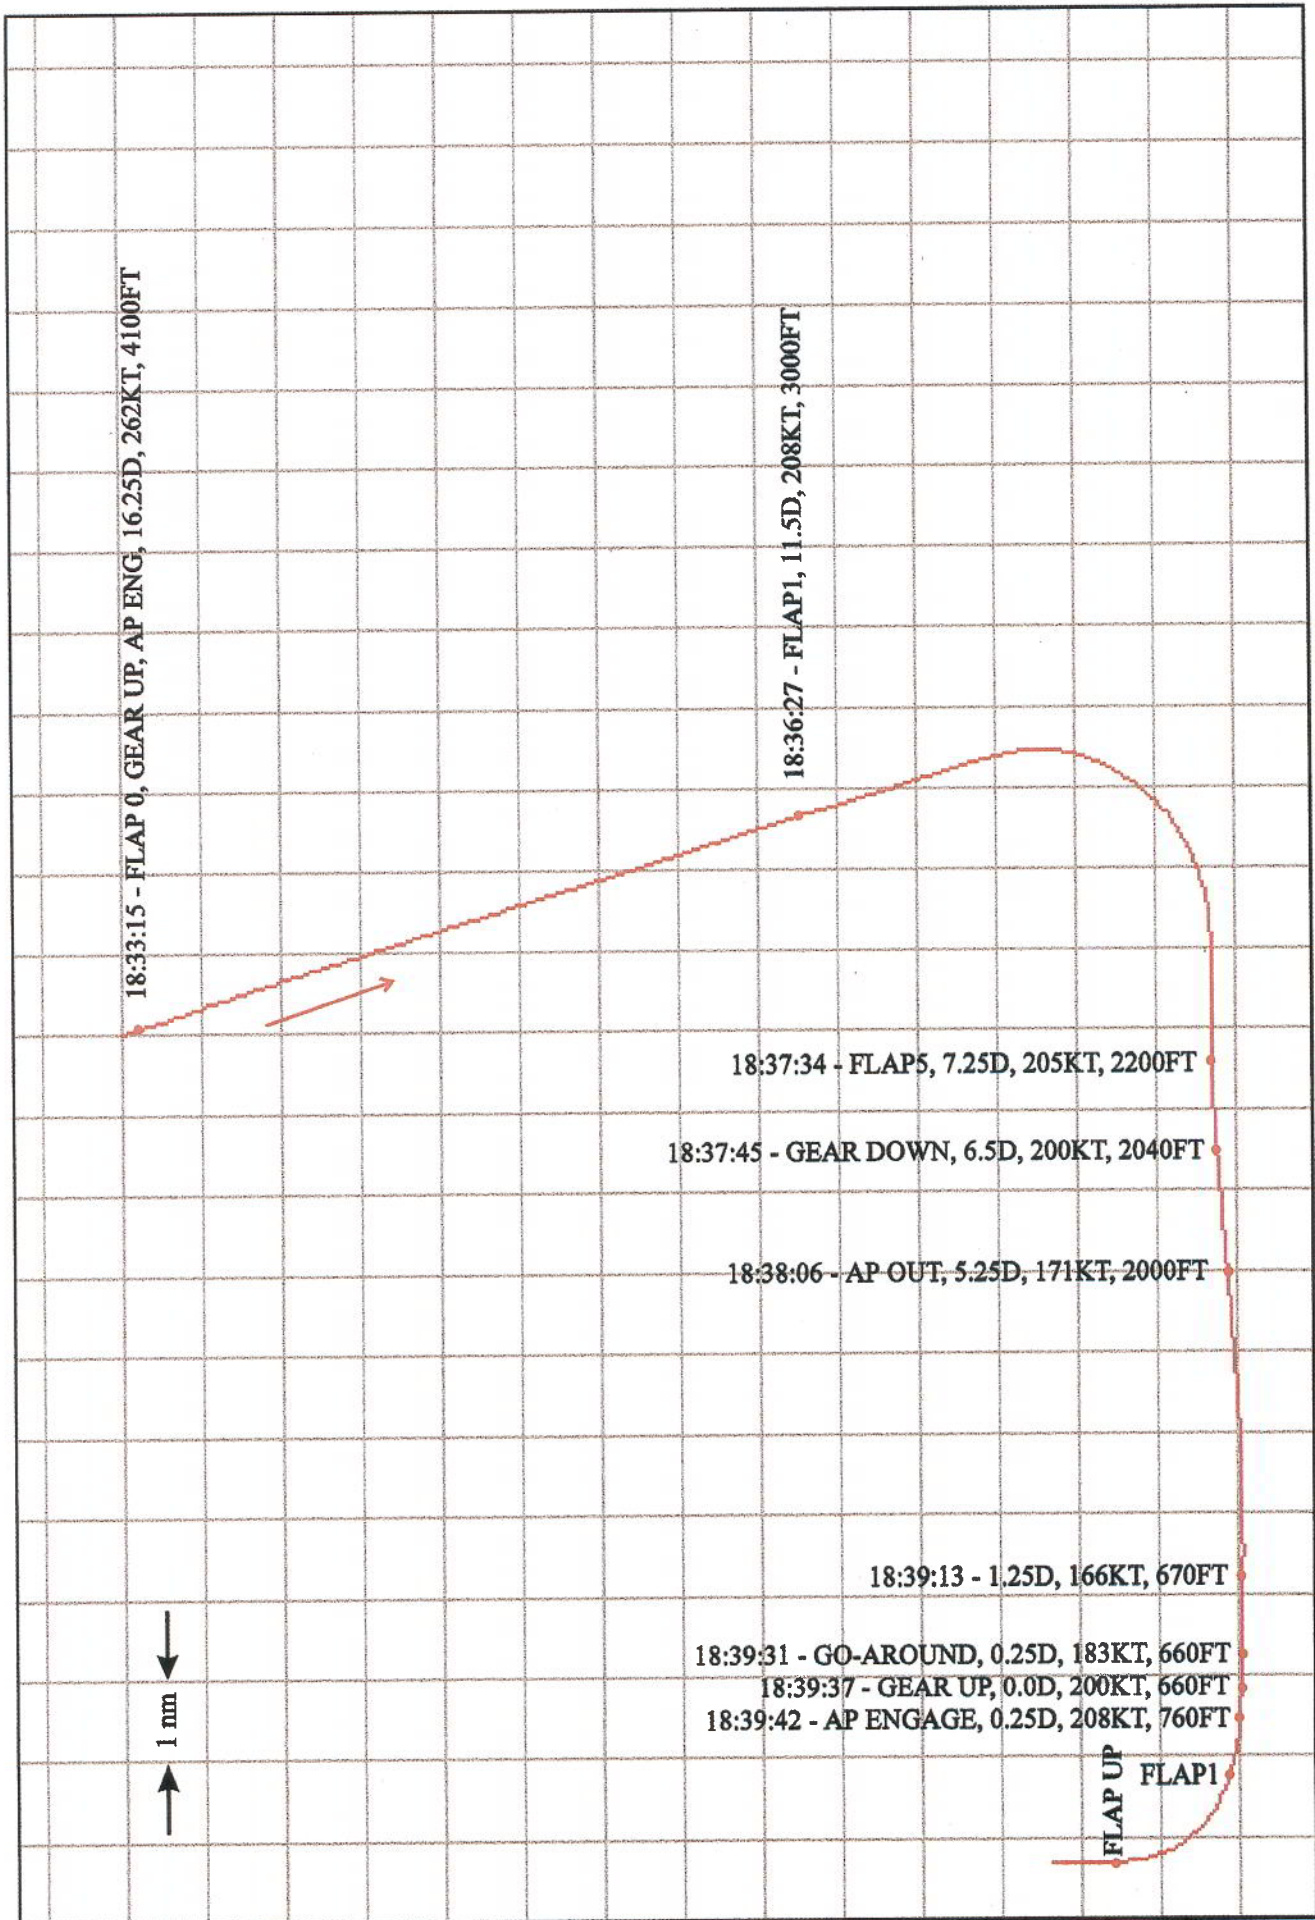
APPENDIX 1

During the right turn onto the inbound track of 263° flaps 1 was selected and the final descent commenced. Once established on the inbound radial, and at a range of 7.25 DME, flaps 5 was selected whilst at 2,300 feet and 210 kt, the gear was selected down at 6.5 DME. The aircraft was still at 2,000 feet at 5.25 DME when the pilot disconnected the autopilot (AP) and commenced the descent to the published Minimum Descent Altitude (MDA) of 660 feet. The aircraft reached the MDA at 1.25 DME and then briefly flew level at this altitude but no visual contact was established with the ground until just prior to commencing the go-around (GA) which was initiated at 0.25 DME by engaging the go-around switches. The published Missed Approach Point (MAP) was at 1.2 DME which was 0.3 nm from the runway threshold. An annotated ground track derived from the FDR using recorded heading and drift angle together with a descent profile for this first missed approach are plotted in Appendix 1 and Appendix 2 respectively.

First missed approach (ground track)

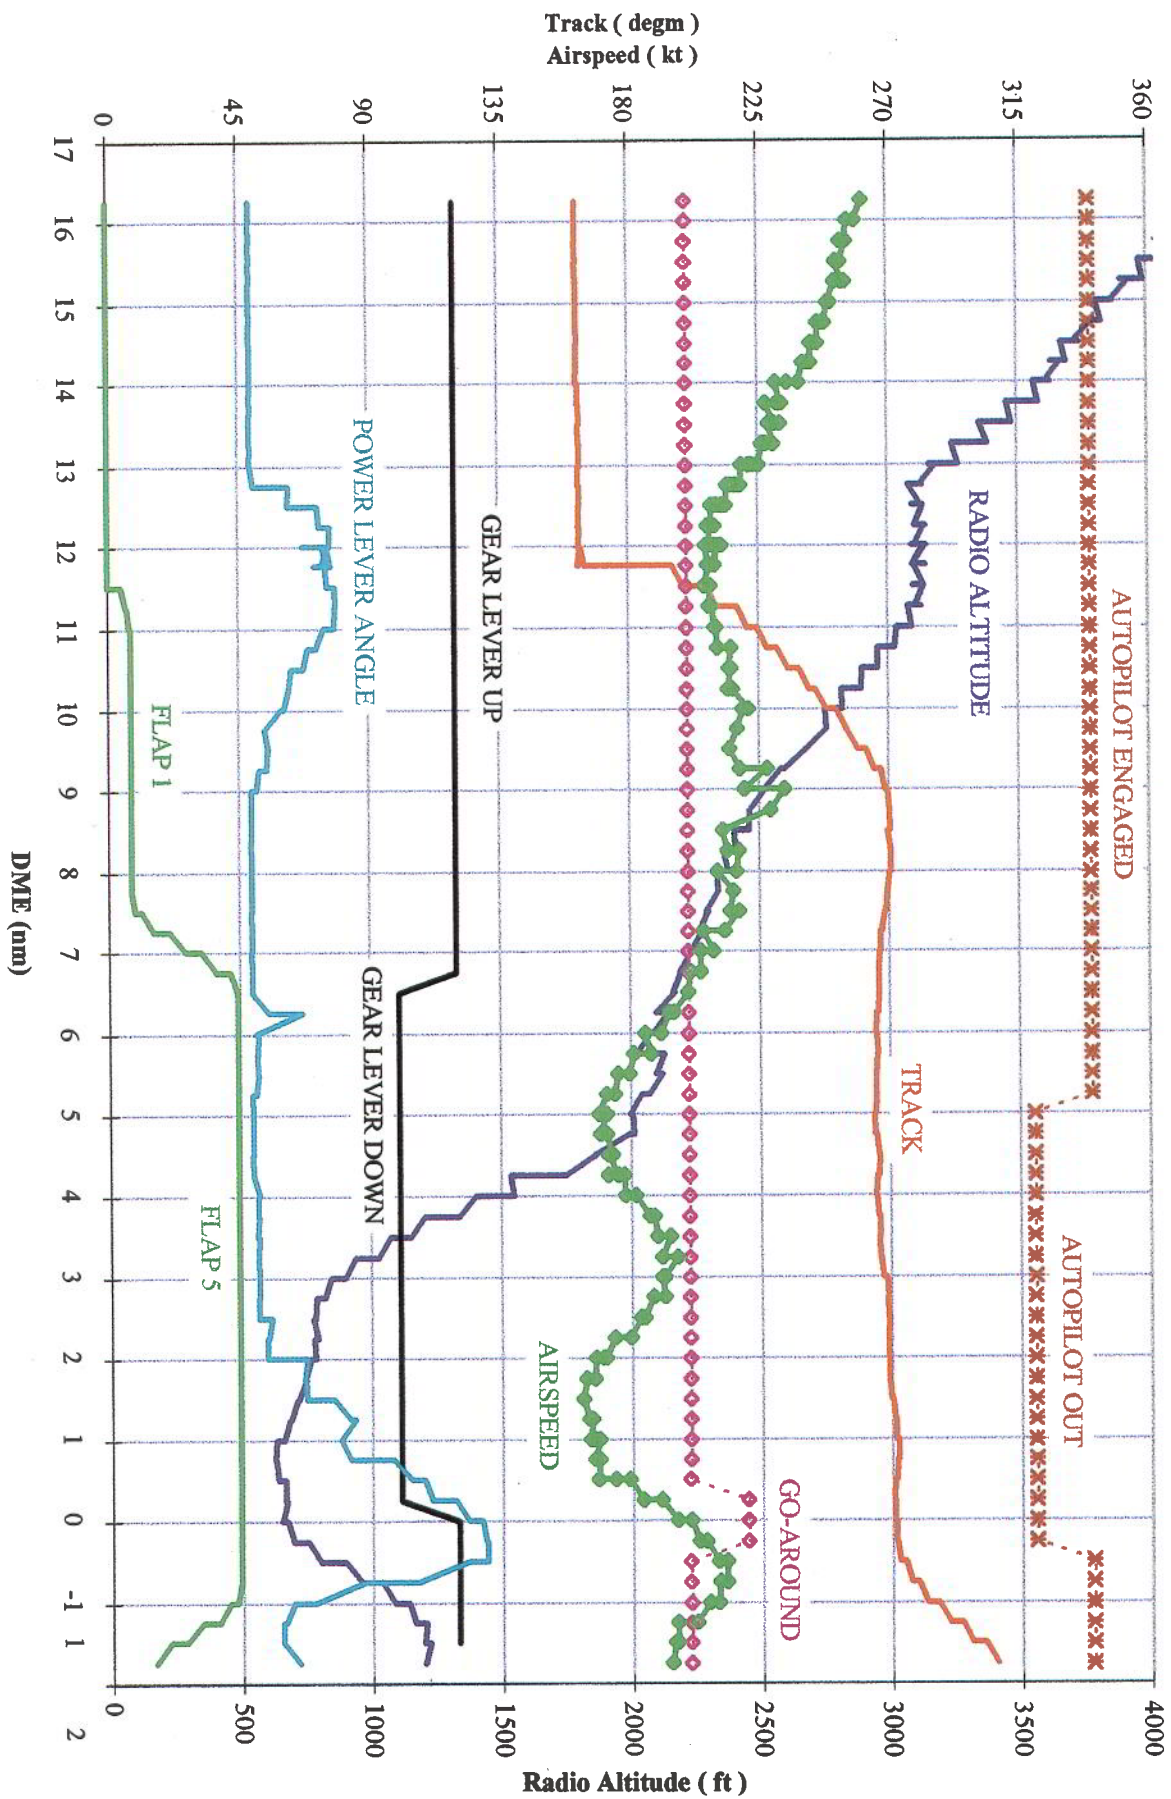
APPENDIX 2

First missed approach (descent profile)

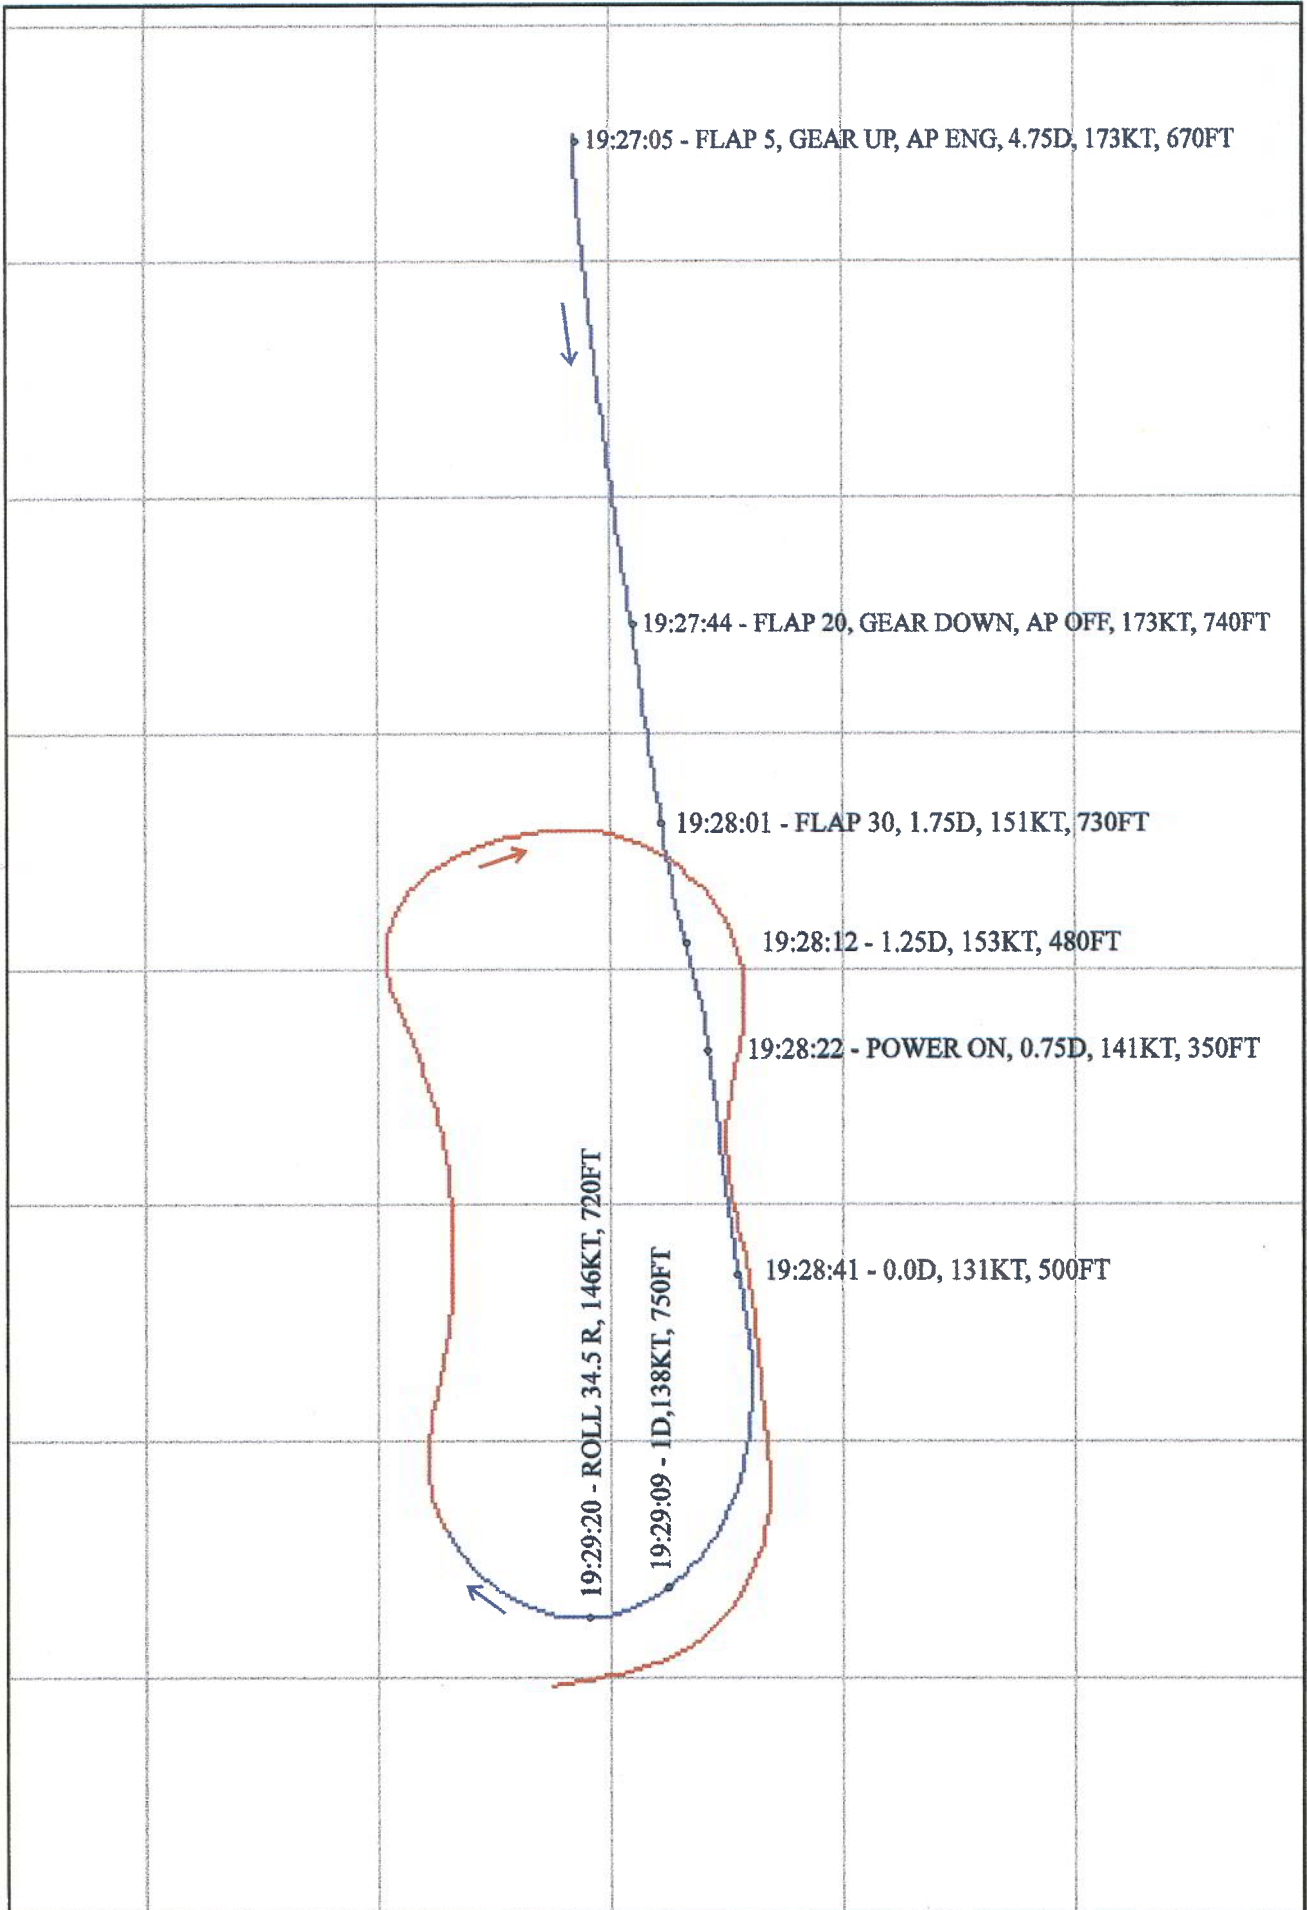
APPENDIX 3

Second missed approach (ground track)

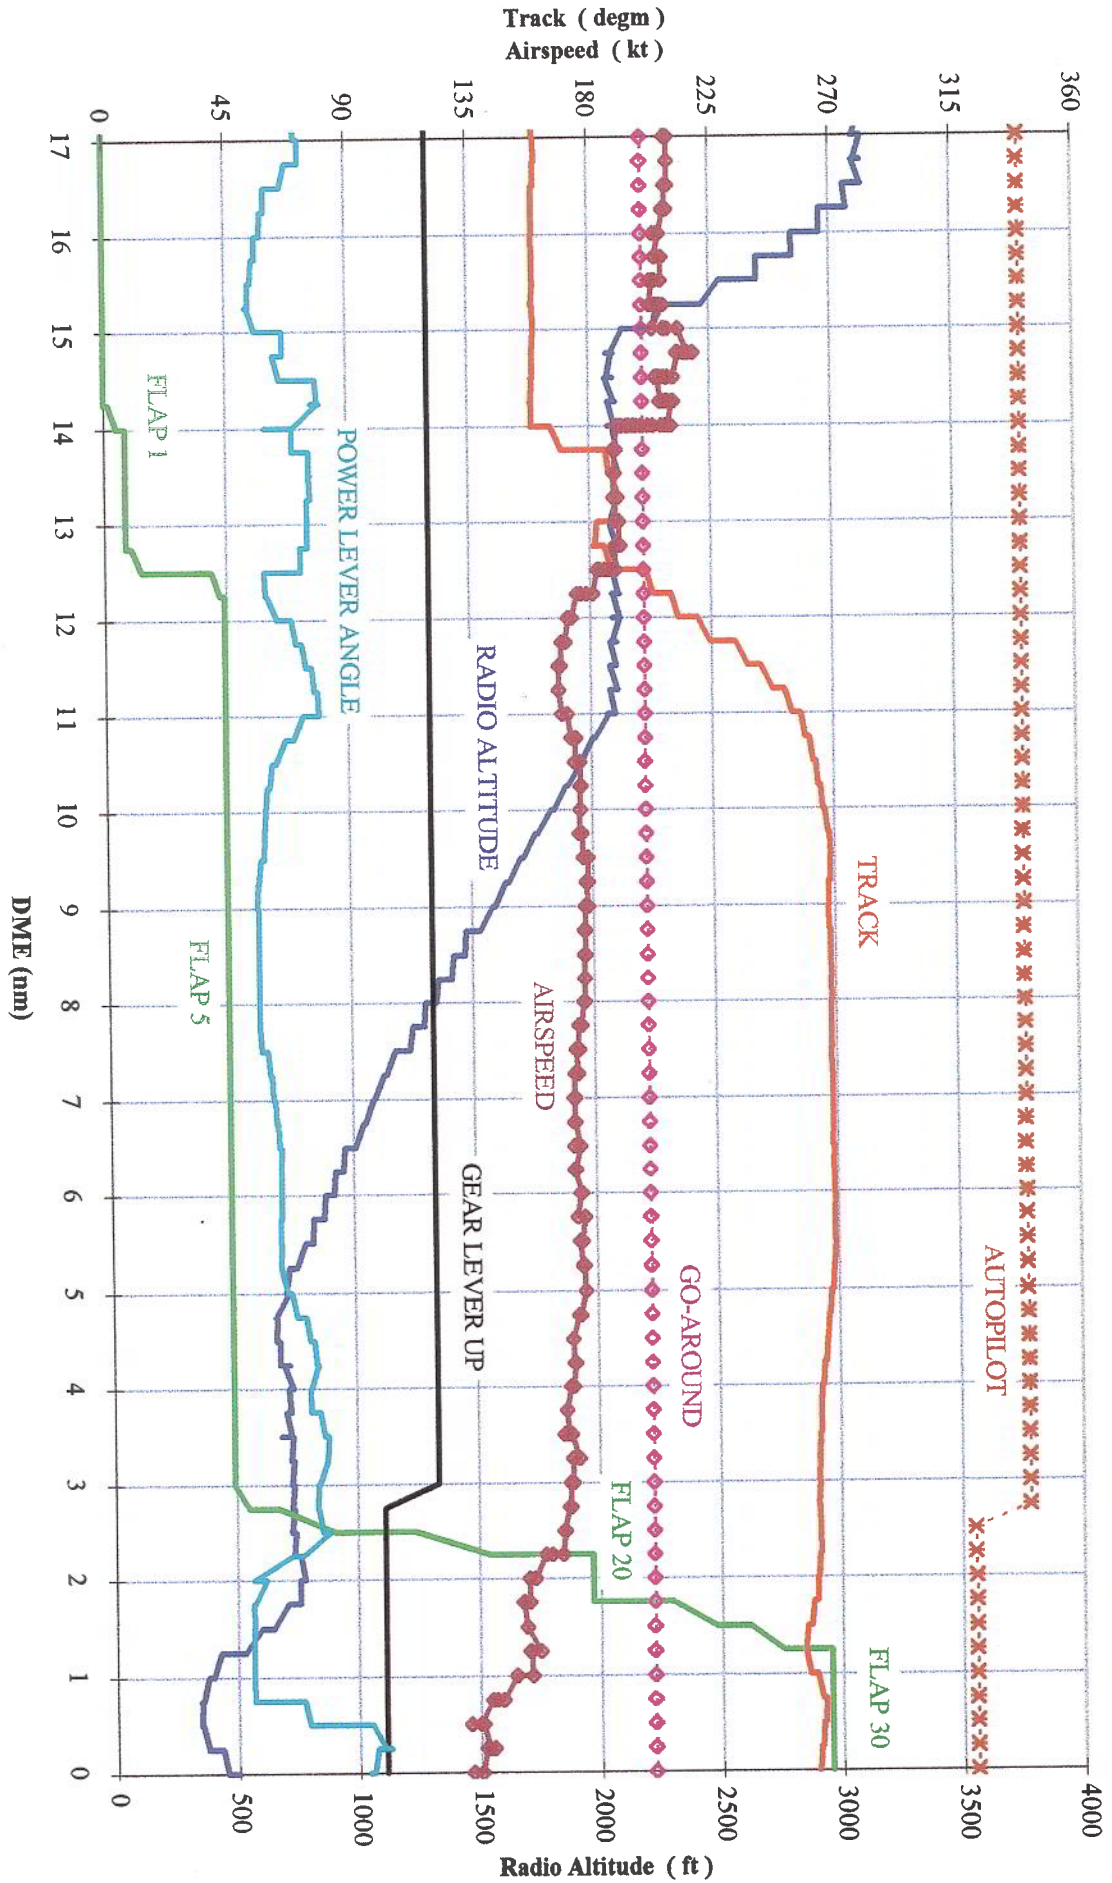
APPENDIX 4

Second missed approach (descent profile)

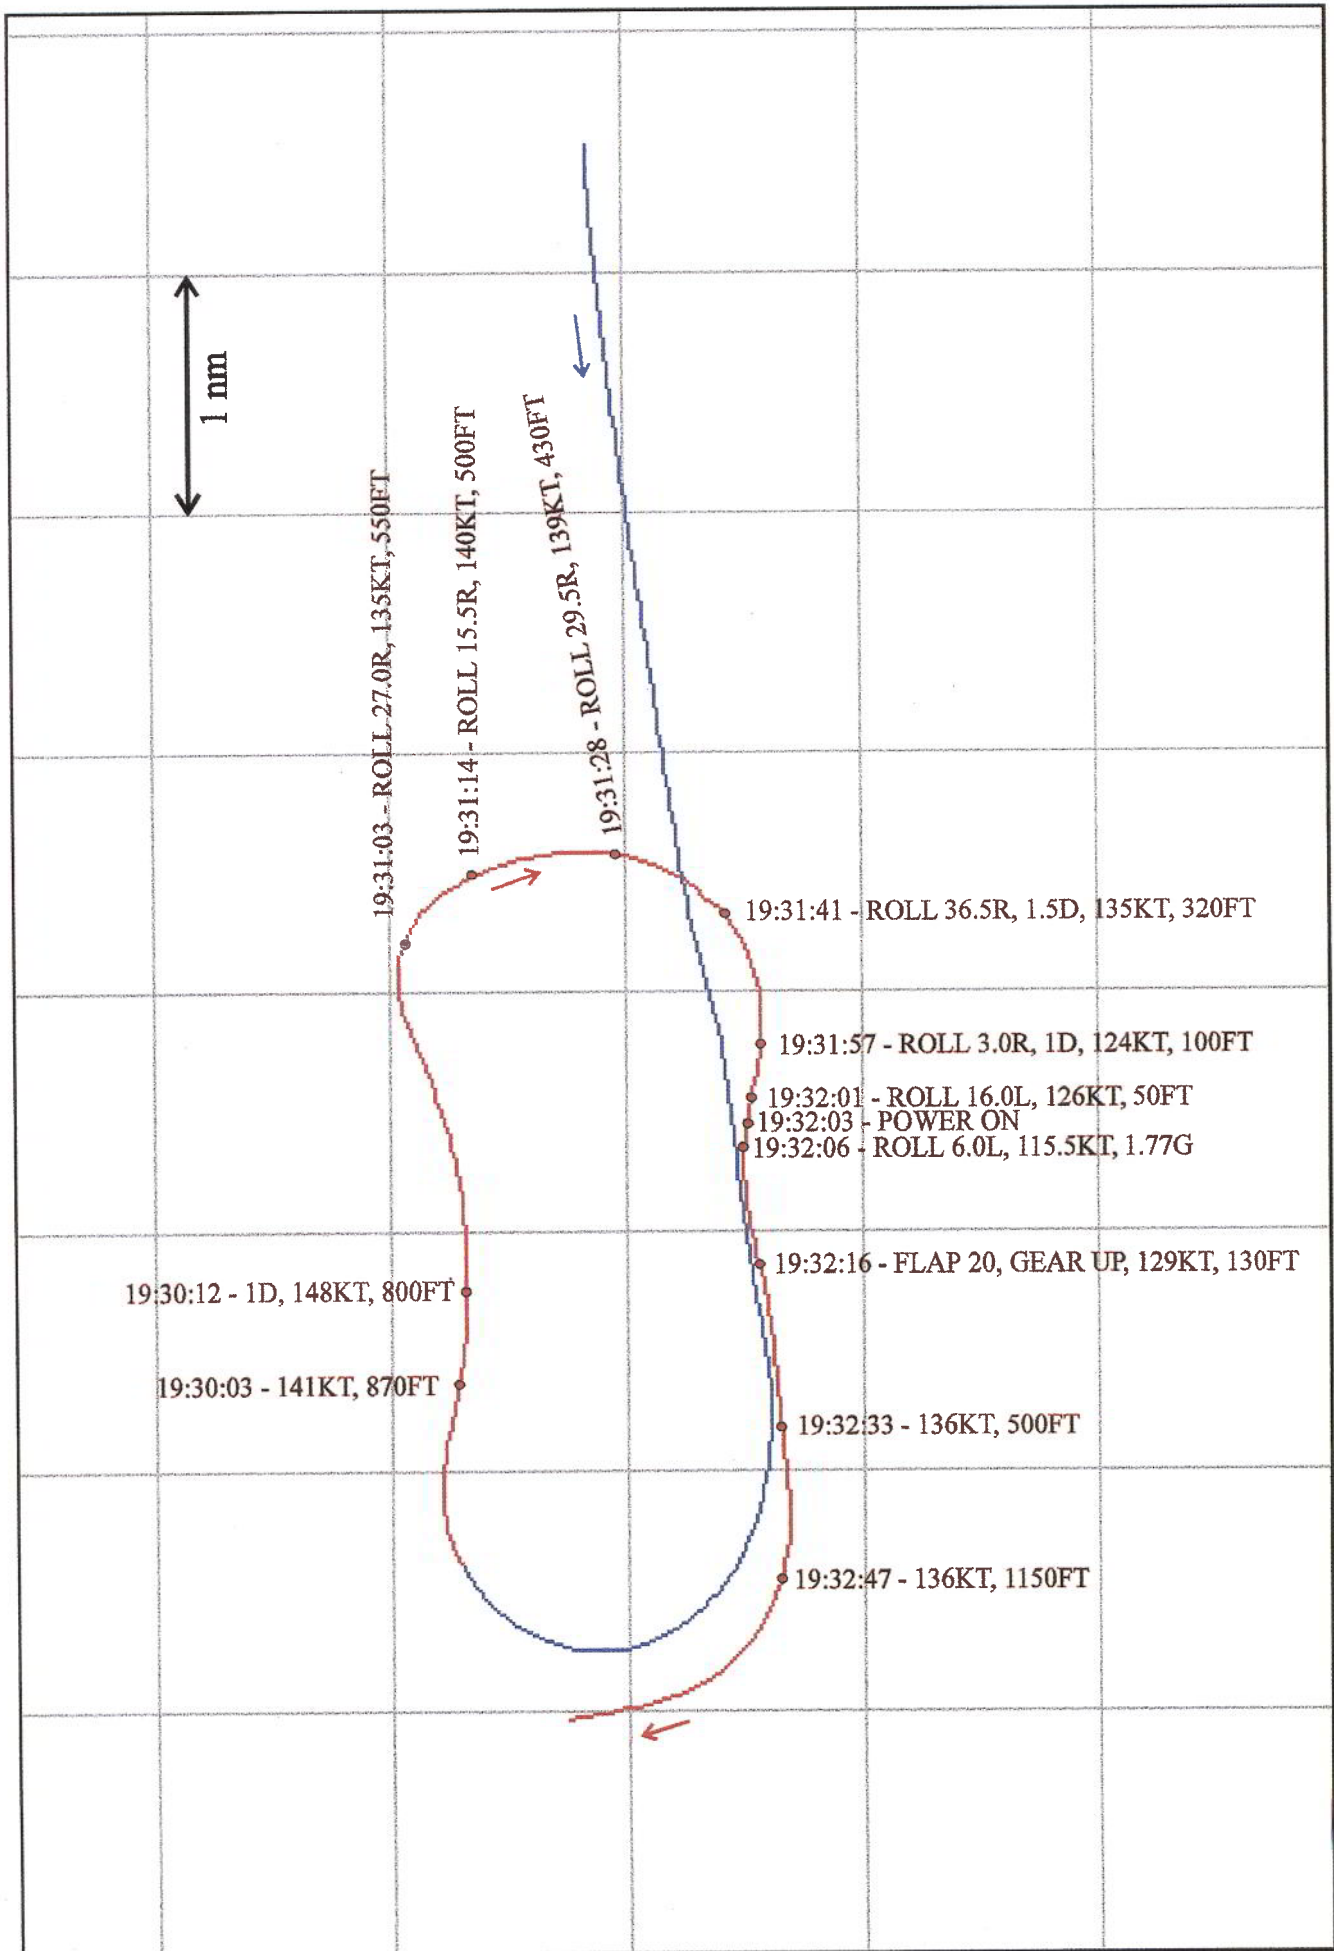
APPENDIX 5

The aircraft was still displaced to the left of the extended centre-line despite the application of these significant bank angles. As the aircraft tracked from left to right onto the extended runway centre-line, below 100 feet, left bank and up to 13.5° of left rudder was applied in an attempt to stabilise on the centre-line but to no avail. As the aircraft crossed the runway threshold both crew members perceived that the inertia was still taking the aircraft to the right. The highest reading of 15.8° left wing down occurred at a height of 45 feet above the ground, the FDR recorded that the thrust levers were retarded and the airspeed decreased to 116 kt. Shortly after the automatic height call out at 50 feet the crew reported that the FO called 'Go-around'. At about this time the bank angle to the left was reduced to 5.6° as the pitch up attitude increased to 10.2° and both thrust levers were fully advanced. One second later, at 1932 hrs, the aircraft struck the ground in scrub land to the right of the runway surface; a normal acceleration value of 1.77g and a lateral acceleration of -0.12g were recorded. At the time of the contact the aircraft was pitched up 10.7° with a roll attitude of 5.6° left wing down and on a heading of 253°M, the indicated airspeed was 115.5 kt and the

descent rate was calculated as 360 feet per minute. An annotated ground track for the low level circuit is shown in Appendix 5. A time history plot of pertinent recorded parameters for the period is shown in Appendix 6. The commander thought that the ground contact was the left main gear striking the runway but the FO was not sure which part of the aircraft had made contact.

Low level visual circuit (ground track)

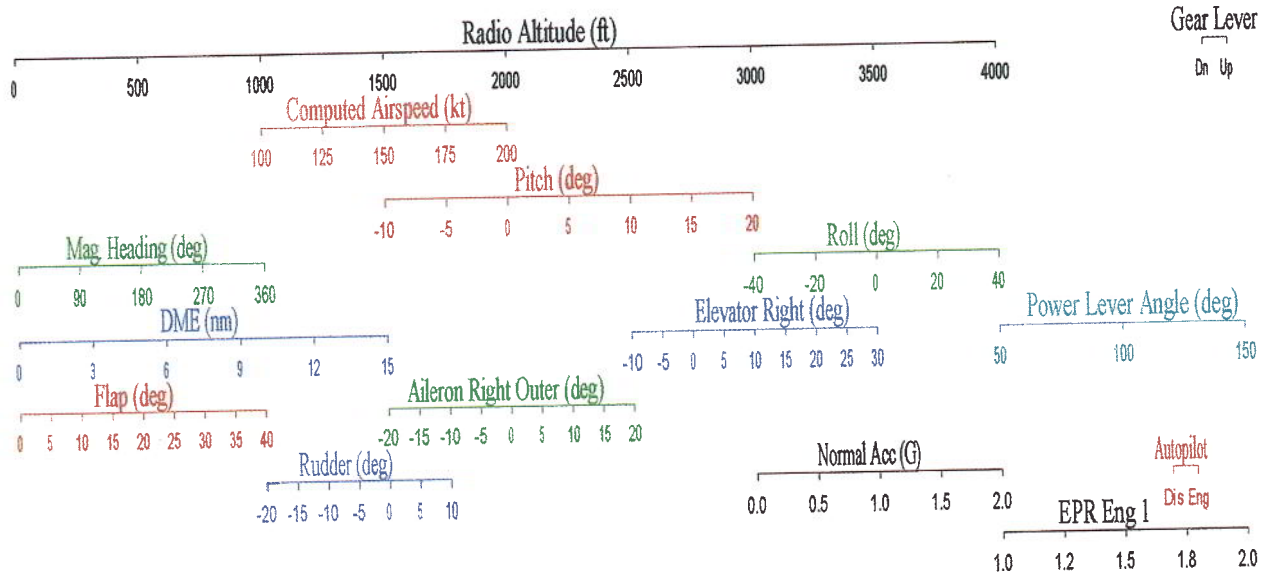
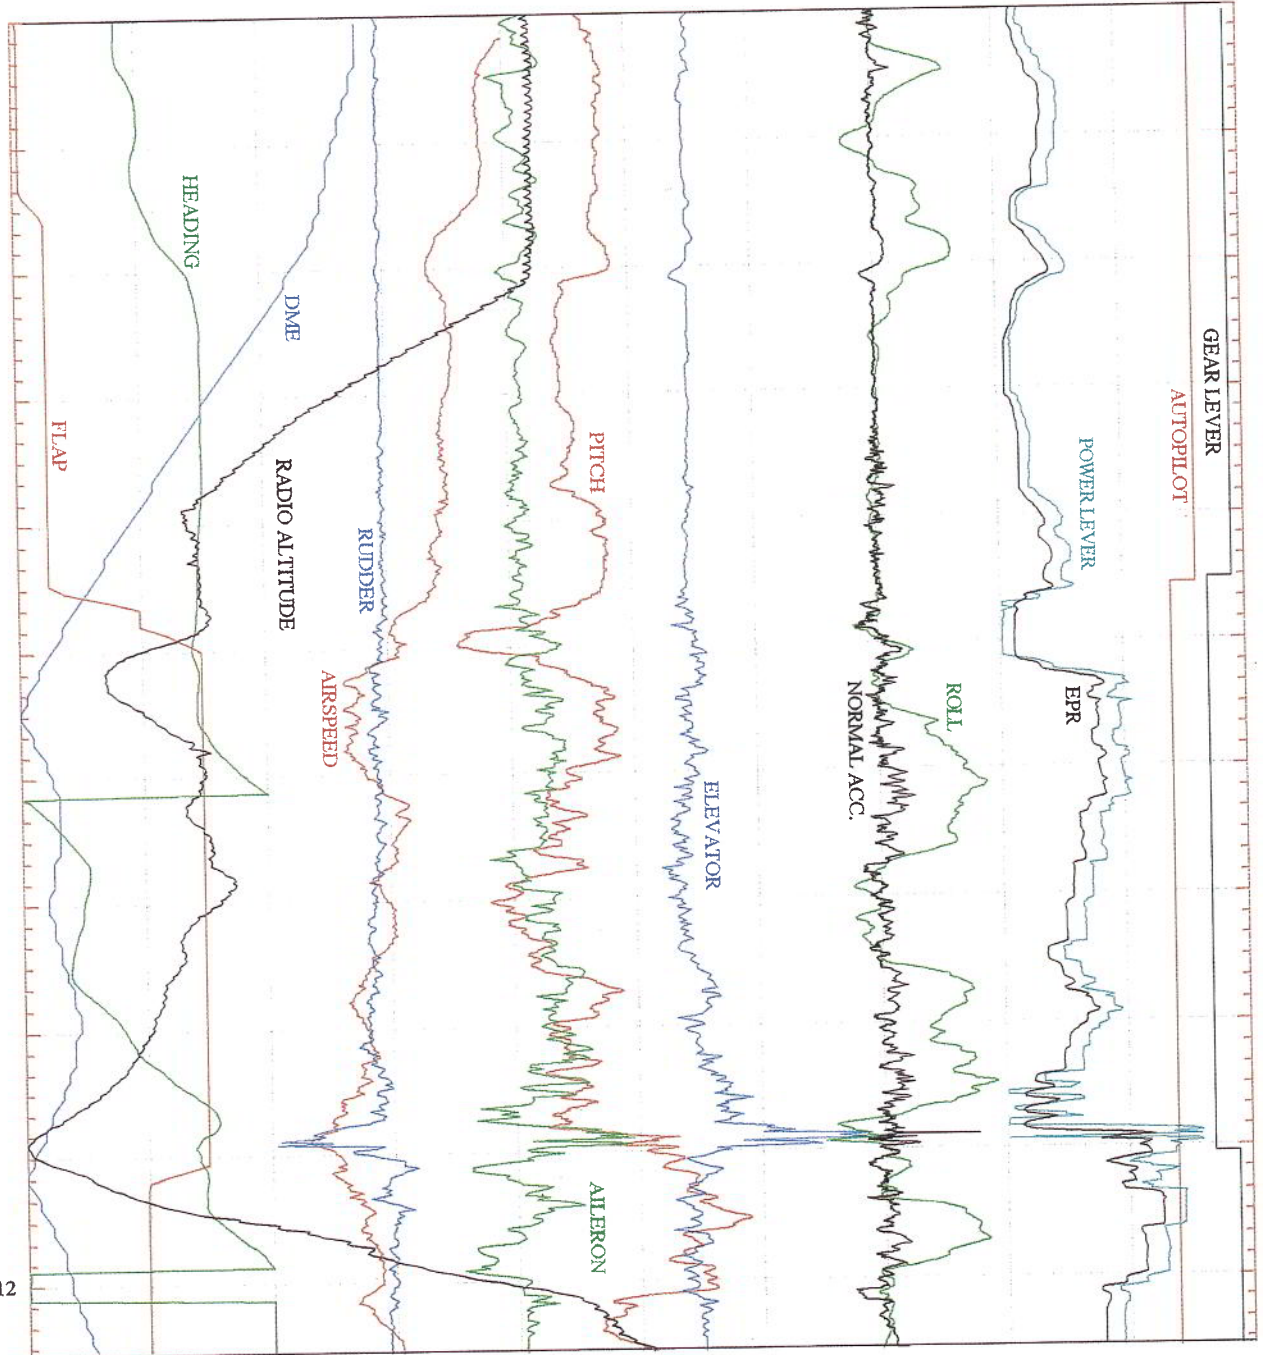
APPENDIX 6

Second and third approach (time history)

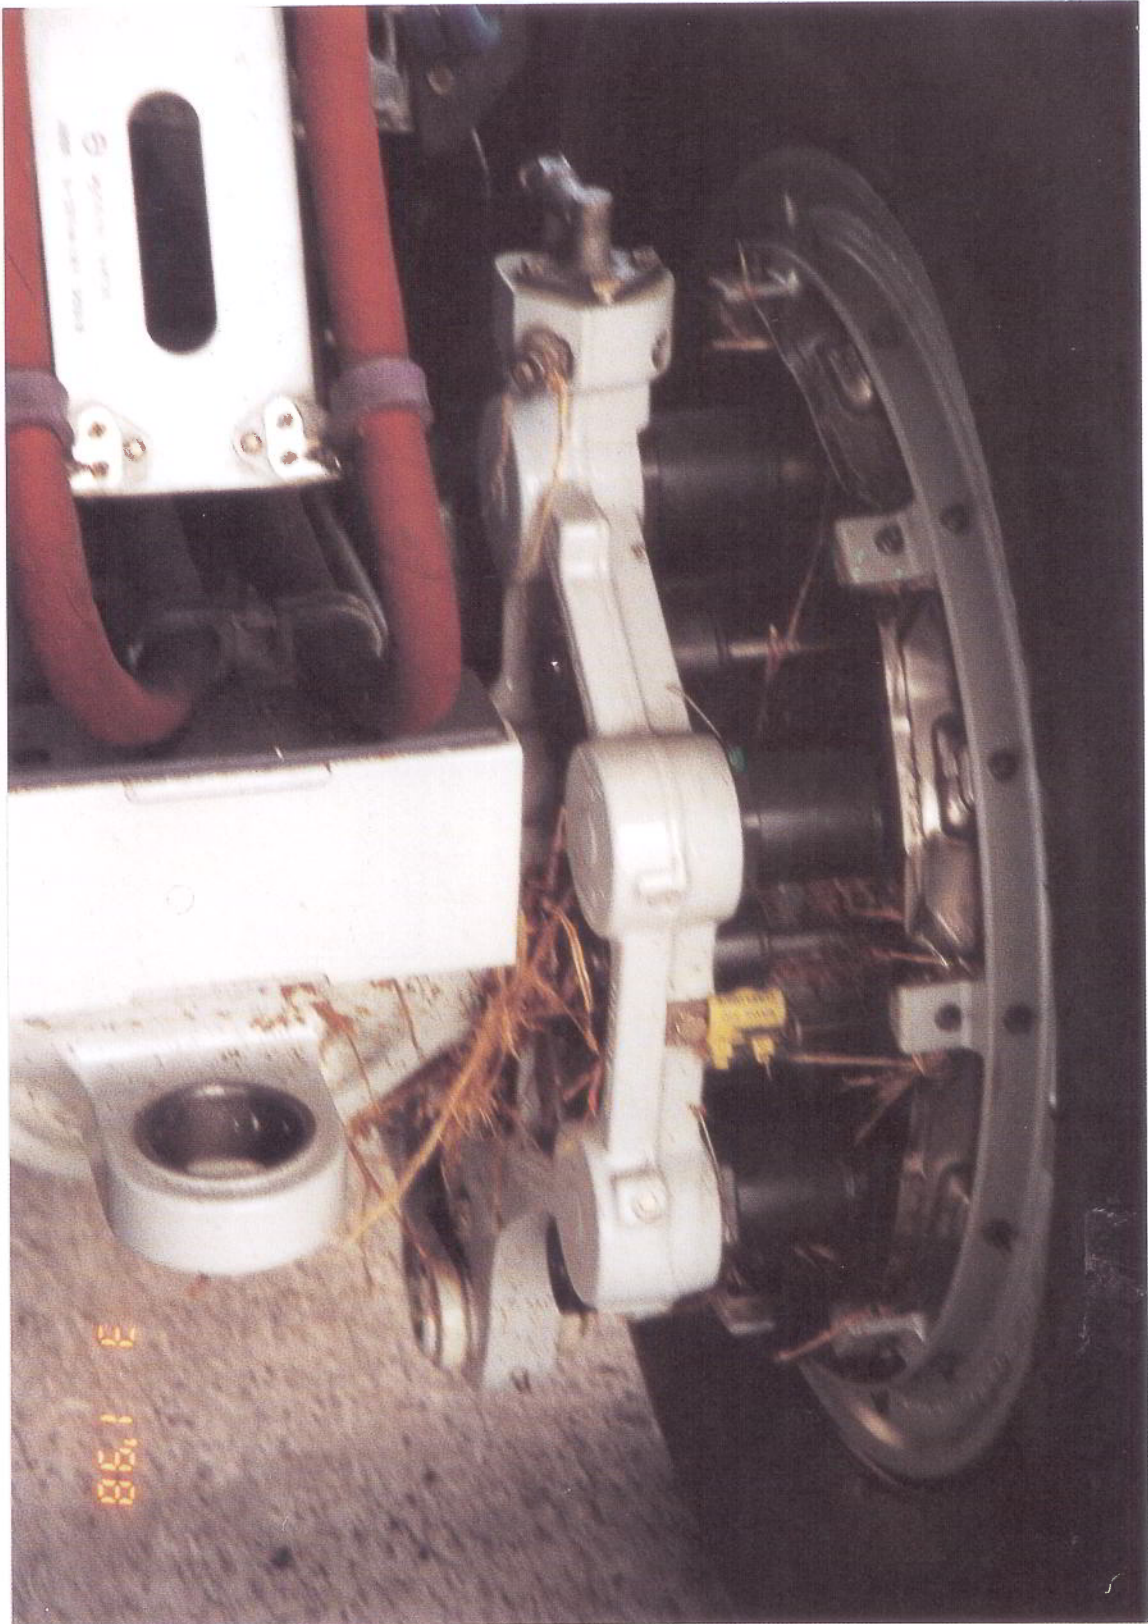
APPENDIX 8

The aircraft touched down in scrub land to the right of the runway surface, the left main gear and the tail area received the brunt of the impact. The left main gear struck the ground 5.3 metres beyond the right-hand edge of the runway surface. Vegetation was subsequently removed from the left main gear. Significant damage was readily apparent in the tail area

Figure 1 View of left main gear

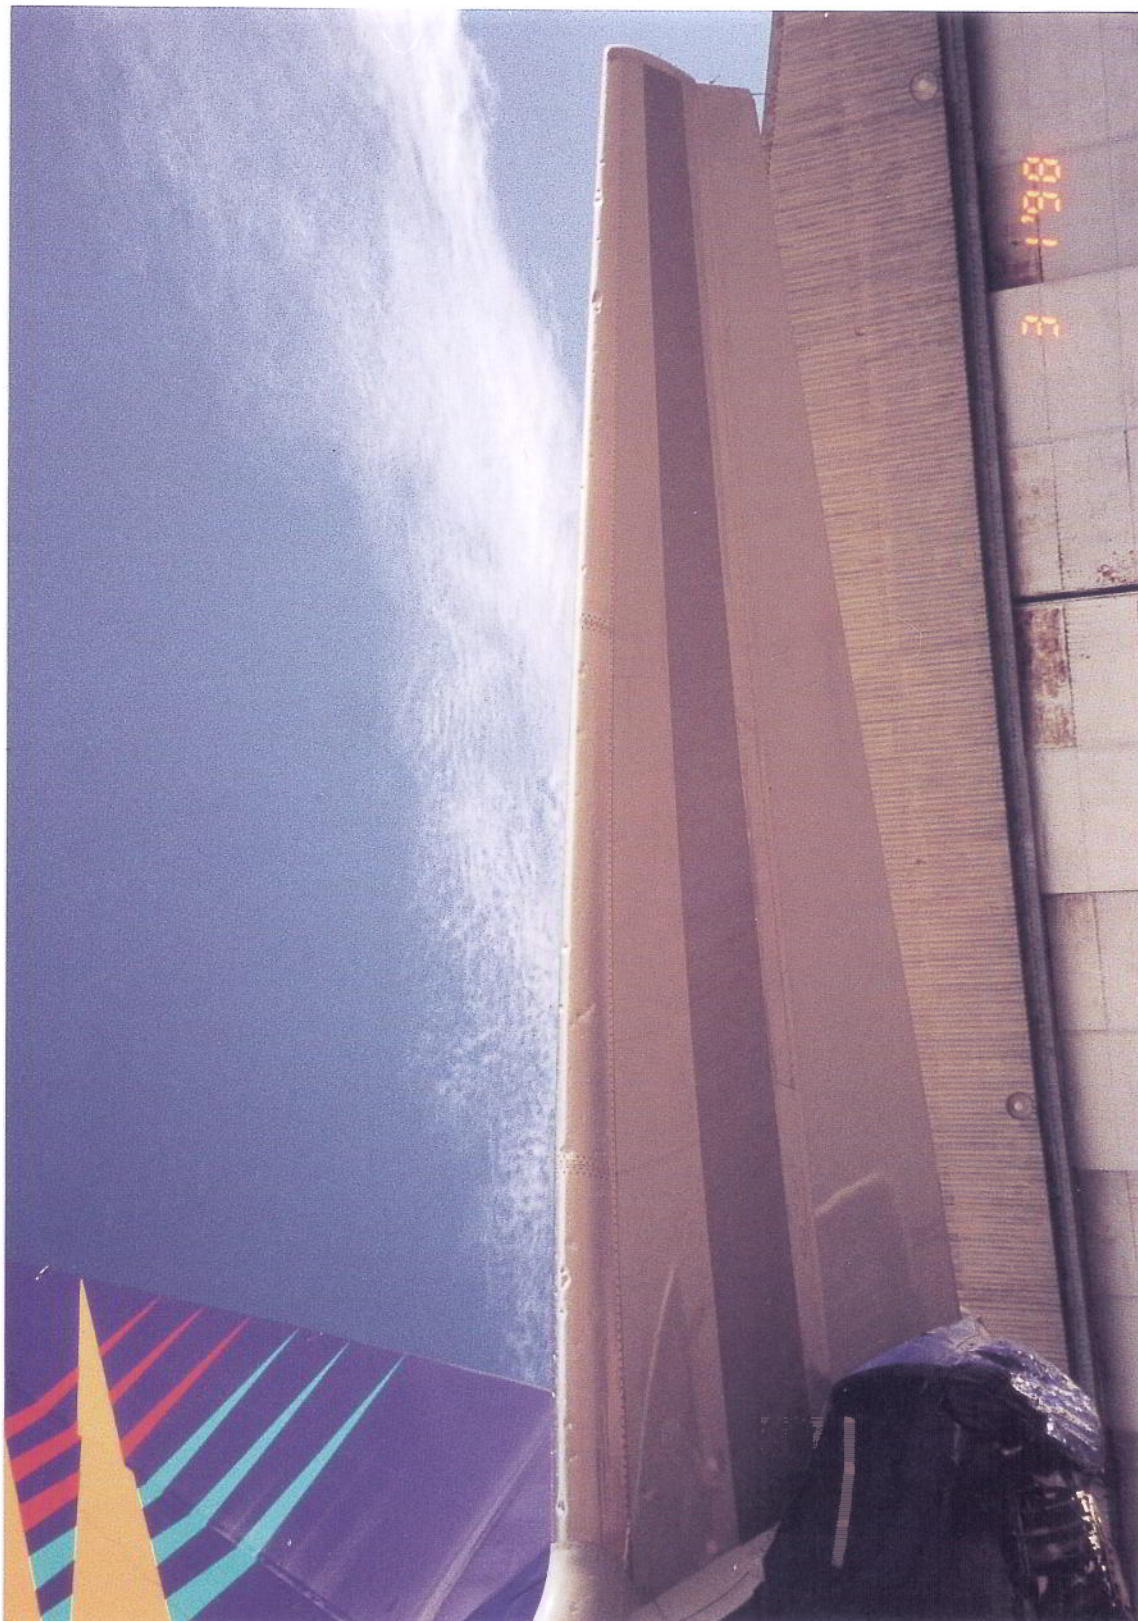
APPENDIX 8

Figure 2 **View of left horizontal stabiliser**

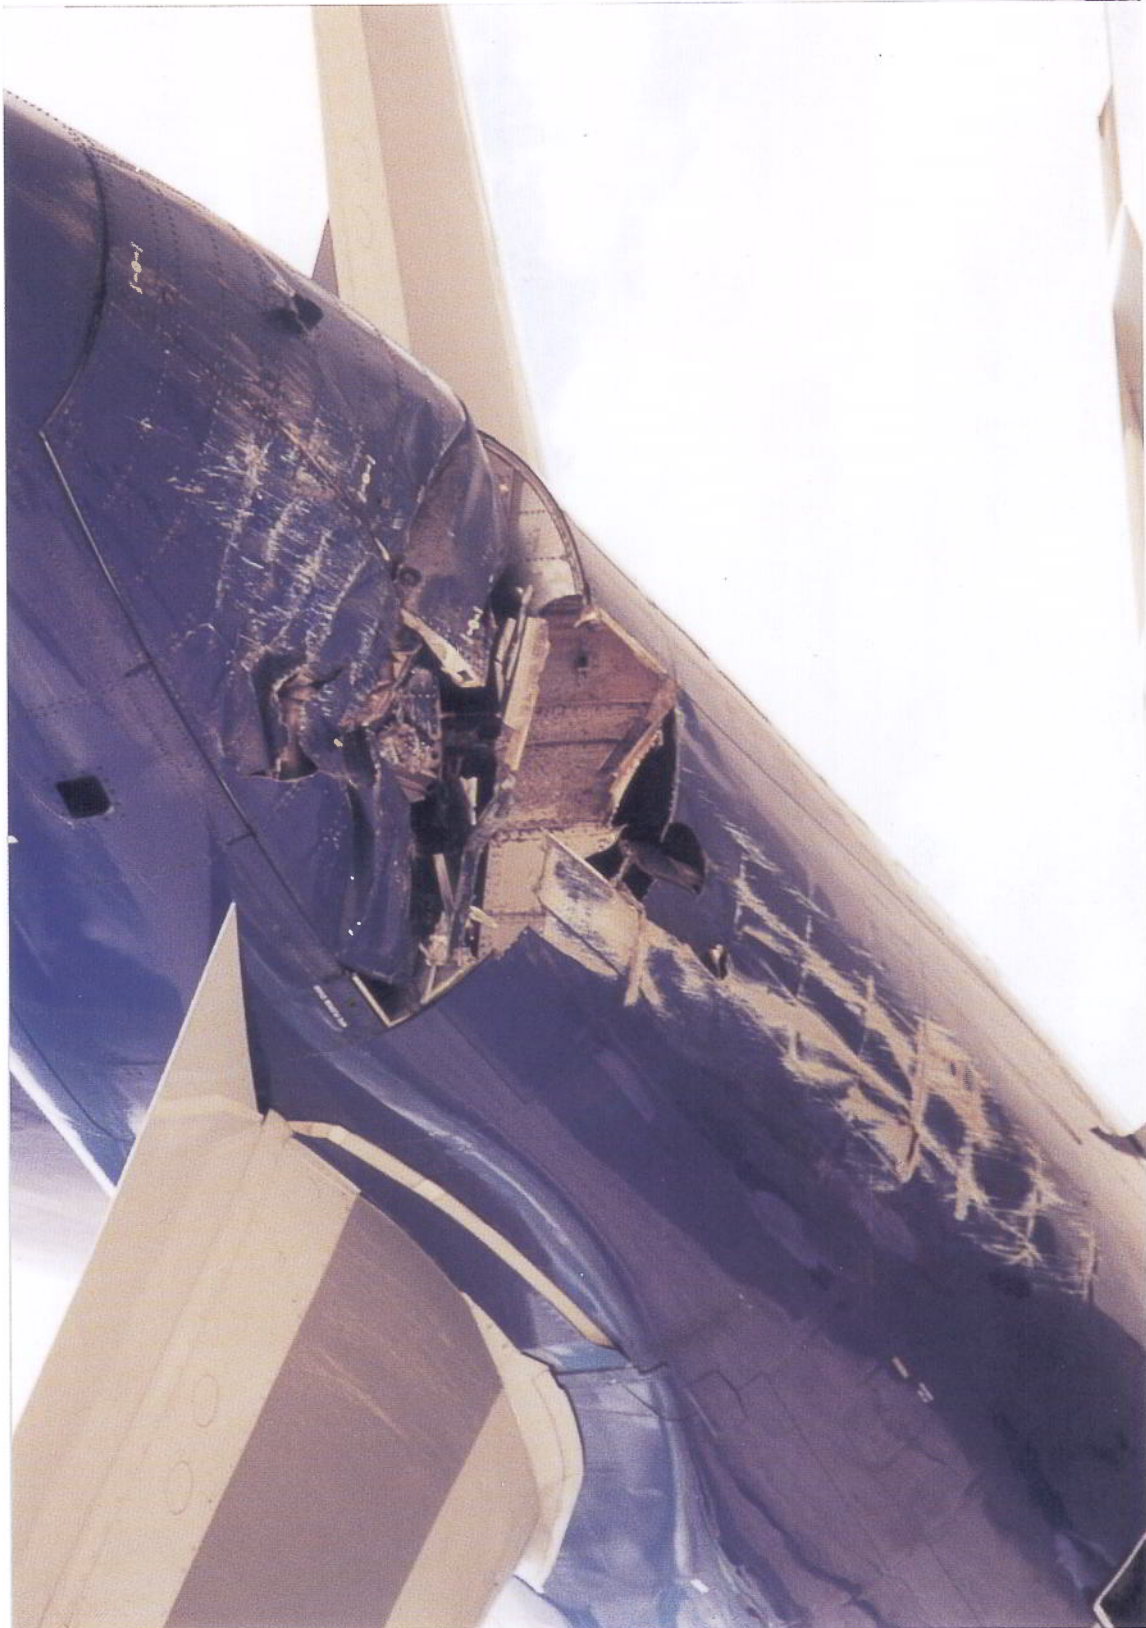
APPENDIX 8

and the APU access doors were badly distorted. The ground impact occurred whilst the engine power was increasing towards the go-around setting. Stones and other debris disturbed by the contact made by the left main gear were propelled by the left engine efflux onto the left horizontal stabiliser which received significant dents and punctures. An inspection by the aircraft manufacturer, conducted at Santo Domingo, determined that the aircraft was not airworthy and a repair team completed the subsequent repairs on the airfield.

The fuselage underside was scraped and crushed from aft of the rear pressure bulkhead (Frame 1720) to the rear of the APU bay doors, the damage being biased towards the left side. The leading edges of the APU bay doors were crushed rearwards and upwards into the bay and the APU fuel supply line had been ruptured at the firewall that had been crushed and torn. Fuselage distortion during the impact left some wrinkling of the skin panels on the left side aft of the wing root fairing but no permanent twisting of the fuselage was detected.

Figure 3 **View of damage to rear fuselage**
