FINAL REPORT

1999035

*Crashlanding due to fuel mismanagement
with the Beech B36TC Bonanza,
registration D-EHHA,
at Groningen Airport Eelde on 1 May 1999*

The Hague, December 2001

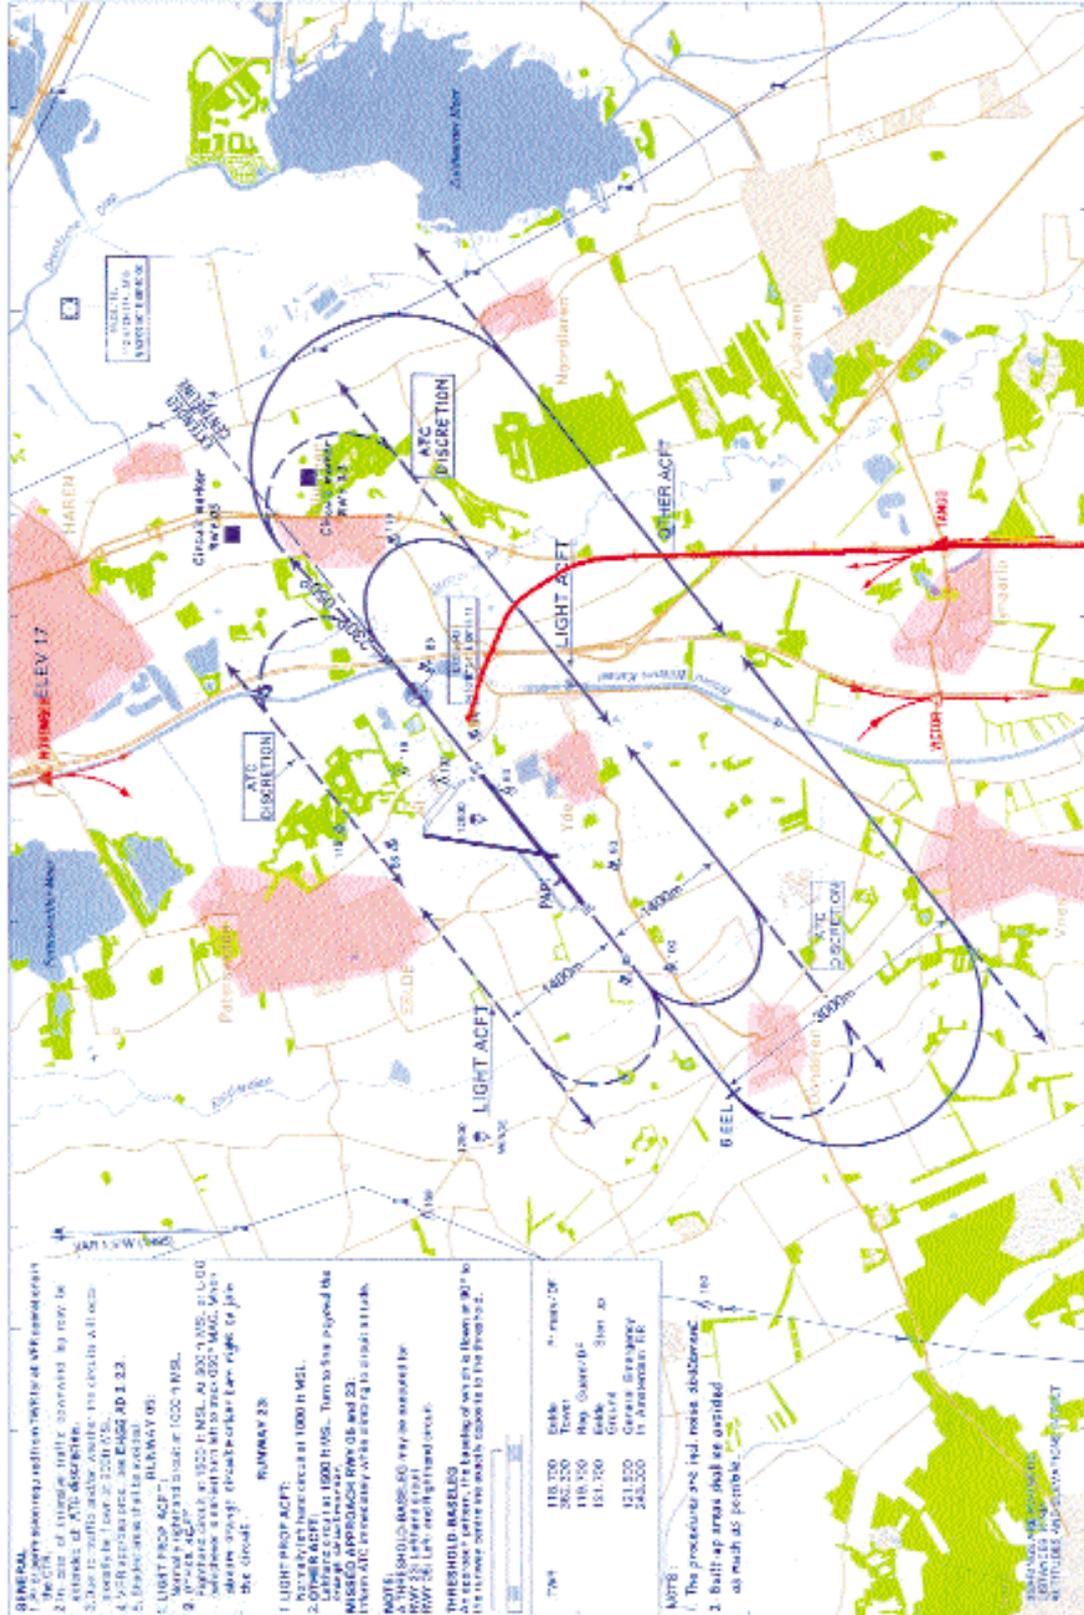
Reconstruction flightpath D-EHHA

At 11:39, after an uneventful flight, the D-EHHA contacted Eelde Tower. The aircraft was 26 miles out and the pilot got permission to enter the CTR and descend to 1500 ft for a landing on runway 23 with a left-hand circuit. According to the pilot the approach was flown with 25 inches manifold pressure and 2300 rpm. The pilot flew a standard VFR arrival route for runway 23 with a northerly course overhead reporting point Tango.

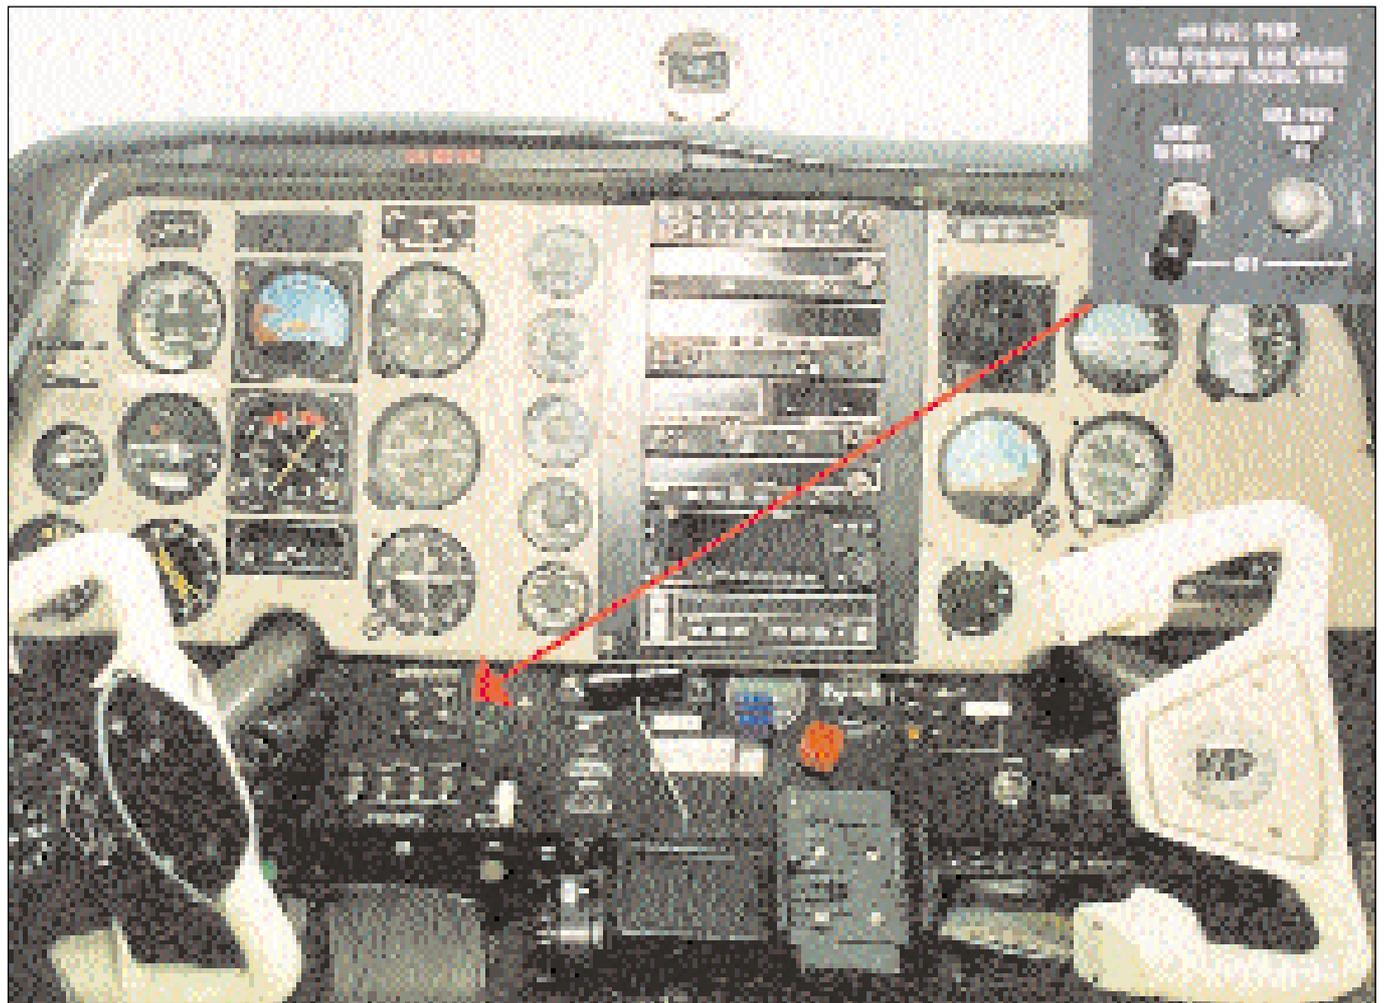
Photo instrument panel and
auxiliary fuel pump switch

The fuel boost pump is actuated by the AUX FUEL PUMP switch, which is located on the instrument panel immediately left of the gear selector handle (See Appendix B).

It is not equipped with a position guard.

The POH contains a statement that use of the HI position during normal flight is prohibited. It will create a rich fuel/air mixture and a rough running engine with the risk of an engine failure.
