A-040/1999

TECHNICAL REPORT

**Accident of aircraft Agusta A-109-E,
registration EC-GQX, in the municipal area
of Villarejo de Salvanes (Madrid), on 26th
July 1999**

AIR ACCIDENTS AND INCIDENTS INVESTIGATION COMMISSION

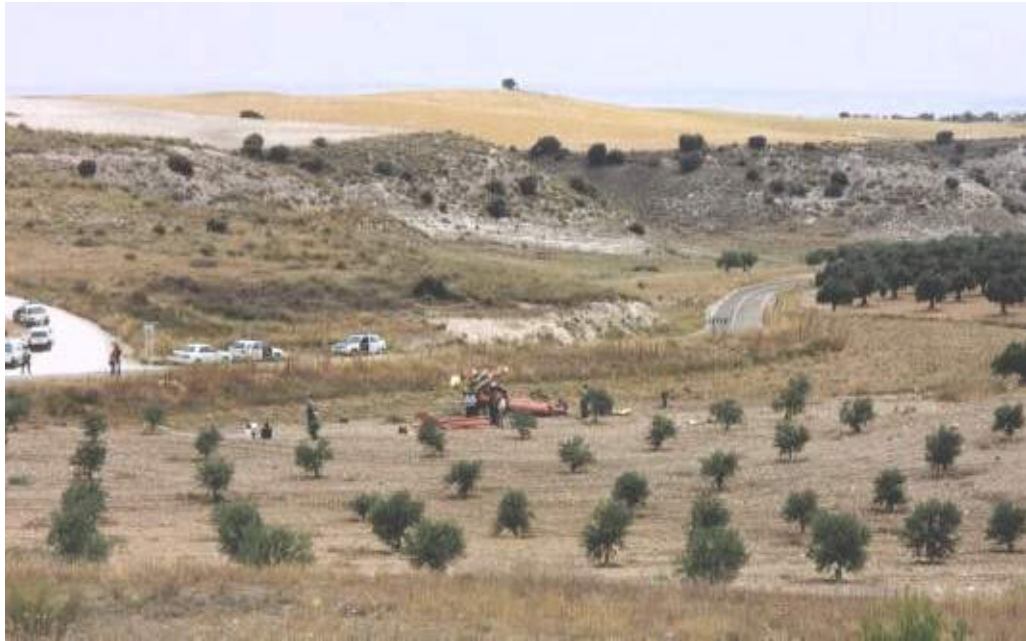
Photo 1.- General view. The helicopter entered from the top right area of the photograph, turned 180° and carried on descending until crashing into the ground

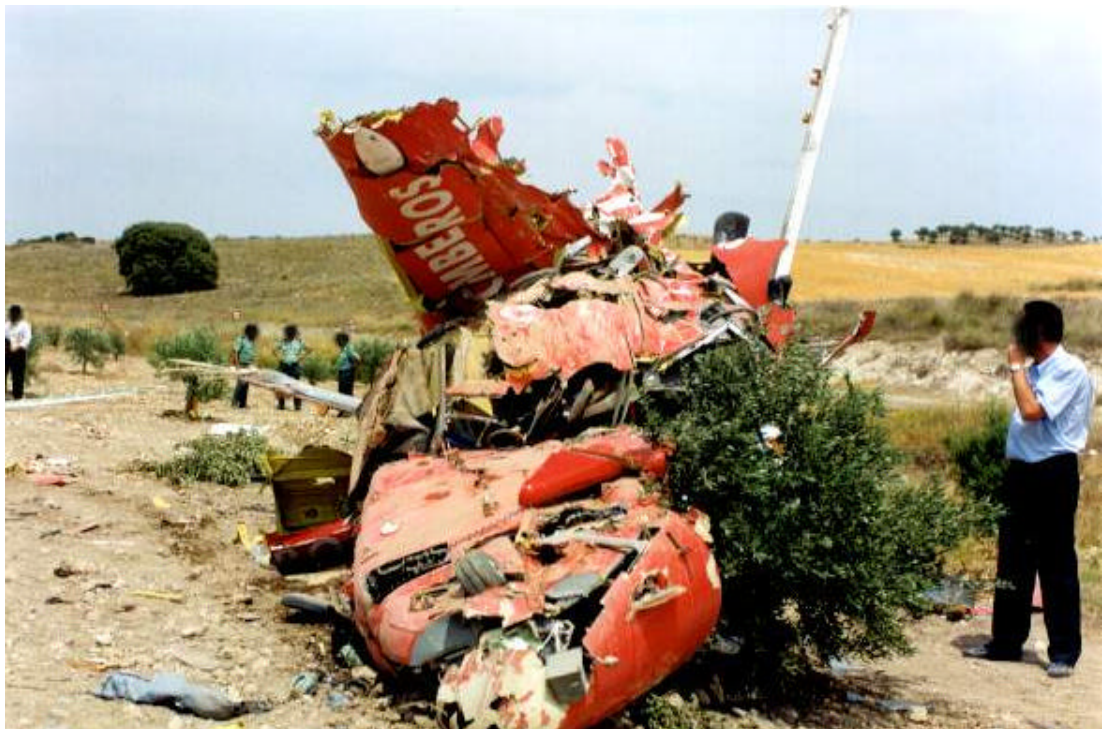
Photo 2.- Nose view. Landing gear retracted.

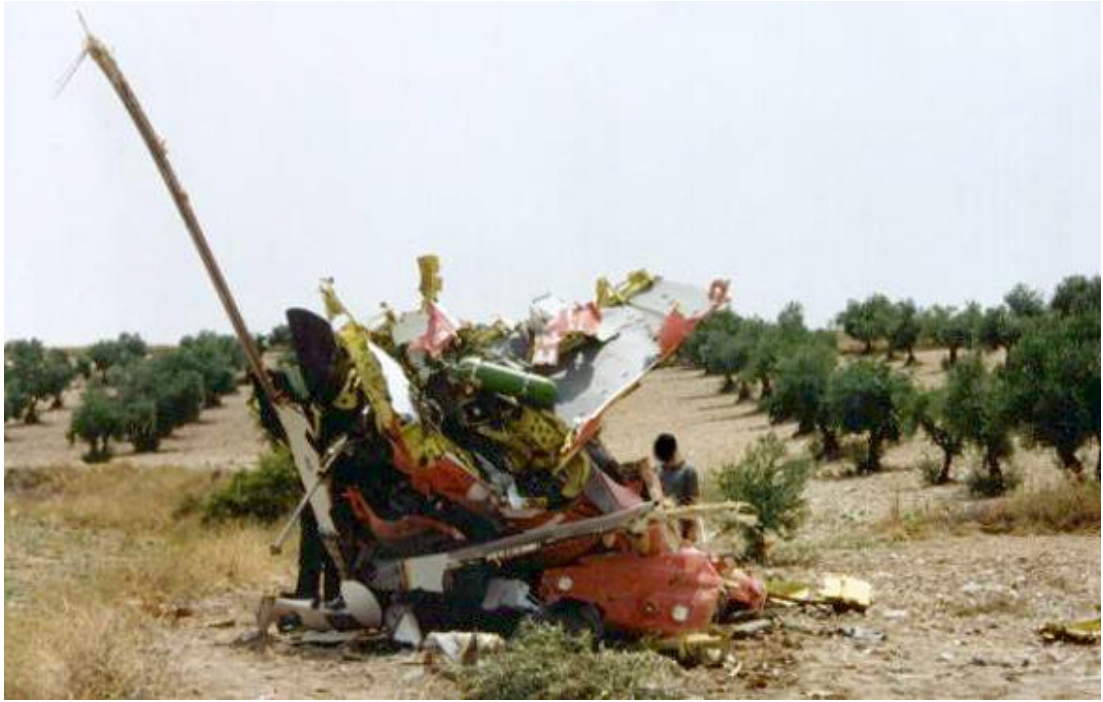
Photo 3.- Lateral view of the wreckage.

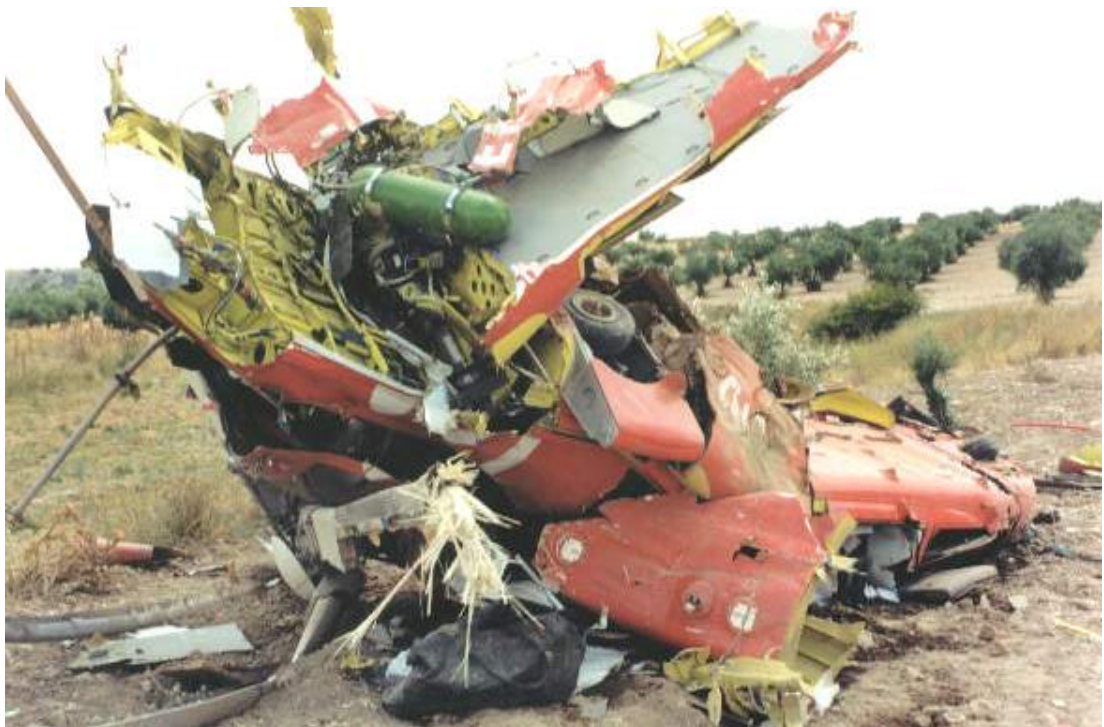
Photo 4.- Left lateral view.

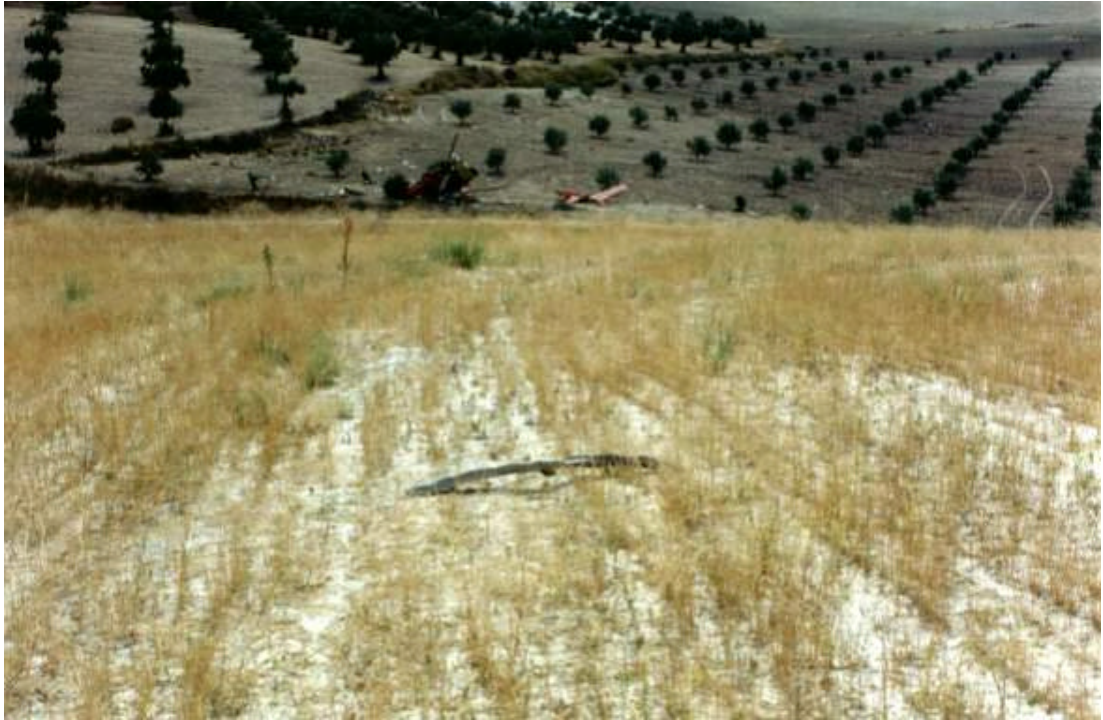
- Leading edge shield of the main rotor (blue blade): One part of this shield was found around 60 m away from the main wreckage site. This part showed a good condition of the spar bonding and the damage was a result of the impact with the ground with the rotor rotating. Therefore, the part had not become detached during flight.

Photo 5.- Blade leading edge shield (blue blade) located 60 m away from the wreckage.

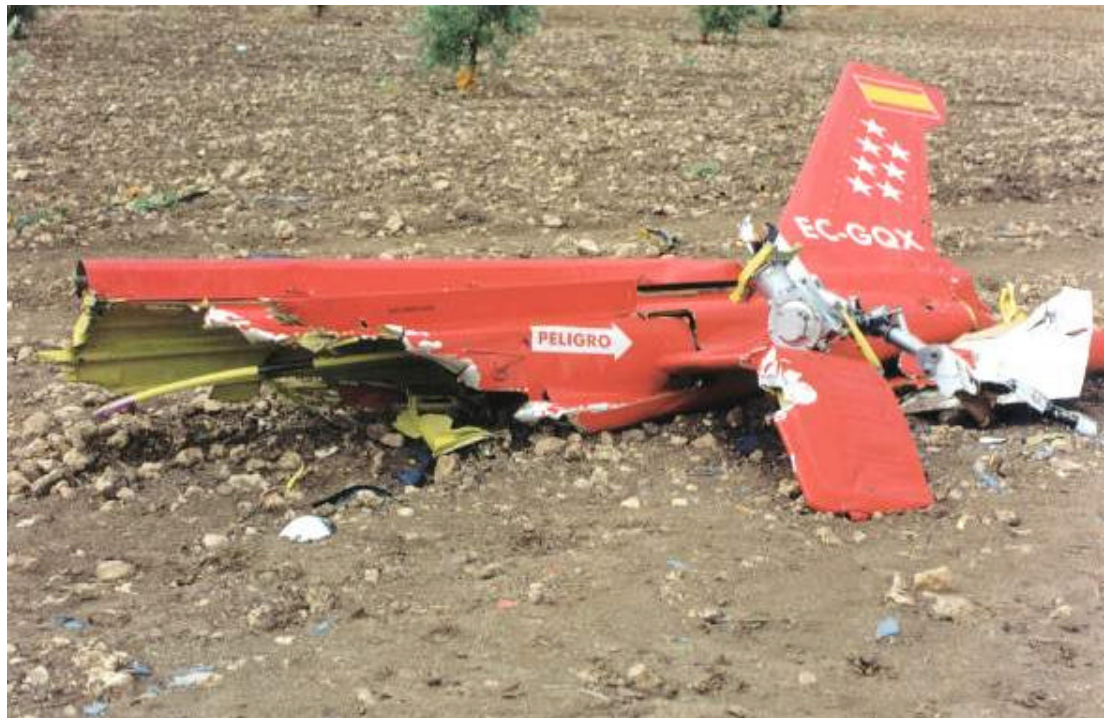
The tail boom had been cut by the main rotor blades during the impact and was left 6 m behind the fuselage. The tail rotor had come loose and ended up near the cone. The two blades of the tail rotor were present and highly damaged.

Photo 6.- Tail boom.

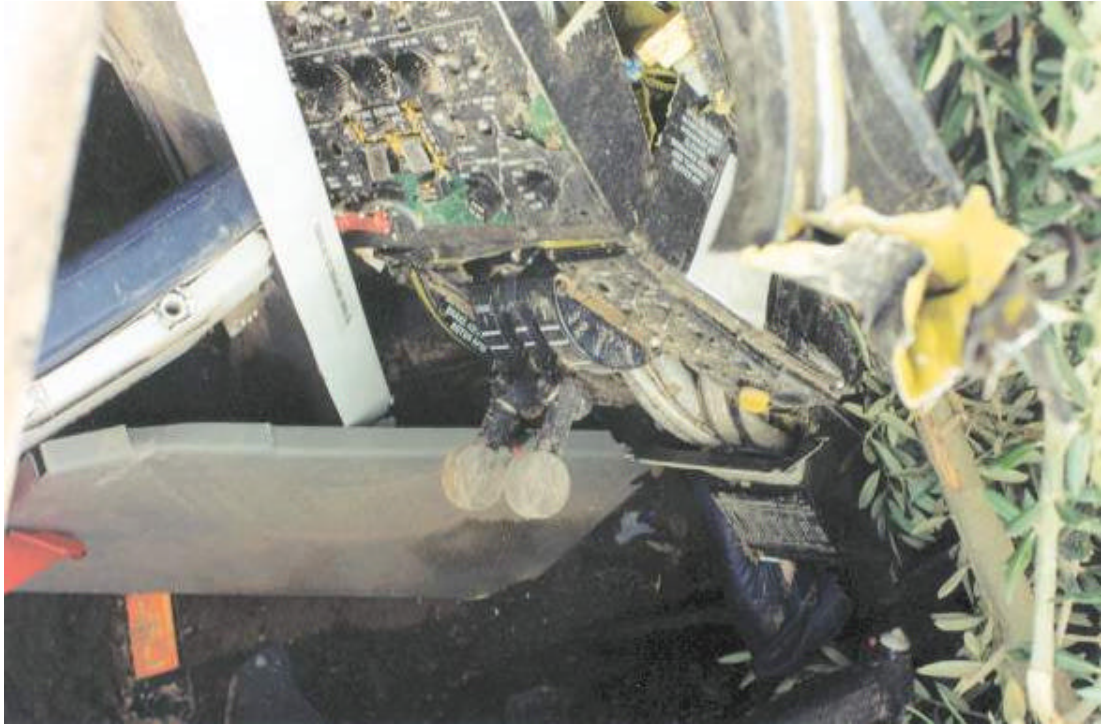
- Engine operating control switches located in the ceiling panel: It was observed that the position of these switches was not the normal flying position. The switch of engine 1 was in "IDLE" and engine 2 in "OFF". The gas levers, used only for manual control of the governor of each engine, were both in the flying position.

The roof panel was highly damaged and other switches were damaged or deformed due to the crash. Nevertheless, the OFF position may only be reached after pushing and rotating the switch, while the IDLE position simply needs to be rotated.

This position of the switch of engine 2 was the only sign of any engine malfunctioning, whilst the marks of the rotating parts indicated that the main and tail rotors were rotating rapidly during the crash. An engine failure would have required, according to the flight manual, the gas lever to be put into OFF and shut off the fuel, whilst both were found in a position consistent with a normal engine condition.

Photo 7.- Detail of the position of the power levers and engine switches on the ceiling panel. Right hand switch is in the "OFF" position.

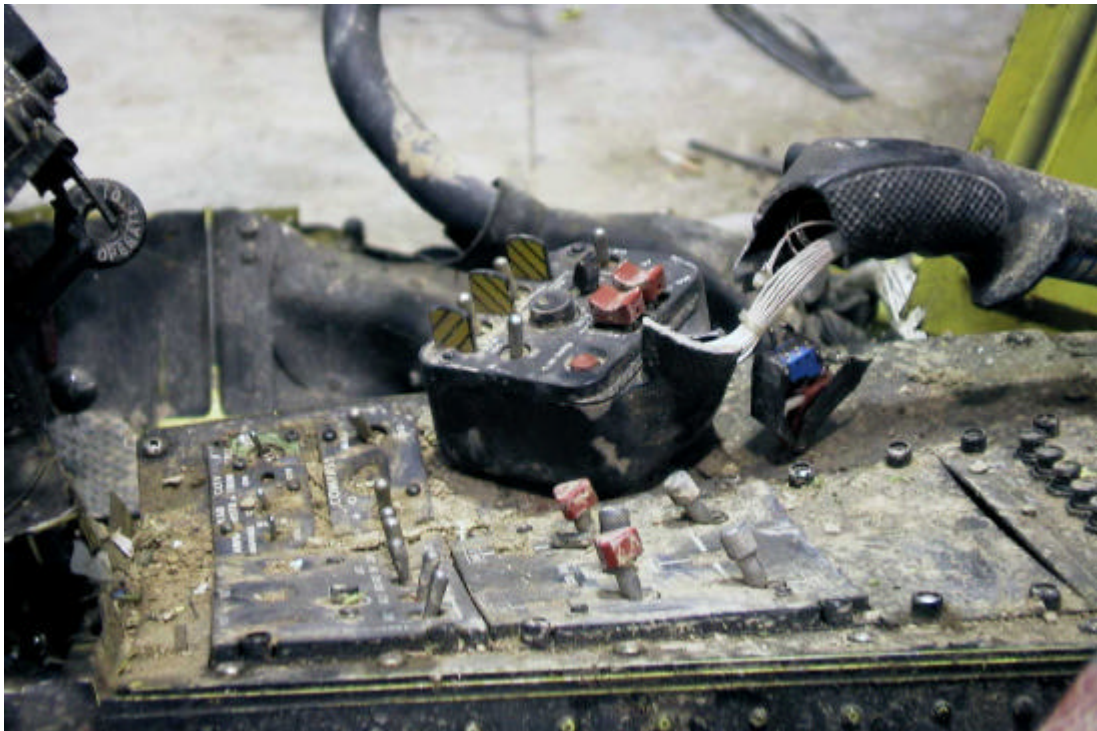
Photo 8.- Switches on the collective lever grip switch box.

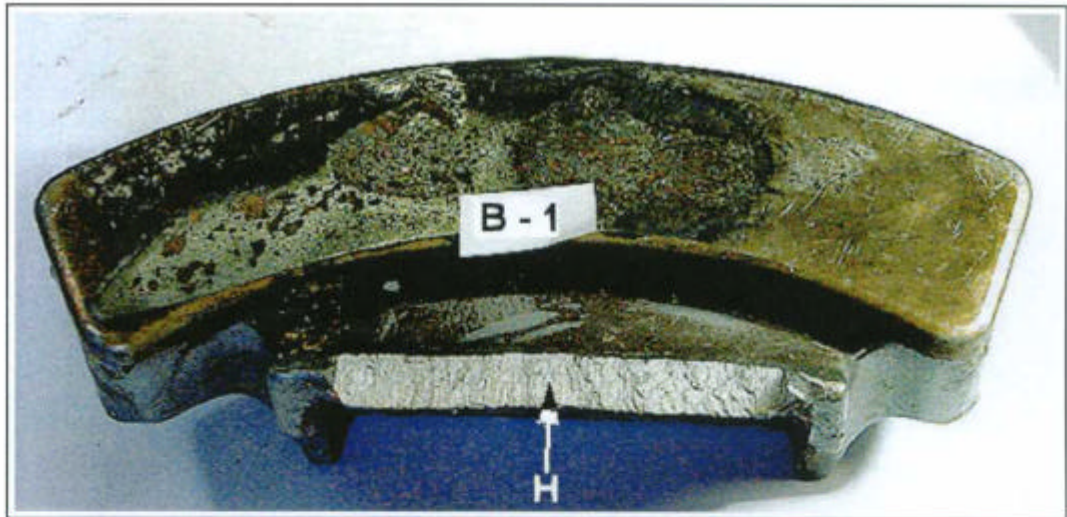
- Grip lower static stop of the main rotor: The four stops had come away from the grips. They showed static failure due to a stroke against the floating ring as a result of an excessive flapping movement.

Fig. 5.- *Tope de posición límite de las palas con rotor parado (rotor principal)*

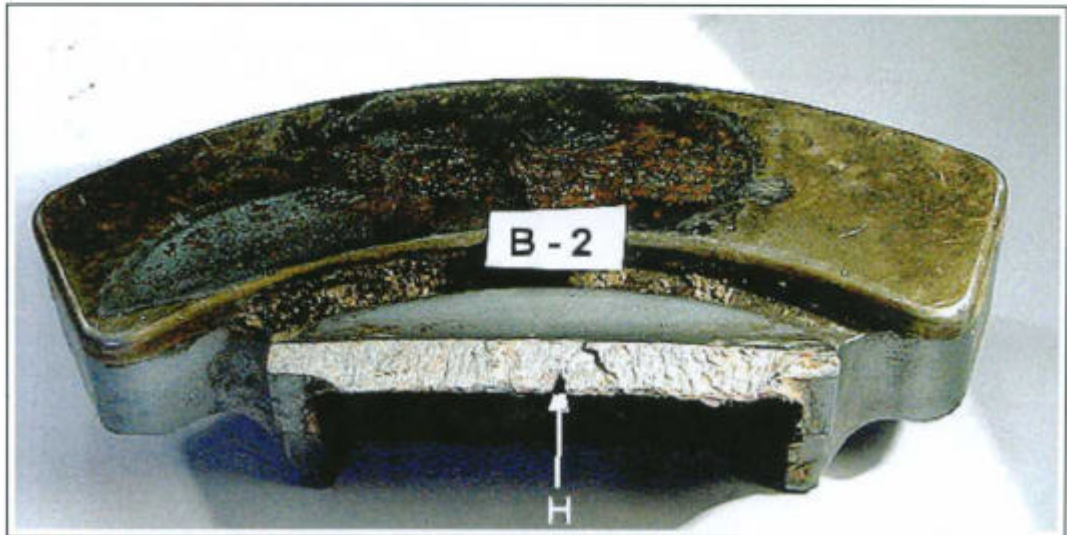
Fig. 6.- *Tope de posición límite de las palas con rotor parado (rotor principal)*

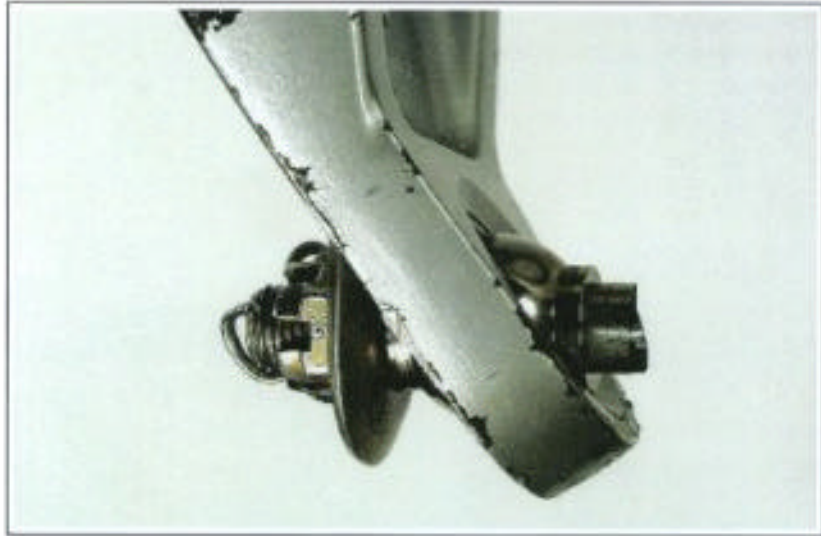
Fig. III.30.- Espacio entre la rotula y la rotura del bulón en el que probablemente estuvieron colocadas las arandelas

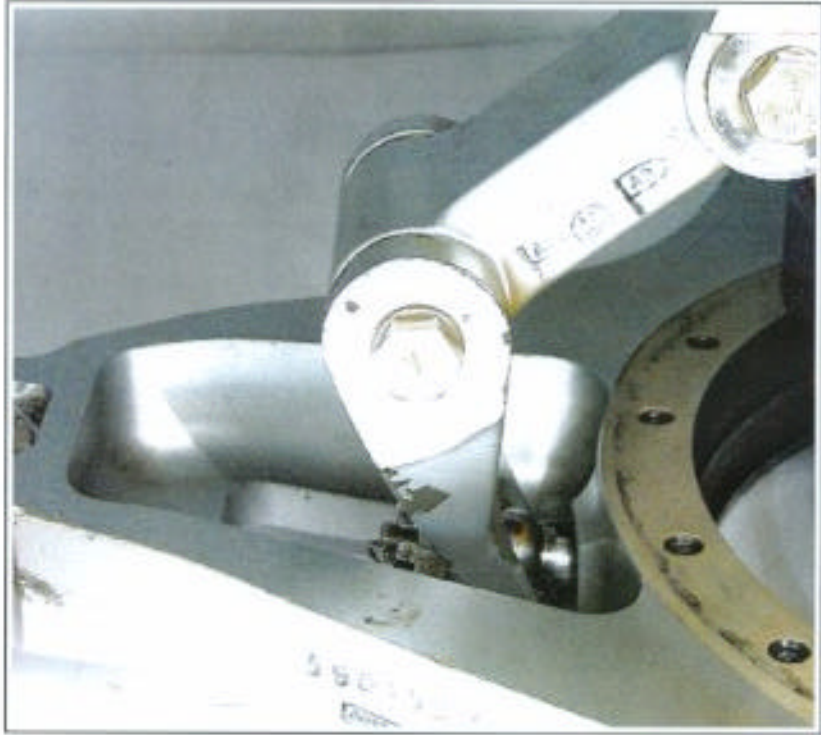
Fig. III.31.- Disposición relativa entre tijera y plato giratorio en las condiciones de montaje

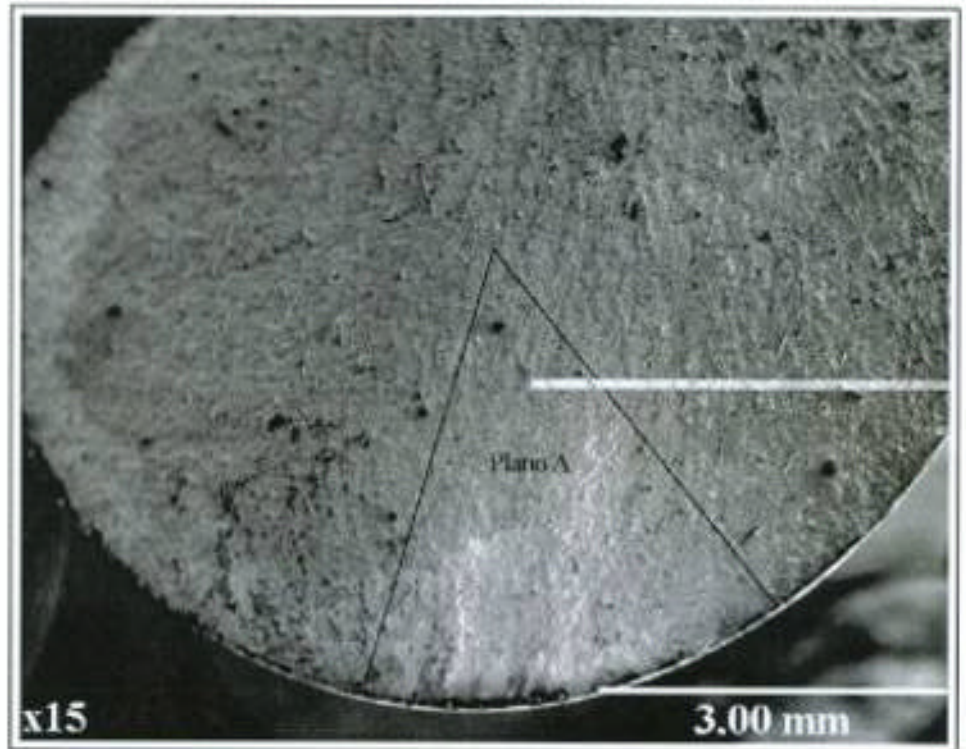
Fig. III.16.- Detalle de la zona A de la superficie de fractura

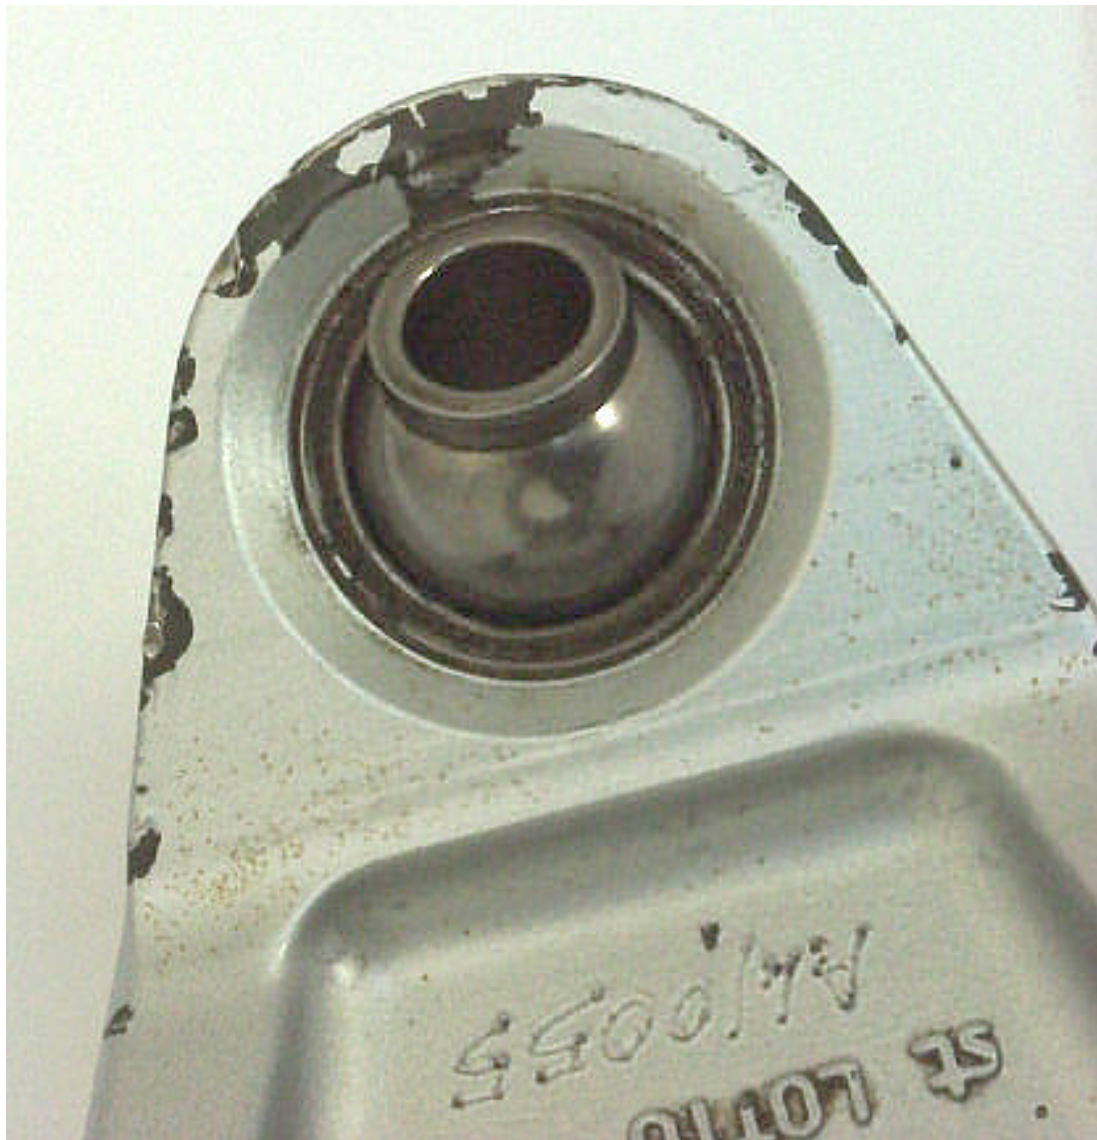
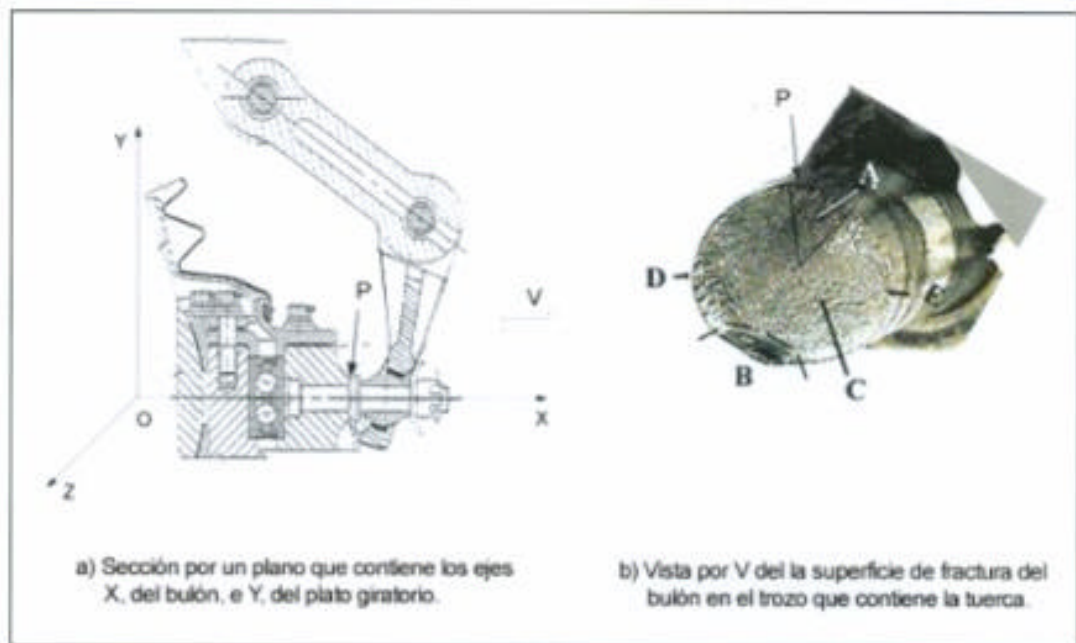
- Lower rotating scissors bolt: It was believed that the failure in this bolt was static caused by excessive shear loads and, therefore, seemed to be a consequence of the crash.

Fig. III.15.- Situación del bulón roto y superficie de fractura del bulón

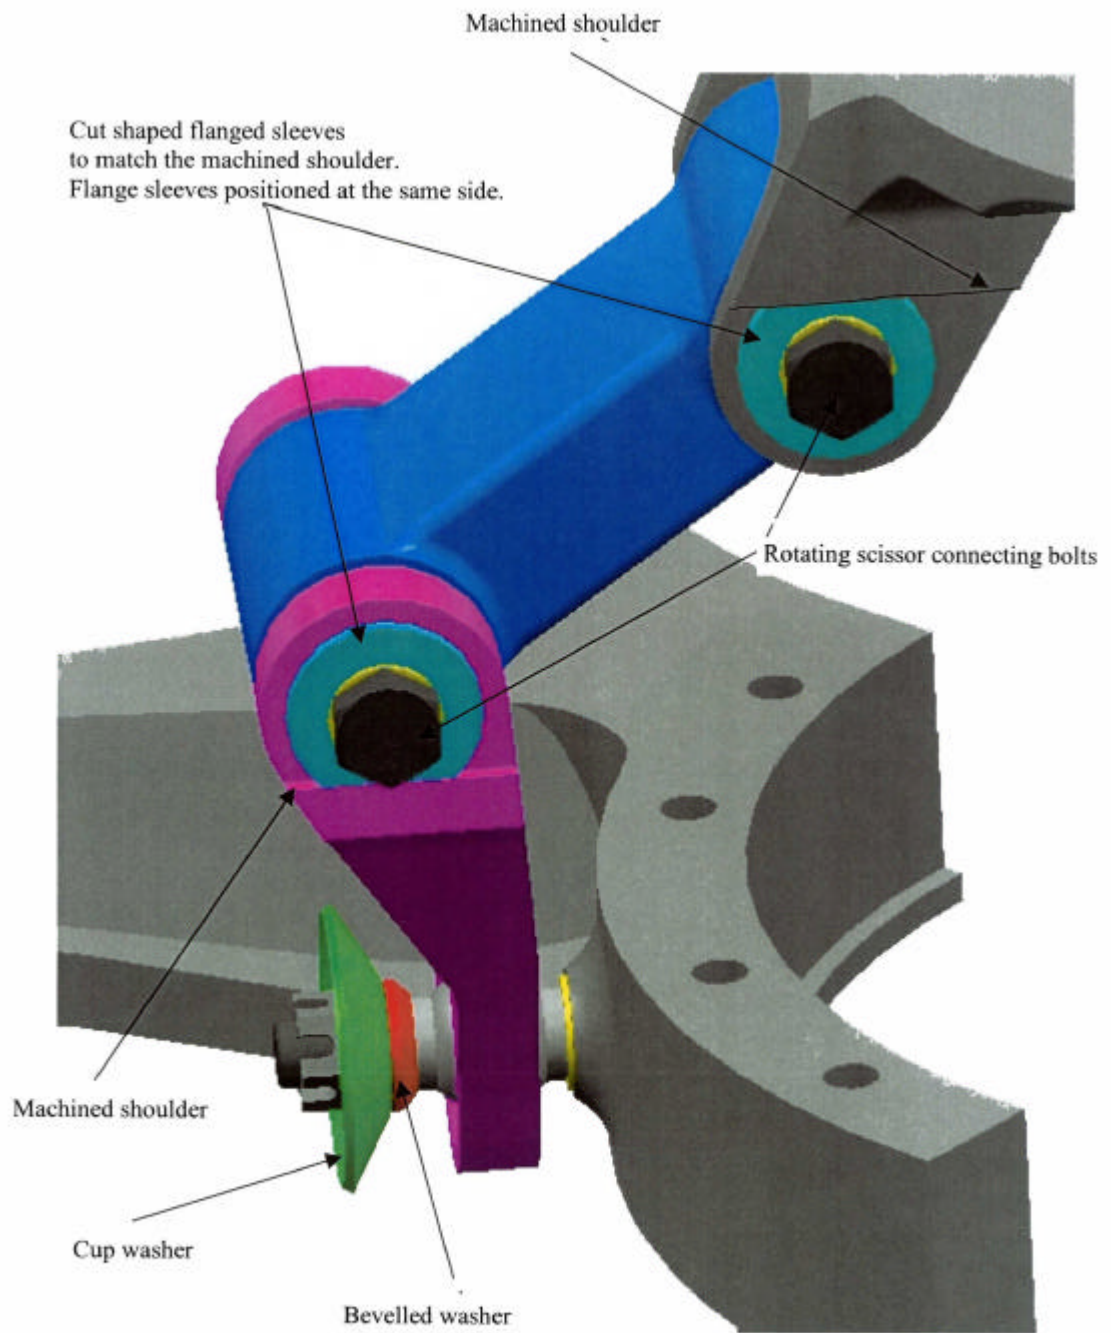
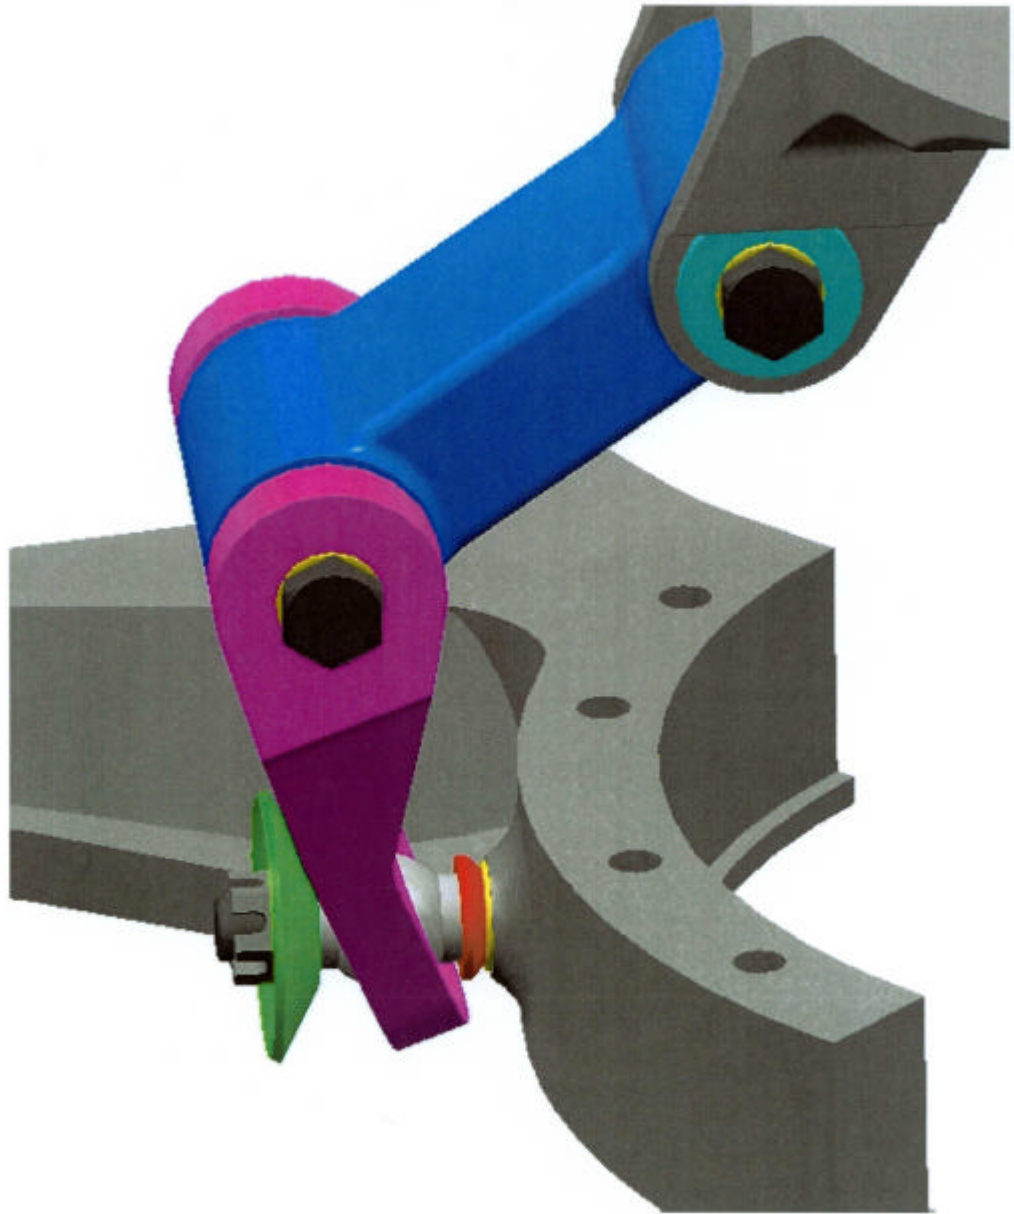
The following three dimension figures clearly show as appear a correct installation in respect to the wrong one. It is evident that a correct positioning of the two flanged sleeves preclude an incorrect installation of the scissors.

The operator installing the lower link in the reverse position (back to front) have consequently assembled also the flanged sleeve in the opposite direction. So doing it was realized an installation clearly not consistent with the indication of the figure 62-27 A.
