Report RL 2000:40e

***Aircraft accident to SE-GDN
8 kilometers northwest of Sundsvall/
Härnösand airport, Y county, Sweden
on the 9th of December 1999***

Case L-107/99

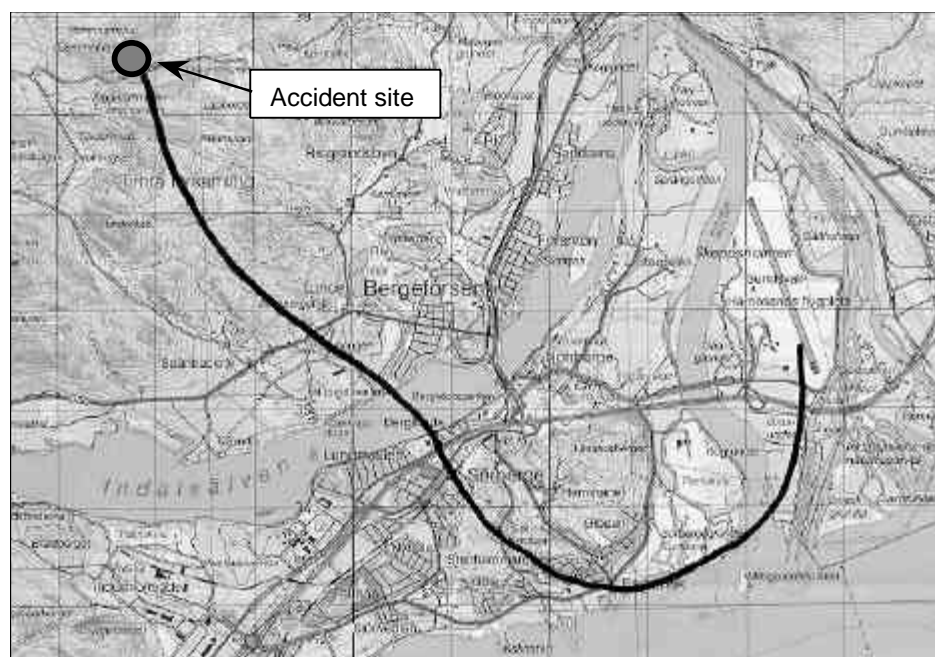
The flight path of the aircraft and the accident site

The accident site consists of hilly wooded terrain. The aircraft impacted in the forest with a dive angle of approximately 40 degrees and a slight bank to the left. Heading at the time of impact was about 150 degrees. The aircraft initially collided with the tops of a few pine trees prior to its impact on a minor mountain plateau situated about 20 meters from the initial tree collision. From the mountain plateau it resumed its airborne condition and continued to a lower plateau with rocks and low vegetation, where it, in inverted attitude, collided with a large boulder, tipped-over into a right-

side-up attitude and finally came to a stop about 80 meters after the initial impact with the ground.

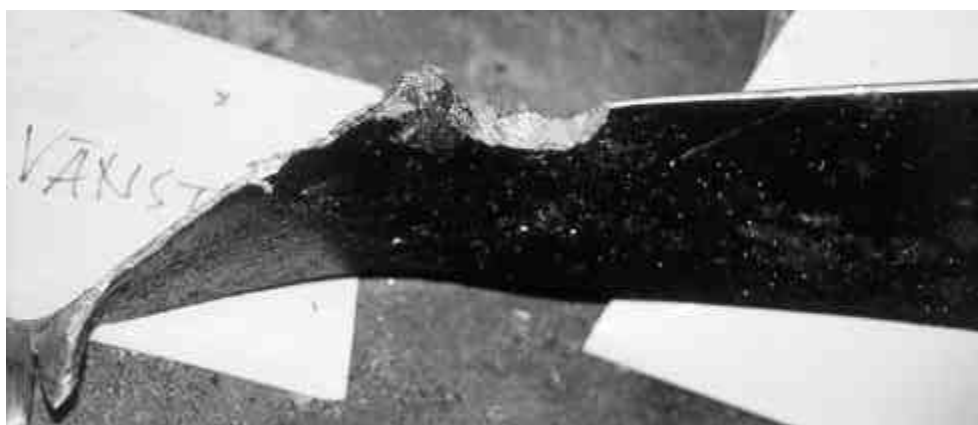
One propeller blade had separated from the left engine's propeller. All the blades were deformed and several severe impact damage zones occurred on the leading edges of the propeller.

The propeller hubs, with adjustable pitch for the propeller blades, have been inspected at an aircraft engine workshop. Apart from the damage that has originated in connection with the accident nothing abnormal was noted. Within a tolerance of 5 mm, the propeller hub's adjusting pistons had jammed in the same position, corresponding to a propeller pitch angle of about 21°. A pitch angle of 21° corresponds to normal propeller setting for climbing or cruise flight.

Propeller blade (leading edge) from the left propeller

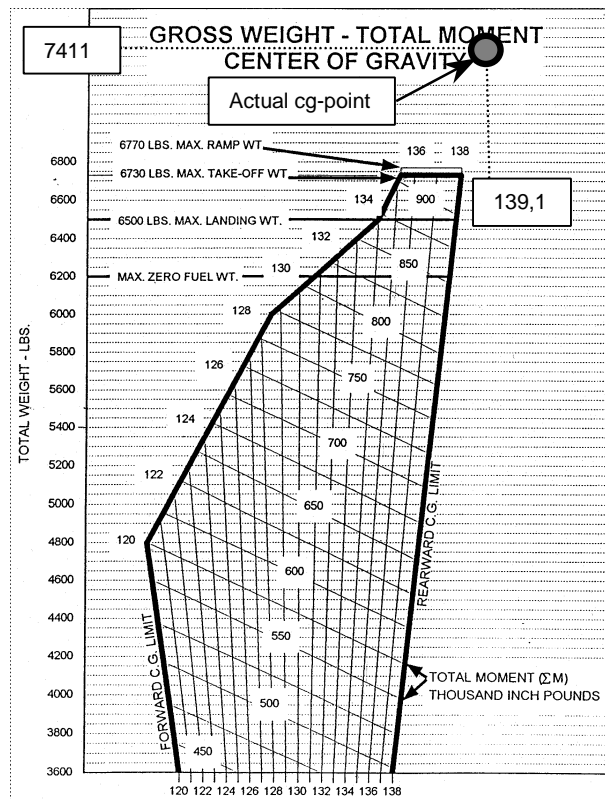
Weight- and- balance diagram

Maximum allowed airborne weight for the aircraft type is 6 730 lbs. (3 053 kg) and the aft center of gravity limit is 138.0 inches.

Actual weight and center of gravity have been drawn onto the weight and balance diagram shown below.

Contributory to the pilot's difficulty in trimming the aircraft to establish a stable climb with correct airspeed can have been the aircraft's overweight condition in combination with the fact that the center of gravity was close to or behind the aft center of gravity limit. This problem can therefore be seen as an additional factor of disturbance for him.

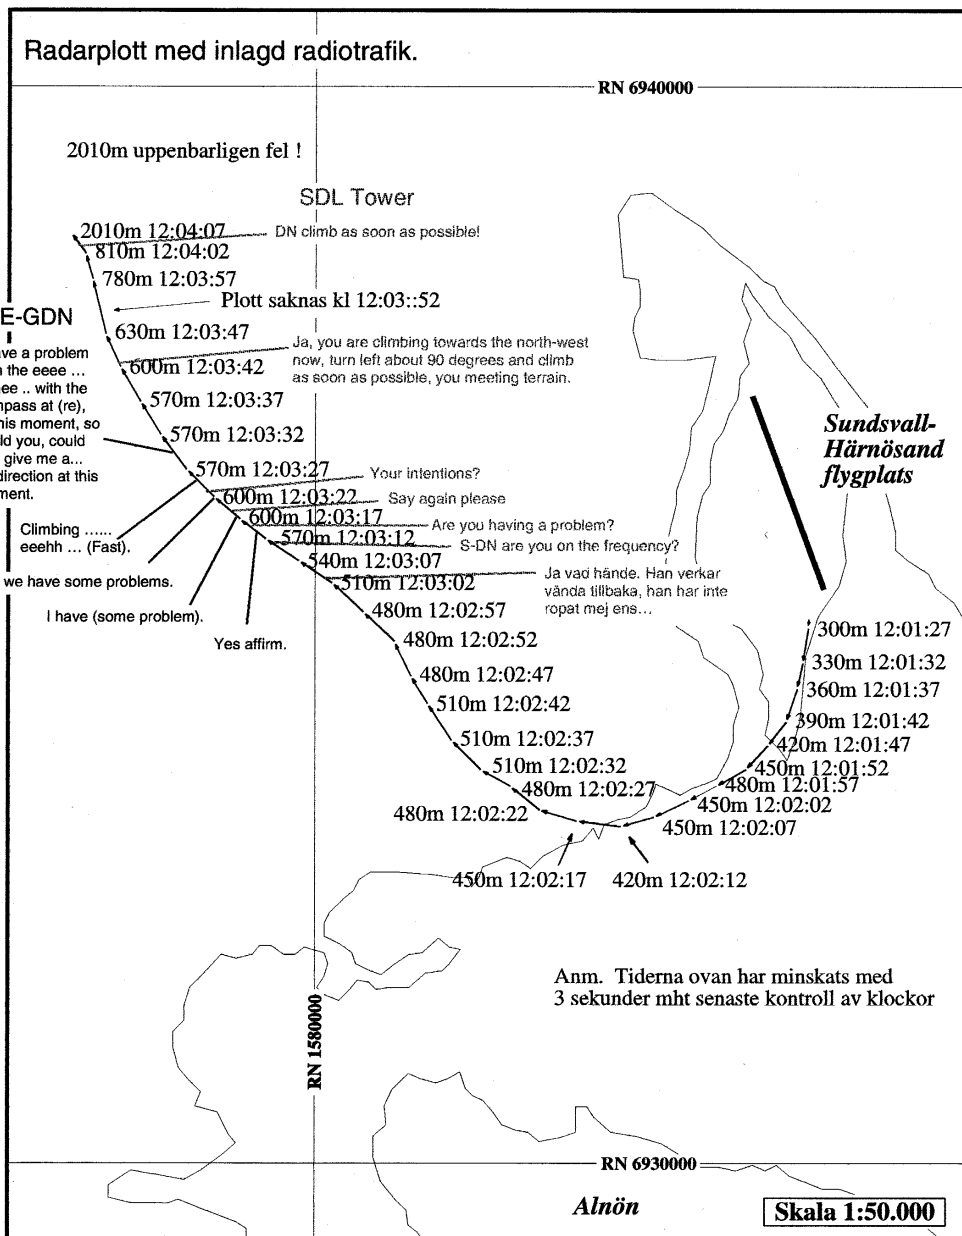
Radar plot with radio communication

The flight path with time references for each radar echo has been plotted below. Radio communication between the pilot ("SE-GDN") and the air traffic controller ("Tower") has also been inserted at the actual time these occurred during the flight.
