Report RL 2001:49e

***Accident involving helicopter SE-HVM
at Fjäderholmarna, AB county, Sweden,
on 7 September 2001***

Case L-073/01

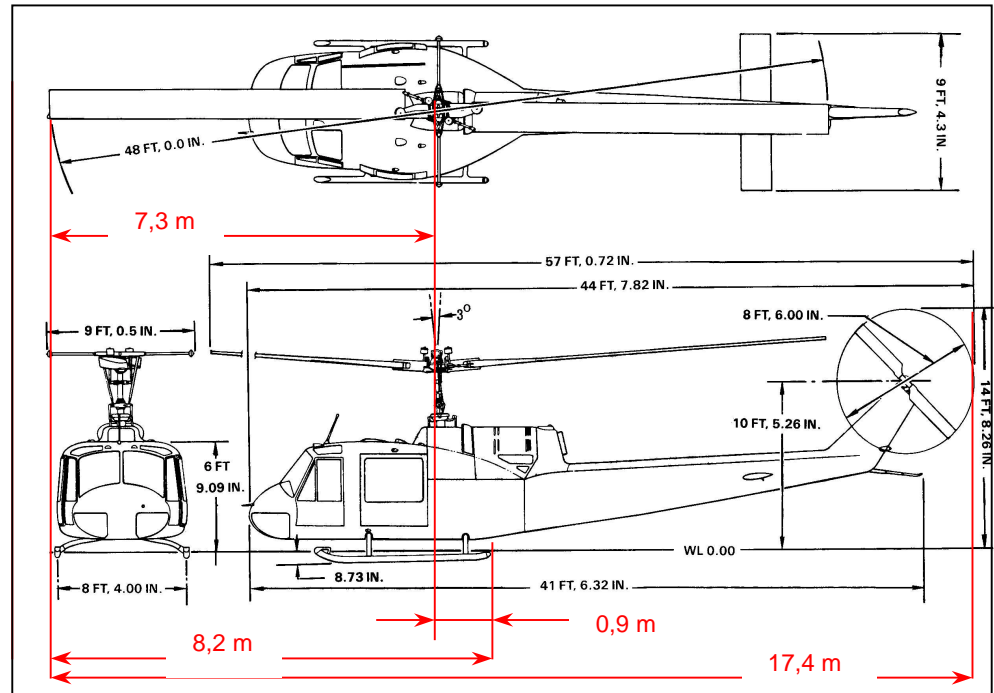
The helicopter has a cockpit with two pilot positions and dual flight controls. Access to the cockpit is gained through a small door on either side of the aircraft. The passenger area, which has a capacity of nine passengers, has a sliding door on each side of the aircraft as shown in the sketch below.

On this particular helicopter both passenger sofas had been placed in the forward facing position because, according to information received, this allowed for greater possibility to adjust the seats in the cockpit. In both configurations the pilots and the passengers are placed forward of the helicopter’s primary center of gravity point.

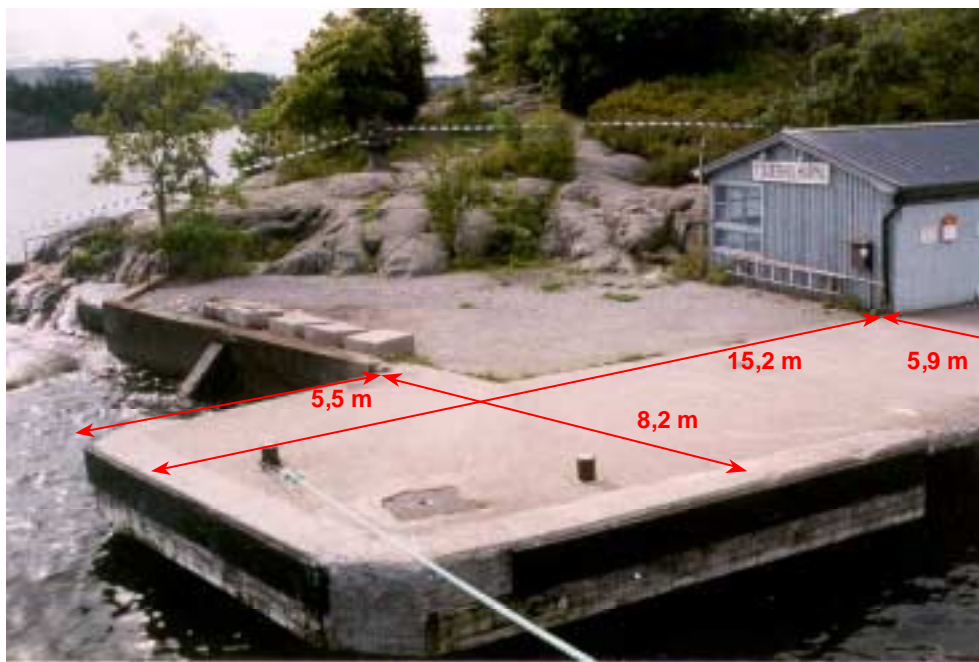
The landing was accomplished on the so-called steamboat pier, which is situated on the easterly edge of the largest island in the group. The pier consists of a concrete dock along the water with a height of a little more than one meter over the surface of the water. On the concrete pier, which has a somewhat rough surface, there are two metal bollards approximately 30 centimeters in height. Directly adjacent to the pier there is a wooden building, that is used as a waiting area for passengers. The applicable sections of the pier have been measured by the police according to the photograph below.

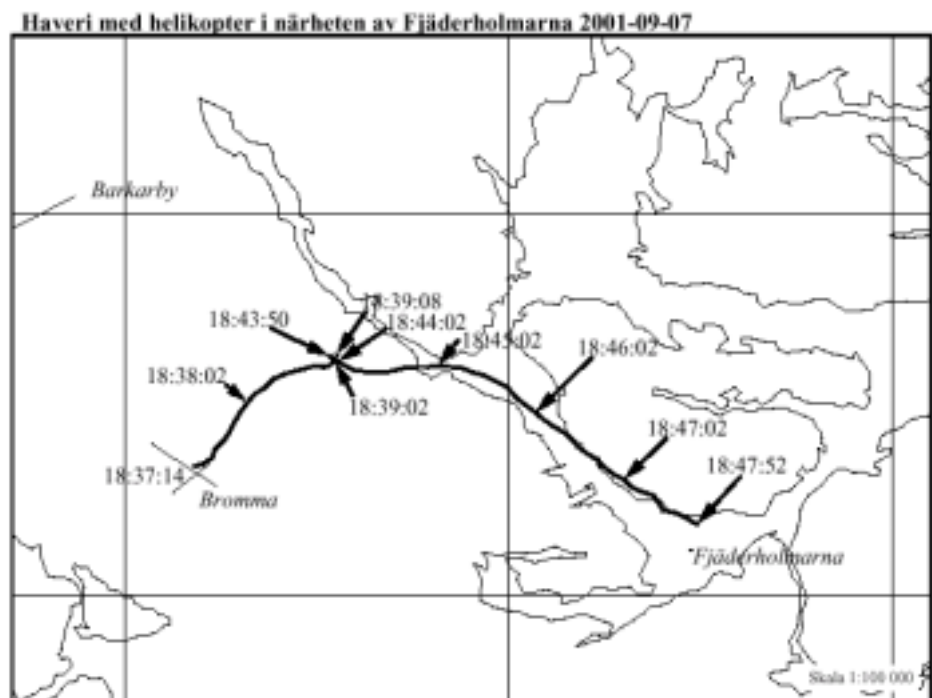
Aided by information from The Swedish Military Intelligence & Security Service (MUST) it has been possible to reconstruct the route flown by the helicopter from the time it departed Stockholm/Bromma airport, and via Järva Krog flew to Fjäderholmarna.

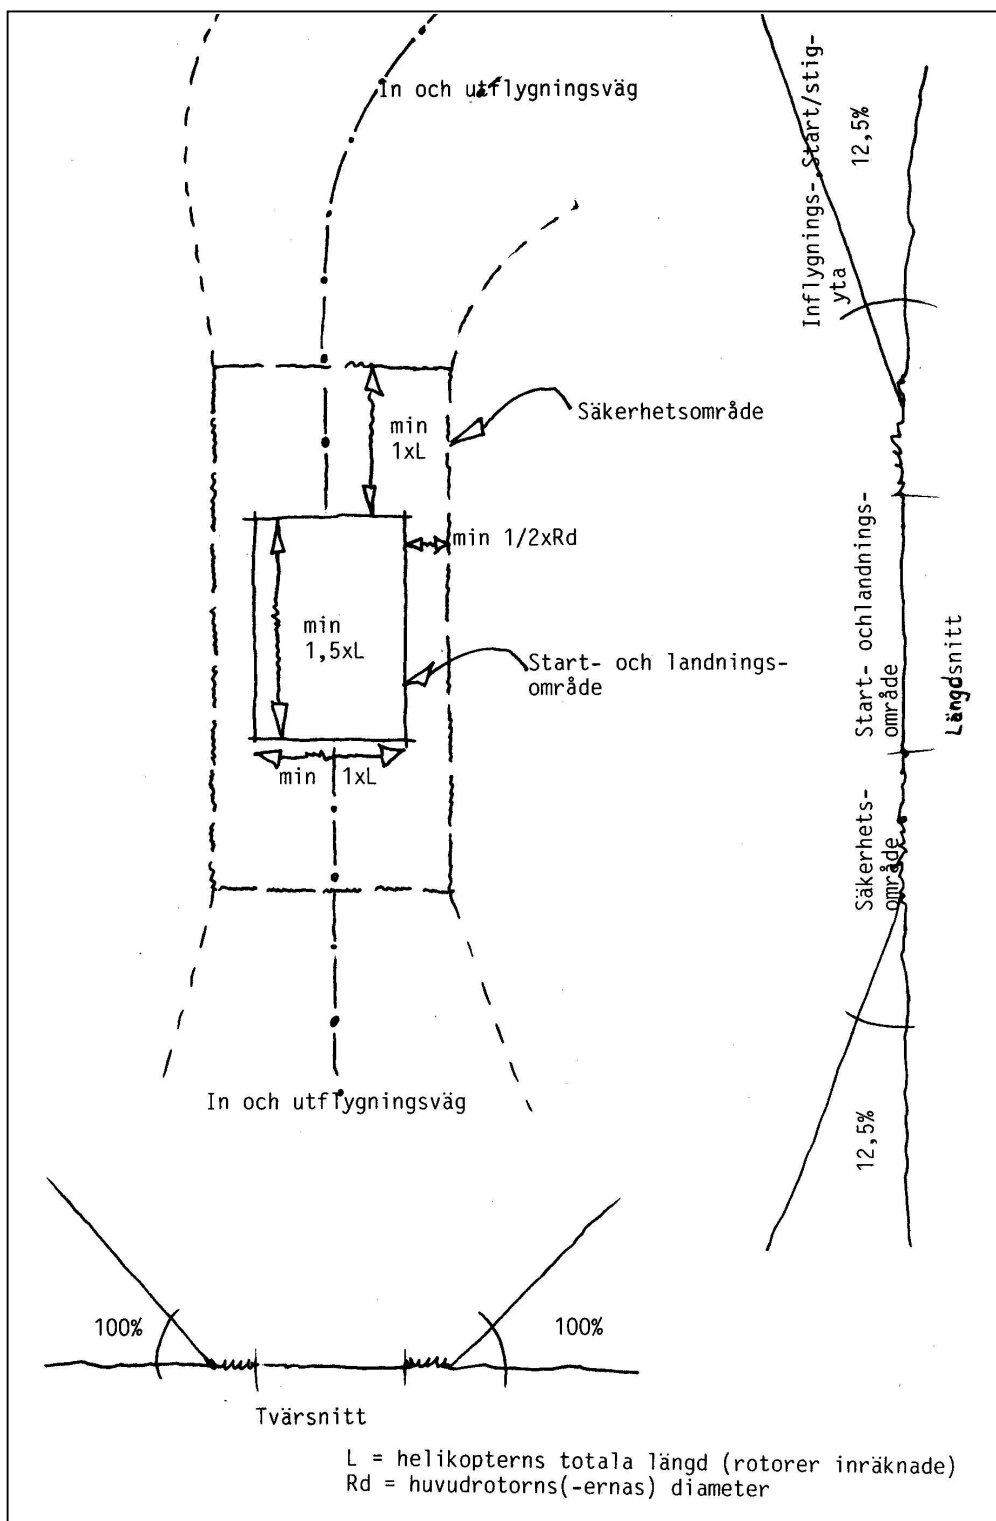
Occasional helicopter landing areas shall meet the requirements concerning takeoff and landing areas, safety zones and approach zones according to the sketch in BCL-D 1.2, Appendix 5 (see below).

According to paragraph 4.5.1 in regards to commercial flights, other forms of the safety zones and the takeoff and climb sector may be accepted for a permanent landing site, upon approval of the company's Chief of Operations. According to paragraph 4.5.3 areas judged to be suitable by the pilot in command, considering (among other things) the performance of the helicopter, may be utilized as occasional takeoff and landing sites during commercial flights. However, in this context, the minimum clearance from the helicopter's rotor tips to a moveable obstacle shall not be less than the rotor diameter and the minimum clearance from the rotor tip to a stationary obstacle shall not be less than three meters.
