Accidents with Russian aircraft stationed in the Netherlands

the accident with the Yakolev 52, RA02080, near Heten on March 9th, 2001 and the accident with the Sukhoi 29, RA01276, at naval air station 'de Kooy' on June 7th, 2002

The Hague, January, 2007 (project number 2001028 and 2002079)

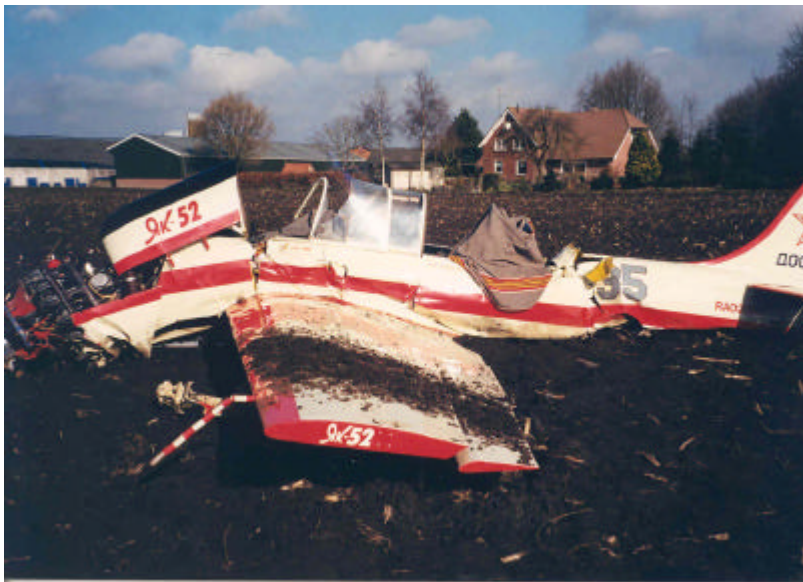
Picture 1: The wreck of the Yak-52 after the impact

The engine and its suspension were bent downwards. The front part of the body also bent downwards at the level of the front edge of the wing. The wings were slightly damaged. The fuselage behind the cockpit was torn, and the main rudder had been lifted from both upper pivots. The back of the fuselage was slightly bent to the left as seen in flight direction. Impacts were visible under the engine and under the wheels of the under carriage. The wreck was complete; except for some small parts, no parts were found in the vicinity of the aircraft. After its recovery, the aircraft was subjected to a technical examination.

The aircraft damage after the accident matches a horizontal or virtually horizontal position of the plane at the time it hit the ground. Given the aircraft damage and the statements made by the eyewitnesses, it is likely that the plane got into a flat spin and did not recover from this condition. This investigation could not determine whether or not the aircraft had entered the flat spin intentionally.

On the basis of the available weather report from the KNMI [*Royal Dutch Meteorological Institute*] and on the basis of the photographs taken quite shortly after the accident, it appears that visibility was excellent; see picture 1 on page 16 of this report. The broken clouds at 1,200 up to 1,500 feet, as indicated on the KNMI weather report, point to a level of coverage of 5/8 up to and including 7/8. At noon, i.e. well after 10:25 a.m., the time of the accident, flying conditions worsen. On the basis of the aforementioned photographs the level of coverage does not seem to exceed 4/8. Depending on the direction in which the photographs were taken even a coverage level of 2/8 (FEW) can not be excluded. It is therefore likely that at the time of the accident the cloud coverage was rather at most 4/8 (and probably less) than the value of 5/8 up to 7/8 as indicated in the KNMI report. The cloud base will not have been less than the 1,200 up to 1,500 feet as mentioned in the weather report, the eventually lowest cloud base as a consequence of the worsening weather conditions starting at about noon. It seems justified to conclude that, at the time of the accident, the visibility and the cloud base were sufficient to be able to carry out aerobatic figures free of clouds and whilst keeping sight of the horizon.

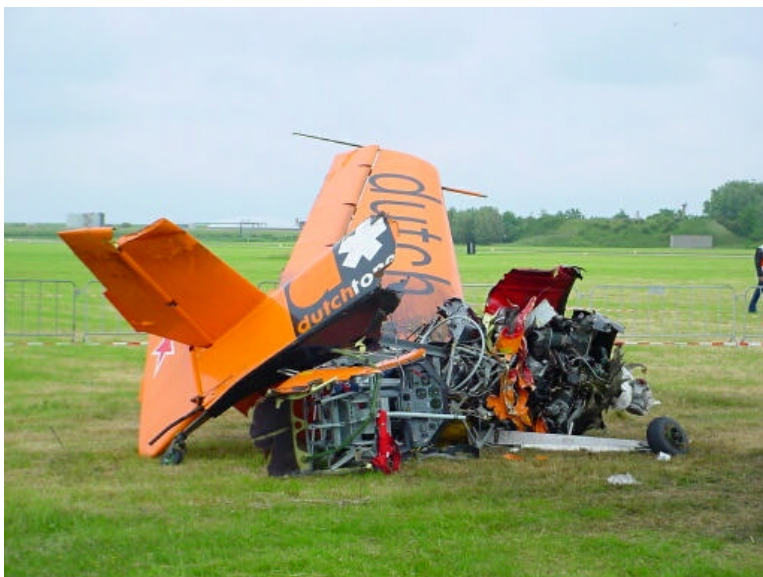
Picture 4: The wreck of the Su-29 after impact

The aircraft touched the ground at the level of the display line laid down for the aviation show. This is a marked line on the show area which often runs parallel to one of the runways and which is used by the demonstration pilots as orientation line. By flying along this line, they prevent flying above the audience during demonstrations, and that in case of an accident, the aircrafts stay away from the audience (see picture 6).
