## AIRCRAFT ACCIDENT REPORT AND EXECUTIVE SUMMARY

Reference:	CA18/2/3/7514	
<b>Aircraft Registration</b>	ZS-HYT	<b>Date of Accident</b>	9 June 2002		<b>Time of Accident</b>	0905Z
<b>Type of Aircraft</b>	Robinson R22 Beta		<b>Type of Operation</b>		Game Capturing	
<b>Pilot-in-command Licence Type</b>		Commercial	<b>Age</b>	56	<b>Licence Valid</b>	Yes
<b>Pilot-in-command Flying Experience</b>		Total Flying Hours	10868		Hours on Type	unknown
<b>Last point of departure</b>		Mkuze District, Pongola				
<b>Next point of intended landing</b>		Mkuze District, Pongola				
<b>Location of the accident site with reference to easily defined geographical points (GPS readings if possible)</b>						
Leeukop Game Farm approximately 30km East of Pongola.						
<b>Meteorological Information</b>		Wind: 5kts/240° Temperature: 21°C Visibility: +10km				
<b>Number of people on board</b>	1+0	<b>No. of people injured</b>	0	<b>No. of people killed</b>	1	
<b>Synopsis</b>

**Name of Owner/Operator** : JJ Du Plessis  
**Manufacturer** : Robinson  
**Model** : R22 BETA  
**Nationality** : South African  
**Registration Marks** : ZS-HYT  
**Place** : Leeukop Game Farm 30 km East of Pongola  
**Date** : 9 June 2

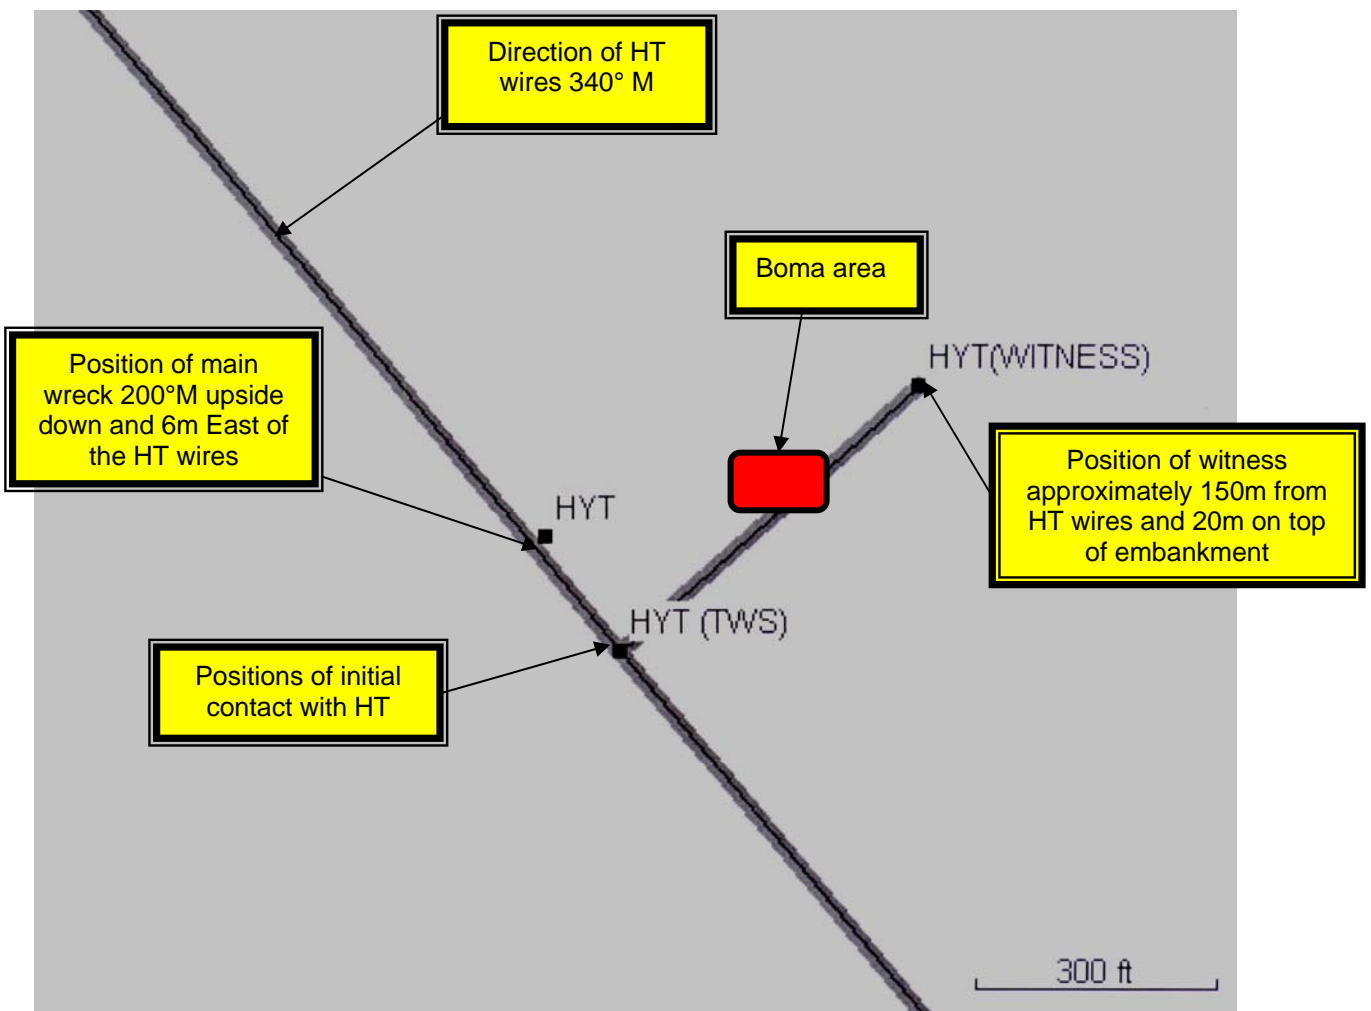
Figure: 1

1.1.2 Another witness standing east of the accident site (see Fig 1 above) observed the helicopter flying to the left of the power line in a southerly direction towards the boma. As the game was entering the boma, the helicopter went into a hover and started to turn anti-clockwise. The helicopter moved rearwards, then the tail of the helicopter hooked onto the top wire of the high-tension power line. The helicopter started to move rapidly rearwards and turned left through 45°. The nose of the helicopter dropped and it entered into a spin, prior to crashing into the ground.

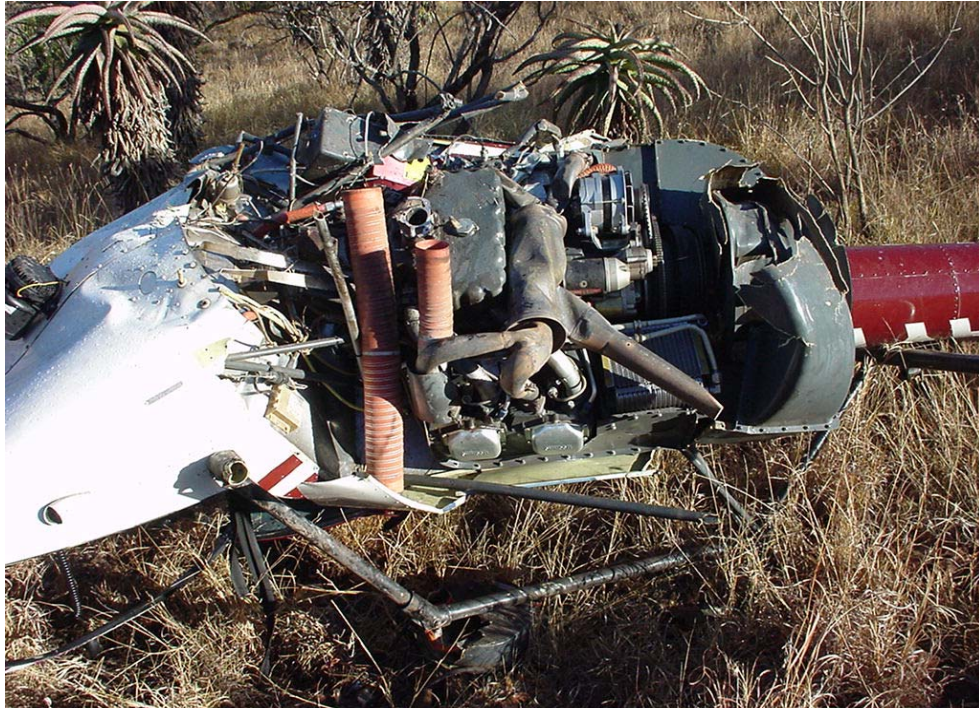
1.12.1 The tail of the helicopter hooked onto the top wire of the high-tension power line. The helicopter then started to move rapidly rearwards and started to turn left through 45°. The nose of the helicopter then dropped and it went into a spin prior to

crashing into the ground. The helicopter had rolled over and ended up in an inverted position. The pilot had the seatbelt and harness fastened and was hanging from his seat.

Figure: 4 showing the helicopter inverted after crashing into the ground.

1.15.1 This accident was considered not survivable, due to the high impact forces associated with the aircraft spinning uncontrollably into the ground. The helicopter crashed in an inverted attitude, which resulted in the destruction of the cabin area. The pilot was left with no protection.
