AIRCRAFT ACCIDENT REPORT AND EXECUTIVE SUMMARY

| | | | | Reference: | CA18/2/3/7609 | |
| Aircraft Registration | ZS-GOS | Date of Accident | 26 December 2002 | Time of Accident | 0845Z | |
| Type of Aircraft | Beech 58 (Aeroplane) | | Type of Operation | Private | | |

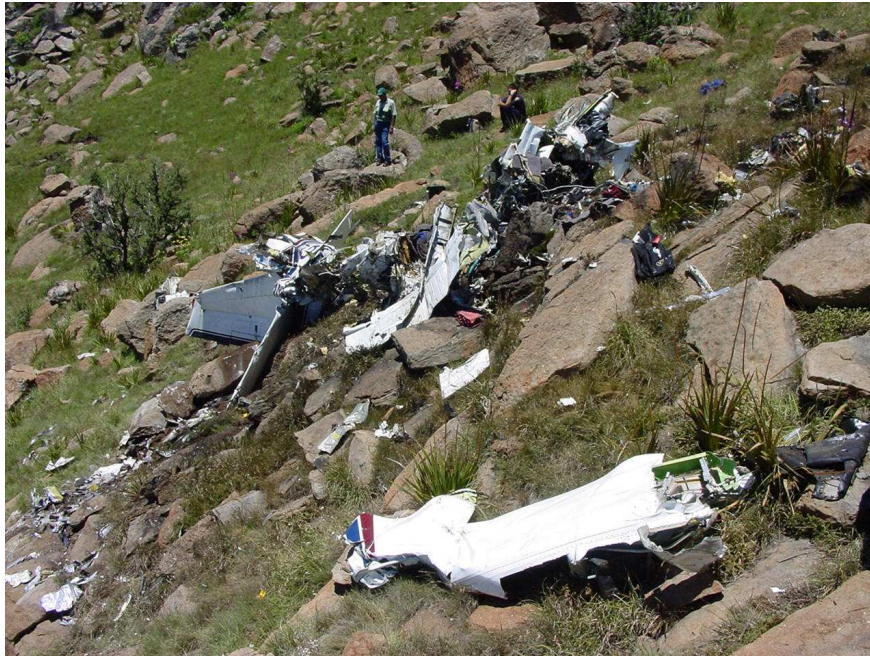
1.3.1 The aircraft was destroyed during the impact sequence with mountainous terrain.

Photo 1. A view of the wreckage following impact with mountainous terrain.

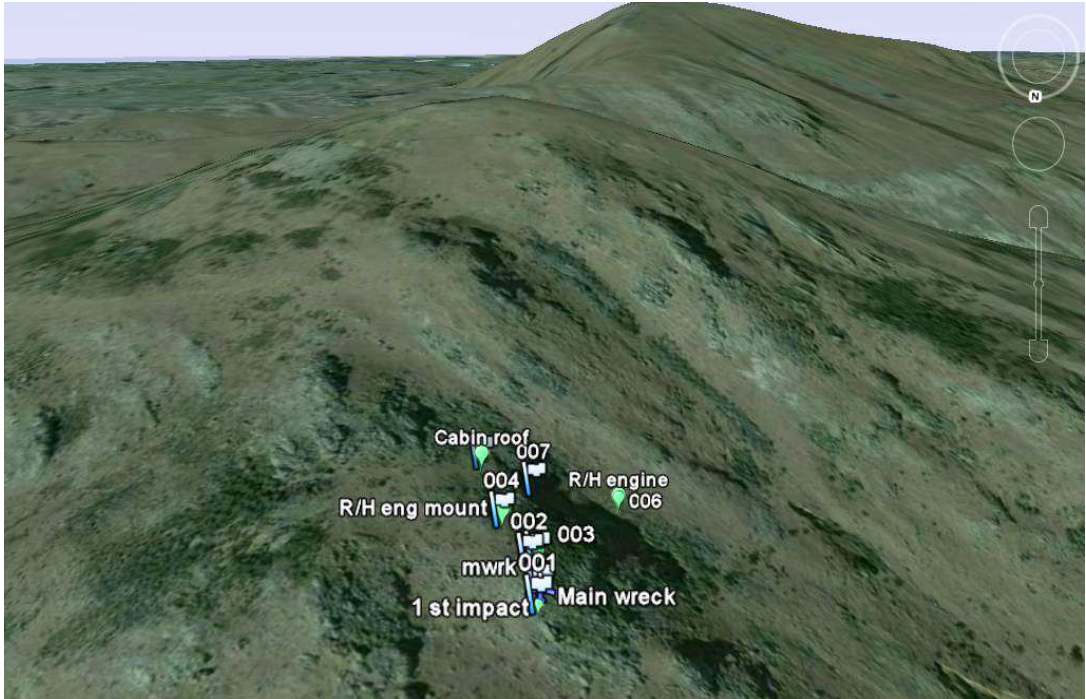
- 1.12.1 The aircraft flew in a southerly direction when it impacted with the Ingele Mountains at an altitude of approximately 6 560 feet AMSL. The initial impact point of the aircraft against the side of the mountain was at a point where the incline of the mountain side was approximately 45°. The main wreckage of the aircraft was found a few feet higher at a position which was recorded as South 30°35'588" East 029°35'122". Below is an illustration of the impact position as viewed in a southerly direction.

Google Earth view of the impact on the side of the Ingele Mountains in southerly direction.

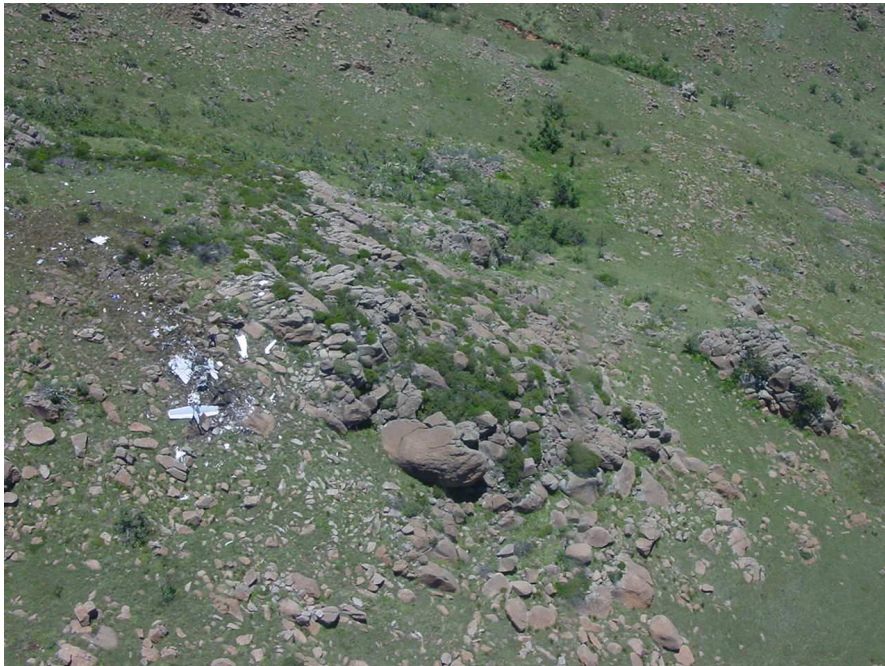
Photo 2. An aerial view of the actual impact on the side of the Ingele Mountains.

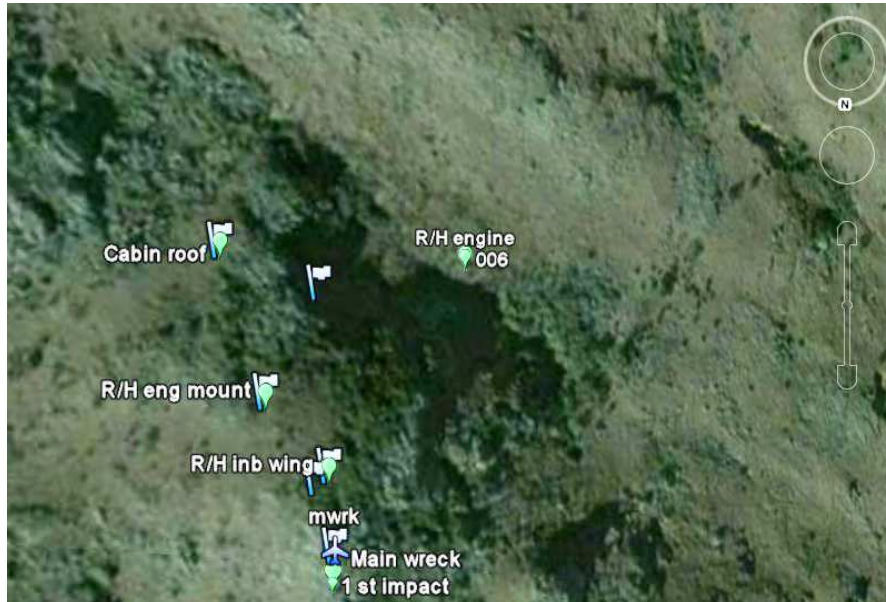
Wreckage layout plotted on Google Earth.

- 1.12.3 The component of the aircraft that was found furthest away from the main wreckage was the right-hand engine at a distance of 82m in a direction of 224°M. Most of the accessories of the engine had been broken off from the main engine assembly as the engine was flung in the direction of impact. The remainder of the engine was inspected as it was found, and no pre-impact failures were observed.

- 1.12.4 The upper part of the fuselage was located to the left of the right engine. The cabin roof had separated from the rest of the wreckage and was flung 63m in a direction of 196°M forward of the main wreckage. Several other wreckage fragments were found spread on the mountainside between these three main points.
