SOUTH AFRICAN CIVIL AVIATION AUTHORITY

ACCIDENT REPORT – EXECUTIVE SUMMARY

Name of Owner : BISON COMPUTERS CC
Name of Operator : None
Manufacturer : Piper Aircraft Corporation
Model : P23-250
Nationality : South African
Registration Marks : ZS-AMM
Place : Segodi Lodge
Date : 20 April 2003
Time : 1520Z

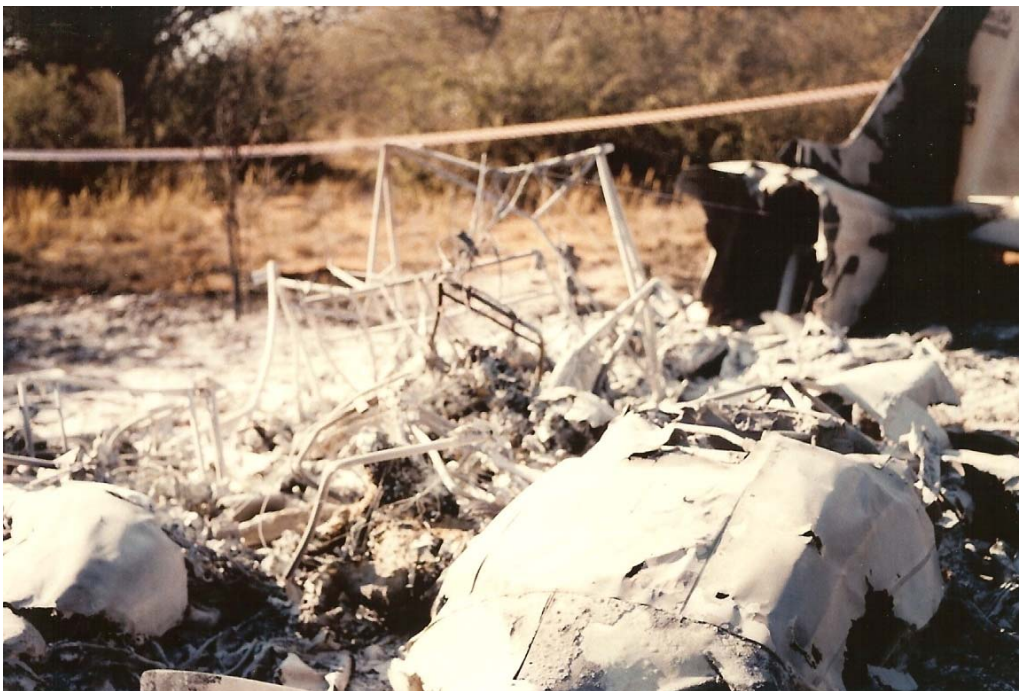
1.3.1 During the ensuing fire, the aircraft was destroyed.

Figure 1: The wreckage, destroyed by the ensuing fire

1.14.1 The aircraft was destroyed and minor damage to the surrounding vegetation was caused during the ensuing fire.
