## AIRCRAFT ACCIDENT REPORT AND EXECUTIVE SUMMARY

Reference:	CA18/2/3/7682	
<b>Aircraft Registration</b>	<b>ZS-WBV</b>	<b>Date of Accident</b>	26 July 2003	<b>Time of Accident</b>	1530Z	
<b>Type of Aircraft</b>	Windlass Trike (Microlight)		<b>Type of Operation</b>	Private		
<b>Pilot-in-command Licence Type</b>		Microlight	<b>Age</b>	40	<b>Licence Valid</b>	Yes
<b>Pilot-in-command Flying Experience</b>		Total Flying Hours	166	Hours on Type	150.2	
<b>Last point of departure</b>		Louis Trichardt Aerodrome				
<b>Next point of intended landing</b>		Louis Trichardt Aerodrome				
<b>Location of the accident site with reference to easily defined geographical points (GPS readings if possible)</b>						
In a bushy terrain east of Runway 10/28 at Louis Trichardt						
<b>Meteorological Information</b>		The weather was fine with no wind				
<b>Number of people on board</b>	1+1	<b>No. of people injured</b>	0	<b>No. of people killed</b>	2	
<b>Synopsis</b>

**Name of Owner/Operator** : H Du Plooy  
**Manufacturer** : Solo Wings CC  
**Model** : Windlass Trike  
**Nationality** : South Africa  
**Registration Marks** : ZS-WBV  
**Place** : Louis Trichardt Aerodrome  
**Date** : 26 July 2003  
**

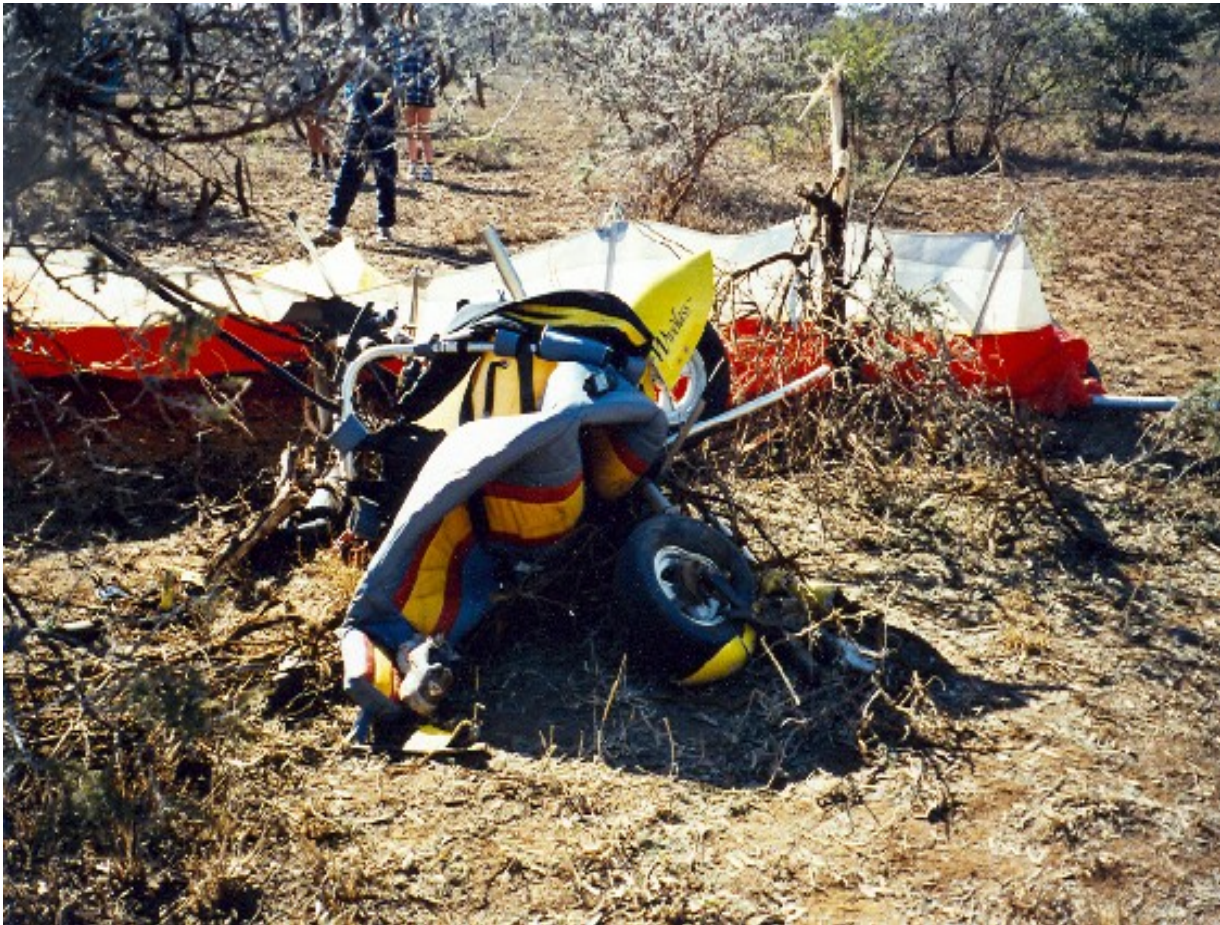
Figure1: Showing the damage to the microlight aircraft.

1.3.1 The aircraft was destroyed in the accident.

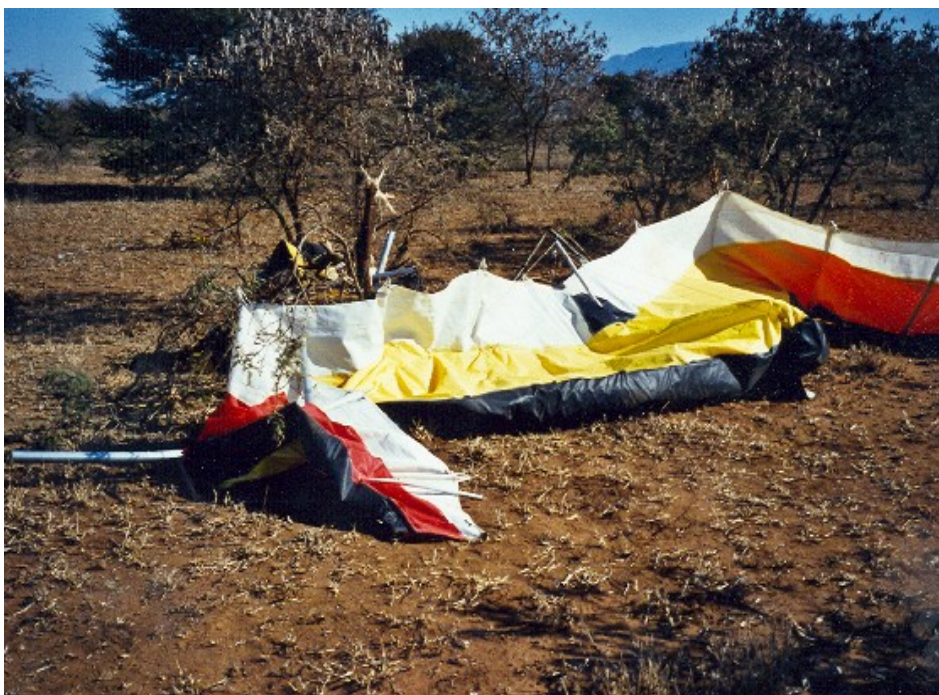
1.12.1 The aircraft lost height during the spiral turn and impacted with the ground. The microlight was destroyed by impact forces.

Figure 2: shows the wreckage as found on the accident site.

1.16.1.1 The left wing leading edge had failed approximately 60 cm from the tip. All the cables were connected.

1.16.1.2 The right hand wing leading edge had failed approximately 1.5 metres from the tip.

1.16.1.3 The king post failed at 2 places.

- 3.2.1 The accident was attributed to a spiral turn which was executed at a lower altitude from which a recovery was not possible, and the microlight impacted with the ground.

4.1 The SACAA should refer this accident to RAASA with the purpose of increasing safety oversight over microlight aircraft.
