CA18/2/3/7741			
		SOUTH AFRICAN CIVIL AVIATION AUTHORITY ACCIDENT REPORT – EXECUTIVE SUMMARY			
Aircraft Registration	ZS-DVF	Date of Accident	16 December 2003	Accident Time	0515Z
Type of Aircraft	PIPER PA 22-108		Type of Operation	Private	
Pilot-in-command Licence Type	Private	Age	81	Licence Valid	Yes
Pilot-in-command Flying Experience	Total Flying Hours	4 065.2		Hours on Type	49.2
Last point of departure	Krugersdorp Aerodrome (FAKR)				
Next point of intended landing	Krugersdorp Aerodrome (FAKR)				
Location of the accident site with reference to easily defined geographical points (GPS readings if possible)					
Farm Moedhou, Hartbeesfontein District (GPS: South 25° 51' 537" East 027° 37' 418", elevation ± 4 200ft)					
Meteorological Information	Surface wind; 020°/10 knots, Temperature; 20°C, Visibility; >10km				
Number of people on board	1 + 1	No. of people injured	0	No. of people killed	1 + 1

AIRCRAFT ACCIDENT REPORT

Name of Owner/Operator : Dr. T.R. Chamberlain
Manufacturer : Piper Aircraft Corporation
Model : PA 22-108
Nationality : South African
Registration Marks : ZS-DVF
Place : Farm Moedhou, Hartebeesfontein District
Date : 16 December 2003
Time : 0515Z

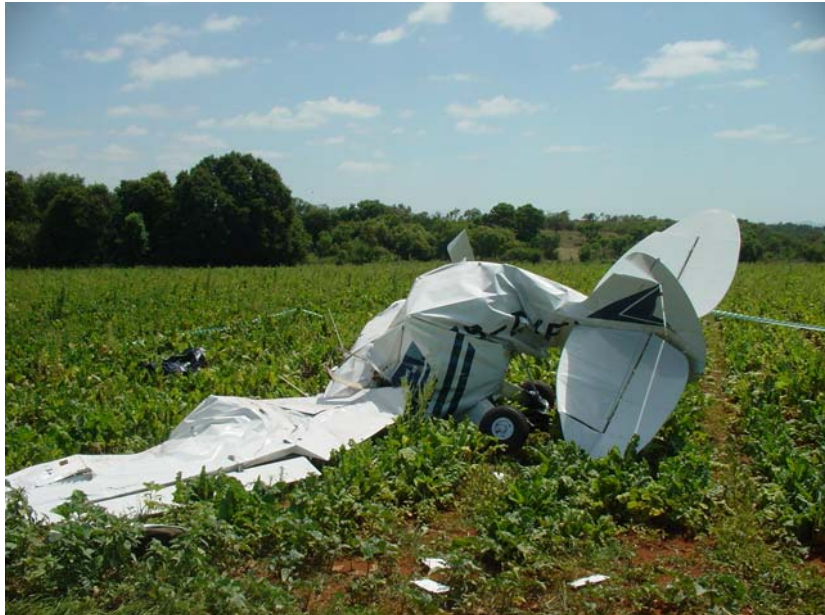
- 1.3.1 The aircraft was destroyed by the impact forces.

Figure 1. A view of the wreckage, which crashed into a spinach field.

1.12.1 The aircraft impacted terrain in a substantial nose-down attitude on a heading of 326°M (magnetic). Following impact with the ground, the wreckage remained stationary in a semi-upright position with no lateral or longitudinal movement evident on the ground surface. The forward fuselage section, including the cockpit area, was severely disrupted following ground impact. Both wings displayed evidence of severe disruption. The empennage area displayed very little damage.
