EXECUTIVE SUMMARY - AIRCRAFT ACCIDENT REPORT

Reference:	CA18/2/3/7829	
Aircraft Registration	ZS-RTV	Date of Accident	6 July 2004		Time of Accident	1330Z
Type of Aircraft	Robinson R22 Beta II		Type of Operation	Game capture		
Pilot-in-command Licence Type		Commercial	Age	41	Licence Valid	Yes
Pilot-in-command Flying Experience		Total Flying Hours	2 506.0		Hours on Type	1 010.0
Last point of departure		Kalahari Oryx Game Farm, Northern Cape				
Next point of intended landing		Kalahari Oryx Game Farm, Northern Cape				
Location of the accident site with reference to easily defined geographical points (GPS readings if possible)						
Kalahari Oryx Game Farm (GPS position: South 28° 32' 325" East 022° 10' 168")						
Meteorological Information		Surface wind 090° at 5 – 10 kts, temperature 19°C, visibility good				
Number of people on board	1 + 1	No. of people injured	1	No. of people killed	0	
Synopsis						
<p>The pilot and a passenger were engaged in a game capture operation.</p> <p>They managed to successfully herd about 15 oryx antelope into the capture boma. As the animals were being herded deeper into the boma by ground personnel, the pilot maintained a hover flight at a height of

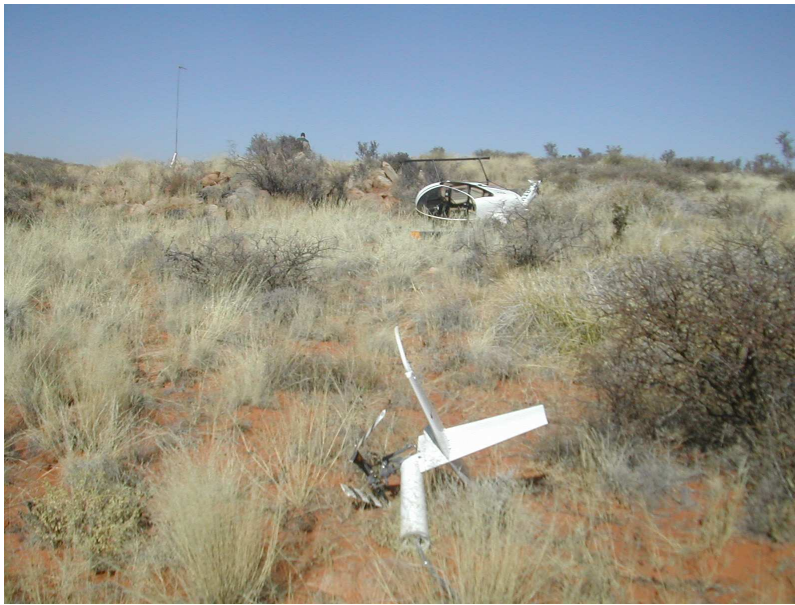
Probable Cause						
<p>The pilot executed a downwind approach for landing and in an attempt to arrest a high rate of descent, overpitched the main rotors. This resulted in a decay in main rotor RPM with a possible vortex ring state, resulting in a hard landing.</p> <p>Contributory factor: The pilot reflected poor airmanship and situational awareness by not assessing the prevailing wind properly prior to initiating his descent.</p>						
IARC Date	28 February 2008		Release Date	Reviewed by EM office: AIID March 2009

Figure 1: A view of the main wreckage and a section of the tail boom and rotor assembly

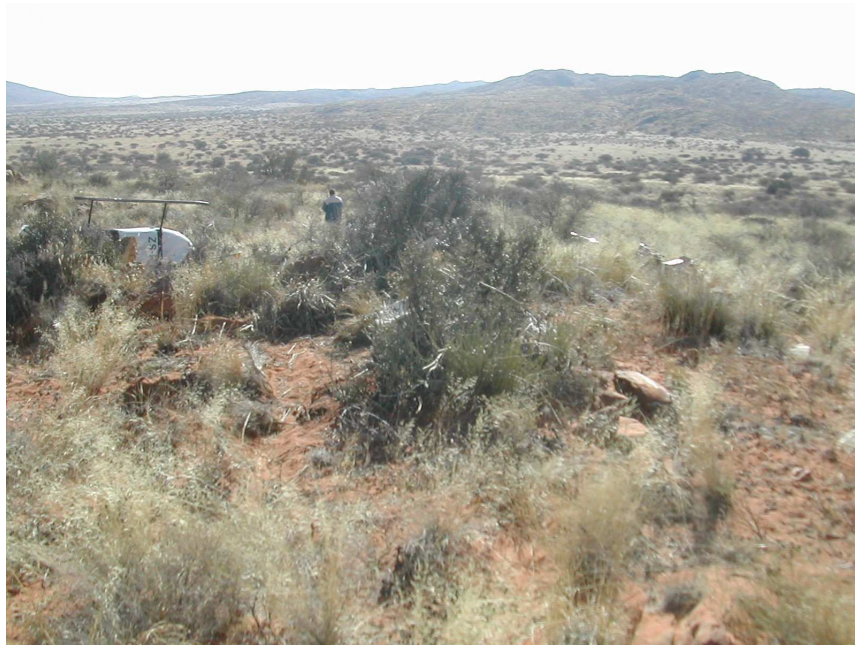
Figure 2: A view of the initial impact point with the main wreckage visible further on
