Statens haverikommission
Swedish Accident Investigation Board

Report RL 2006:12e

**Accident involving aircraft SE-GOP
at Optand airport, Z county, Sweden,
on 6 August 2004**

Case Number L-31/04

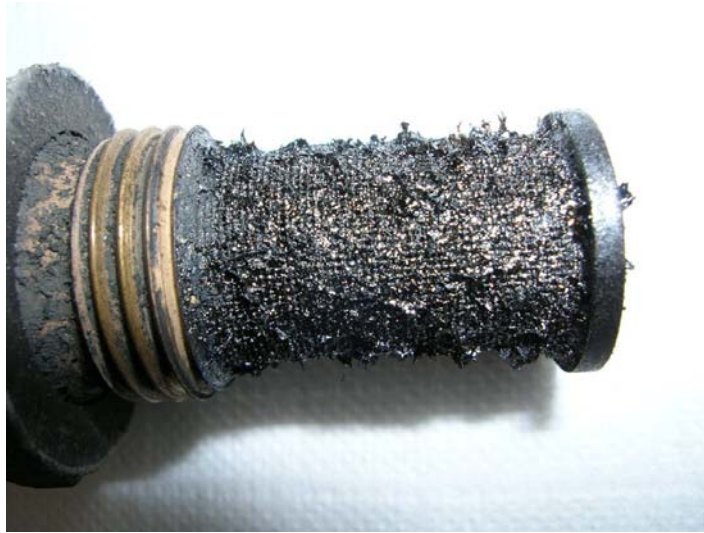
FCU filter with contamination

To investigate what the foreign material in the fuel filter and on the M/V cover consisted of they were analysed by Applied Technical Services (ATS) in Marietta, Georgia, USA and by the Swedish National Testing and Research Institute (SP) in Borås.

The ATS testing was carried out using the FT-IR method and 10 x stereo microscopy. This method showed only that the material on the filter consisted mostly of carbon, i.e. was probably a carbonised substance. The material found in the cover was nylon.

After the crash the aircraft wreck, as mentioned earlier, lay practically upside-down. In consequence of this the fuel line into the clogged filter was higher than the filter. The rubber part of the line was completely destroyed by the fire that broke out at the time of the crash. Since the black substance, and its quantity, could not be linked with contamination normally to be found in this filter, the Board decided to check whether the substance could be remains of the burnt-up fuel line.

The Swedish Accident Investigation Board has found no technical reason for the engine failure. The clogged fuel filter could be one, but even though the TOF-SIMS analysis and the fire tests cannot be claimed to prove that it was remnants of the fuel line that were found in the filter, a balanced analysis shows this hypothesis to be the most plausible.

- In its supervisory activity ensure that correct emergency checklists are available in all aircraft (*RL 2006:12e R4*).
- Seek to ensure that cleaning of the FCU filter is introduced into Cessna inspection lists for those aircraft that may be relevant (*RL 2006:12e R5*).

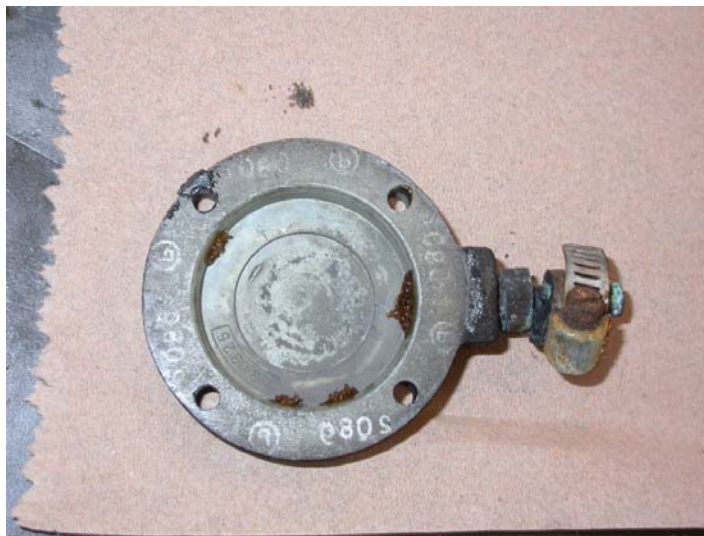
M/V cover with contamination. Ventilation tube inlet to the right.

The yellow impurities in the M/V cover can only have been deposited there after the aircraft turned upside-down. A blocked ventilation hole in the cover is not likely to have caused such serious engine malfunctioning as that in the present case.

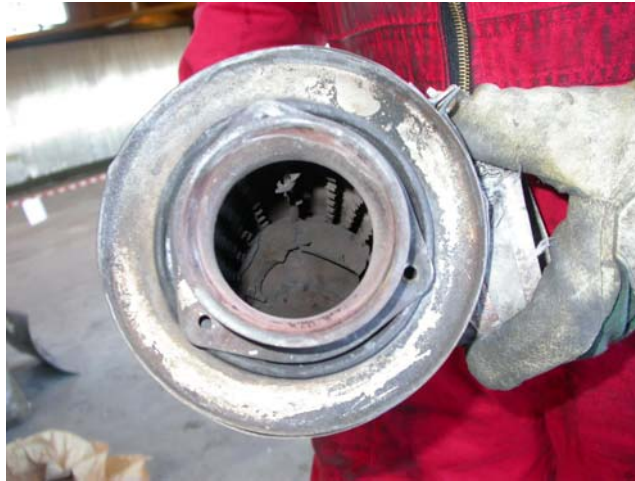
The illustration above shows the left silencer from the input side. Around its inside are flanged studs. These increase the heat-transferring surface and are also fixing points for three sheet metal cones mounted in series to conduct the exhaust gases onto the studs. As seen in the illustration, the first cone has collapsed and parts thereof are resting against cone number 2.

The damage to the exhaust system is a possibility, since blocked silencers/mufflers have caused many emergency landings. The Board considers it less likely that the loose parts in the left silencer could have blocked this so much that the engine largely stopped delivering thrust. The TCM tests support this view. An engine installation such as the one in question is naturally less vulnerable than one in which all the cylinders exhaust into a common silencer.

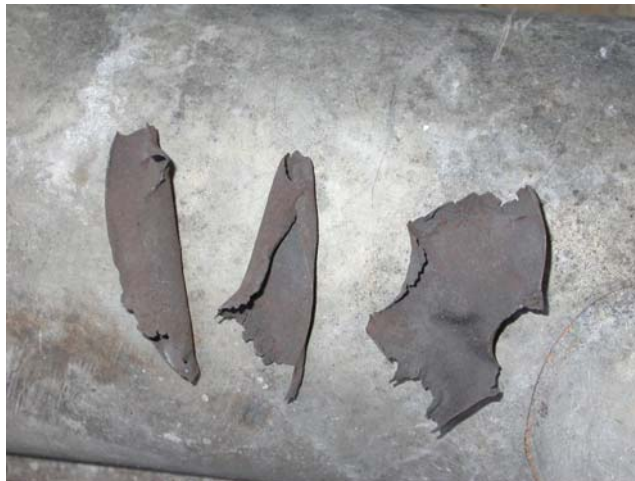
Below, the loose parts are shown separately.

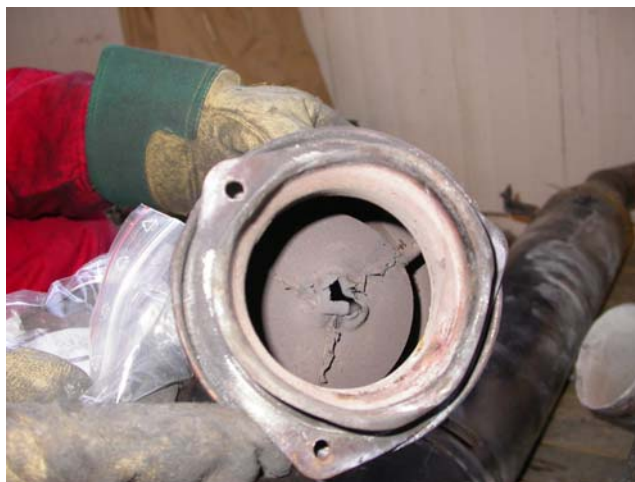
The right silencer is of similar design but without heat exchanger and therefore studs. Three sheet metal cones are included so that left and right silencers shall have the same flow resistance. Here also the first cone is damaged but it is still in its position.
