Report RL 2006:16e

**Accident involving helicopter SE-JUJ
at Skräckskär, Gryts skärgård, E County,
Sweden, on 18 September 2004**

Case L-46/04

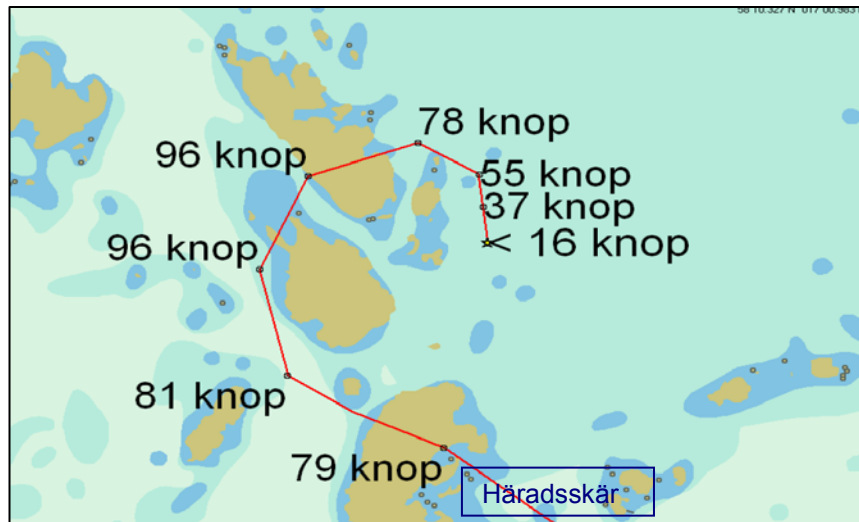
Approach flight according to AIS records

The helicopter flight path was recorded by the National Maritime Administration Control Centre via the AIS system. The approach path towards Häradsskär and the calculated speed are shown on the map below.

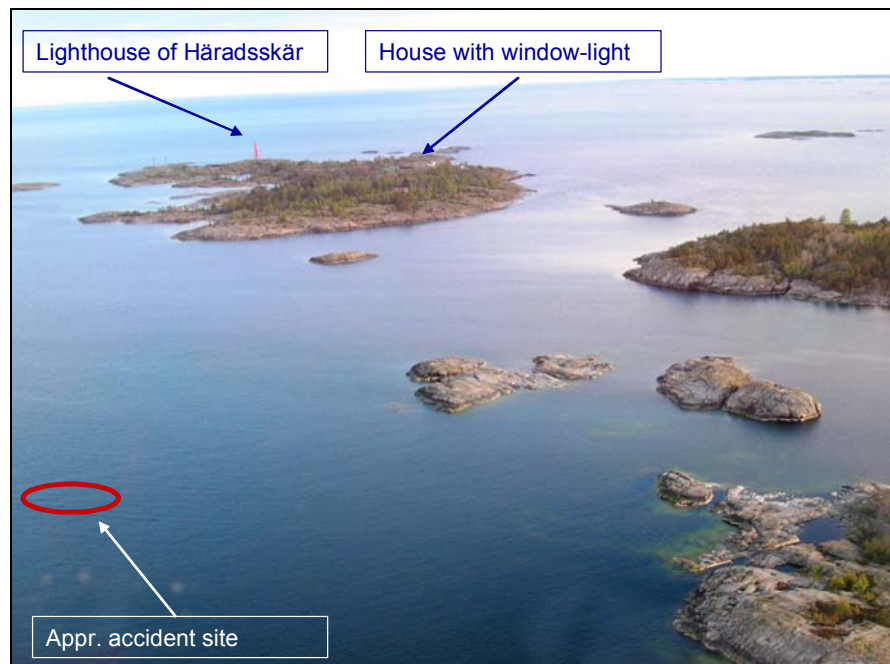
Approach to Häradsskär seen from the north

The helicopter struck the water approximately 500 metres north of Häradsskär. Häradsskär lighthouse is located on the southern part of Häradsskär. The patient was in a house situated roughly in the middle of the island.

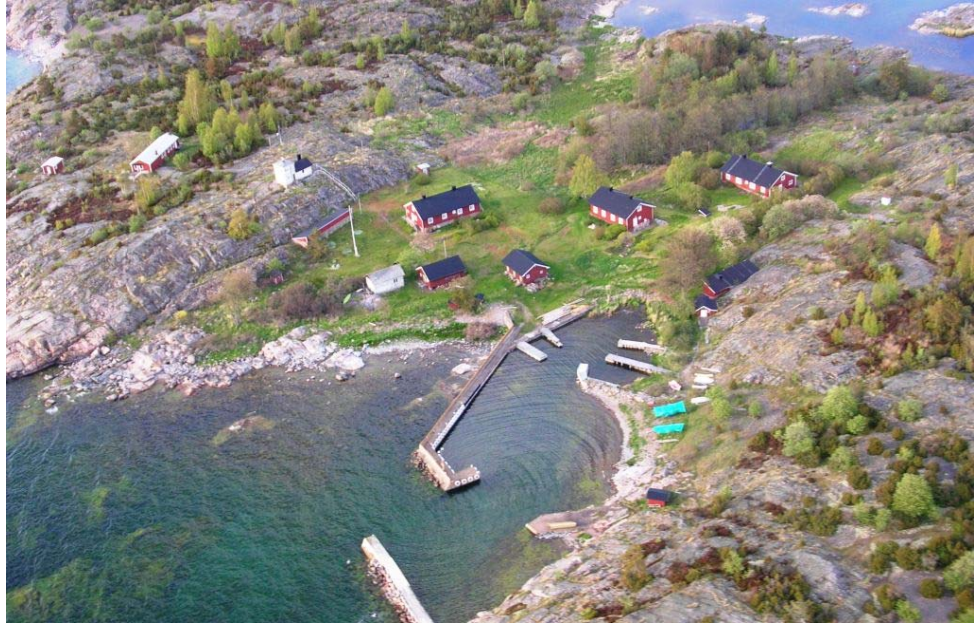
The area where the summer cottage with the patient was situated

- reconnoitring from the air prior to the approach was at a distance of approximately 300 metres north of the intended landing site,
- the approach turn was started almost immediately after the fly-over and was relatively sharp, and
- the ground is uneven, offers few flat open areas and is crossed by many power and telephone lines.

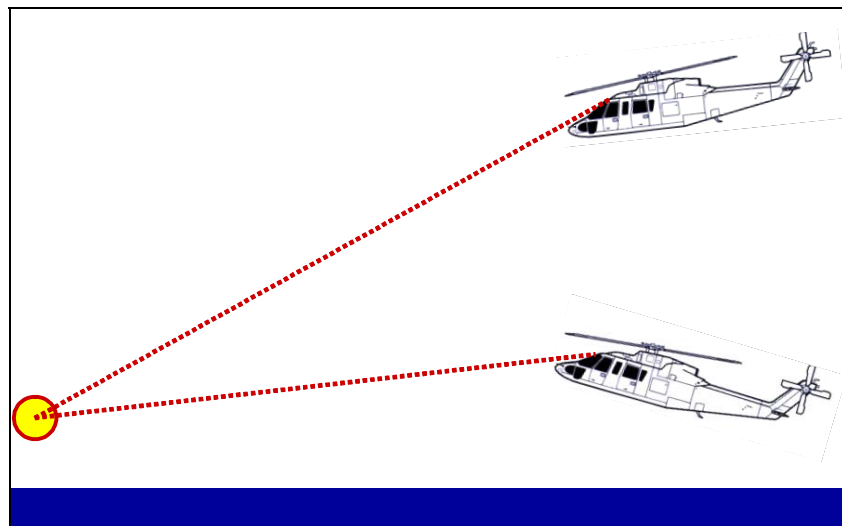
Experience shows that it is practically impossible, with only a few light sources in front of a helicopter as references, to determine its position and movement with any certainty.

The illustration below shows the problem of attempting to determine flight attitude using just one light source. The light source has the same position in the windscreen in both cases. The difficulty of determining the helicopter's attitude is particularly serious during speed reduction, which is usually accomplished with a successive raising of the nose position.

At the accident site, moreover, the light from the window was obscured by the terrain when the altitude was below 250 feet. If the helicopter passed the 250-foot level when the lighthouse was shining, the light from the window did not reappear when the lighthouse beam passed on. It is possible that the captain understood this to mean that the helicopter was so high on its planned glidepath that the light was hidden by the helicopter nose, and so he reduced speed and altitude. When the pilot became aware of the helicopter's true height he had no possibility of being able to avoid impact on the water.
