Report RL 2006:08e

**Aircraft accident to SE-LTF
at Gråbo, O county, Sweden
on 15 February 2005**

Case L-03/05

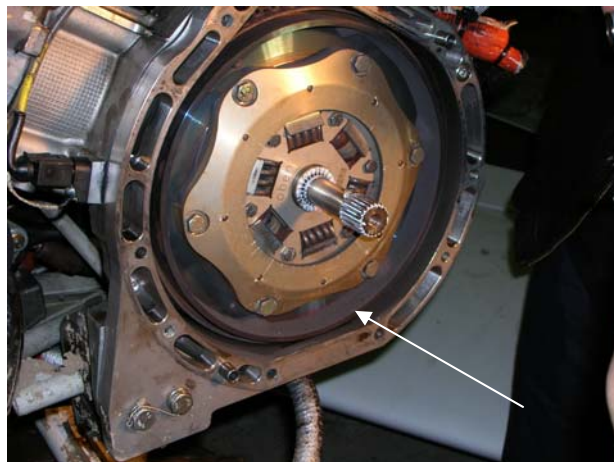
The figure above shows the flywheel and clutch basket after the gearbox was removed.

At the center of the clutch basket is the plate center with a shaft to the gearbox. The shaft is connected to the plate center via a splined coupling. It could be seen immediately that the flywheel was discolored blue and that the lower part of the flywheel was filled with dust (see arrow). The six bolts visible in the figure fasten the clutch basket to the flywheel and were flush with the clutch basket but could be loosened without any measurable torque being required.

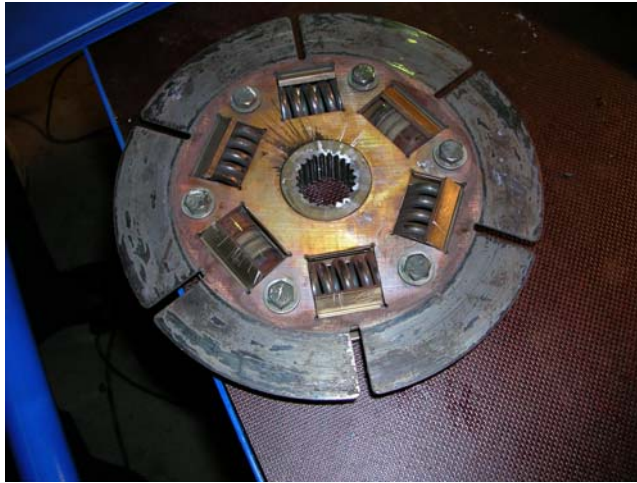
The plate (above) showed signs of overheating and the friction coating was practically entirely worn away.

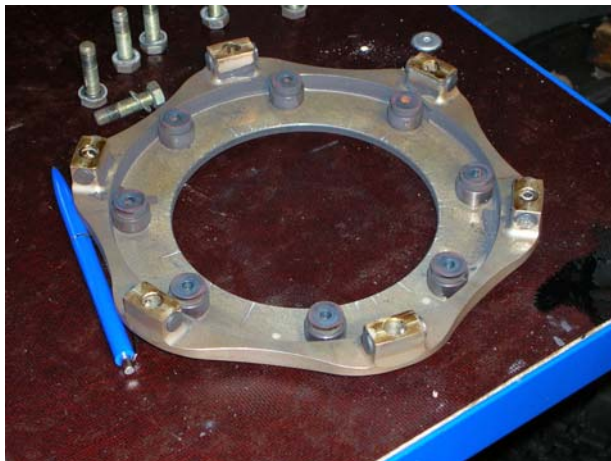
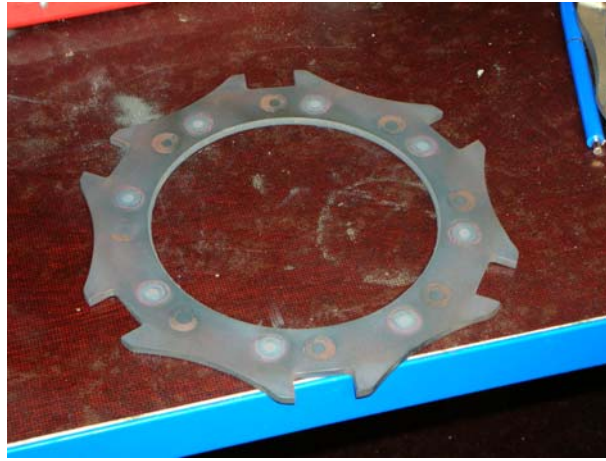
The rear side of the pressure plate showed clear marks from the spring stacks, but with an extra set of marks, probably from a previous assembly.

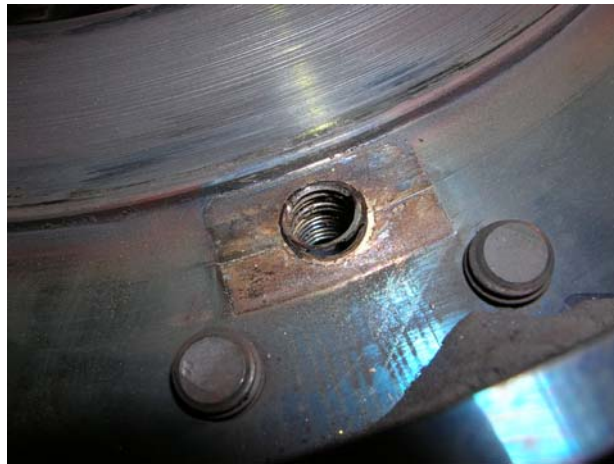
Close-up of the flywheel and one of the bolt holes in the clutch basket. Remnants of hardened locking fluid can be seen in the hole. Note that the blue discoloration that resulted when the clutch slipped and overheated is nearly entirely missing around the hole where the clutch basket had been in contact with the flywheel. In the picture there can also be discerned a line that cuts through in the bolt hole. This actually is a change in level, so that the clutch basket pad had complete contact with the flywheel only on the outer portion, the portion where the blue discoloration is missing. SHK studied several other flywheels and found that this difference in level is not uniform, but rather can vary in size.

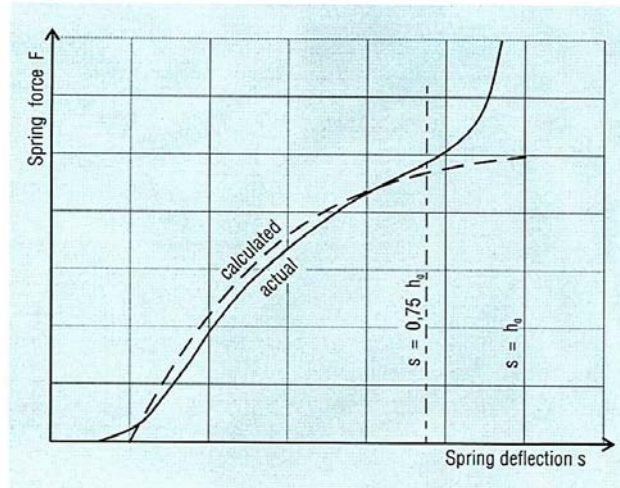
The forces that were previously calculated indicate a compression in the springs assembled three-and-three in parallel of about 0.35 mm, that is, 87 % of the maximal compression. Compression of the other springs is 100 %, that is, they are completely flat.

The assembly order chosen resulted in several springs in the spring stack being compressed together completely and flattened, which resulted in the spring force decreasing very rapidly when the compression decreased; in this case, with the wearing of the clutch plate.

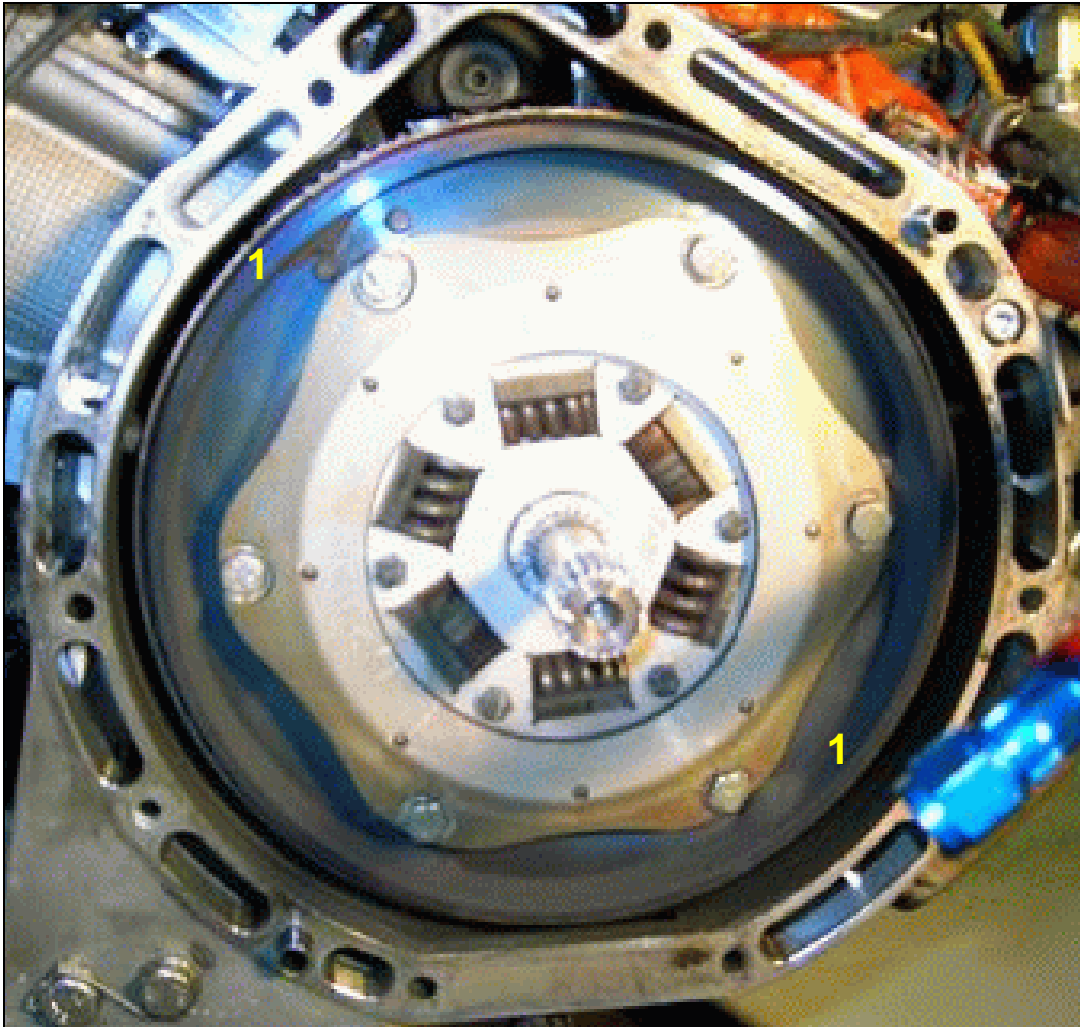
The metal of the clutch cage, the screws to fit the clutch cage, the flywheel mass disk and flywheel mass have different colours (yellow, blue and gray) as a result of thermal load. The zinc coating of the screws to fit the clutch cage was flaking off as a result of the high temperatures. Inside of the flywheel mass grouted (sintered) metal dust near the positions of the screws (1) was accumulated. All components were dry, no oil was found on the surfaces.

It was found that the torque of the screws that fit the clutch cage was less than 8 NM. However all screws were tightened so far that the clutch cage seemed to have contact to the flywheel mass. This could be seen on the pressure points of the clutch cage on the fly wheel (2).

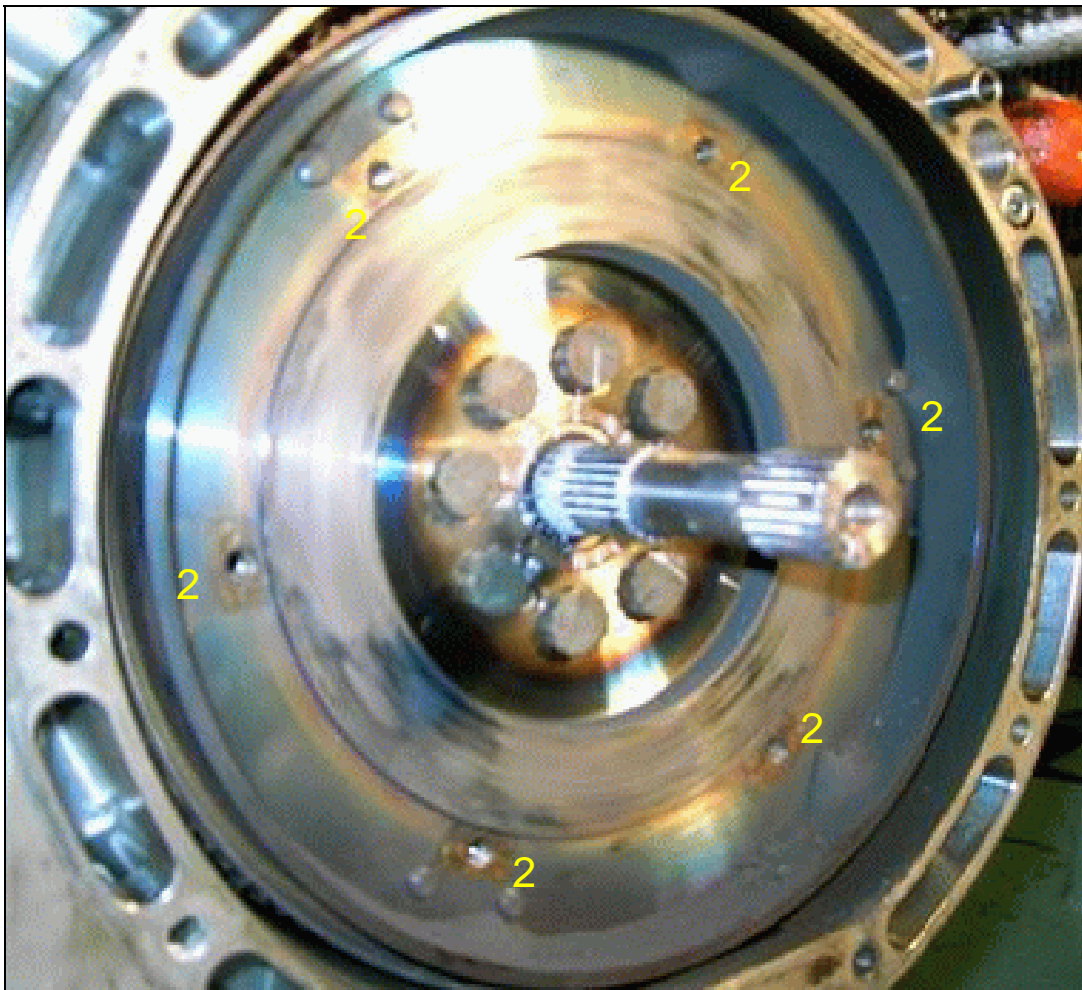
At the screws that fit the clutch cage could be recognized traces of Loctite rests that looked blue and black, located at the base of the thread.

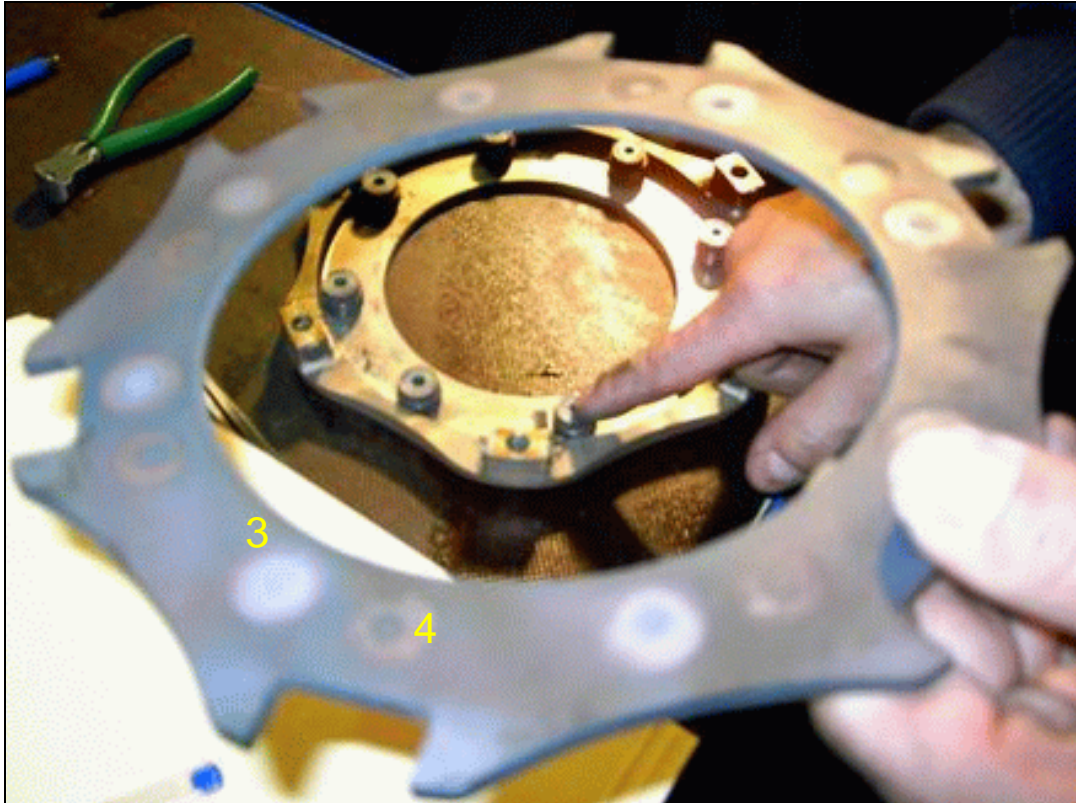
On the back side of the flywheel mass disk were found 16 marks of the spring packages that push the flywheel mass disk against the friction plate. 8 of them from the actual installation (3), 8 of them with red-brown traces of corrosion (4).

The clutch was installed only one time, and for less than 20 hours of operation, so the corrosion marks can only be from a previous installation, before this clutch was delivered from Thielert to Sweden.

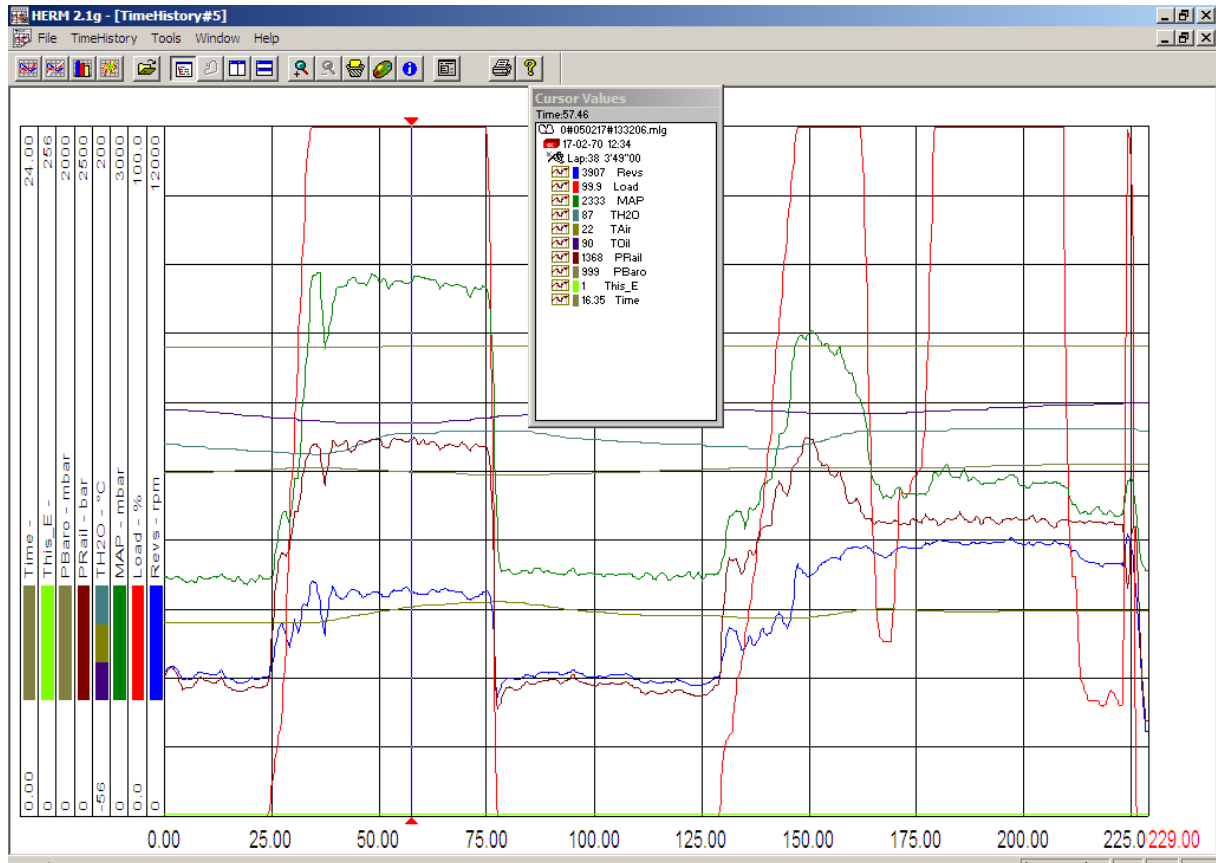
Graph 2: Motor 02-01-0408-SL01-104-0063, Start of the flight, Take Off

The increase (Revs above 3900 engine RPM) can be caused by a slipping clutch.

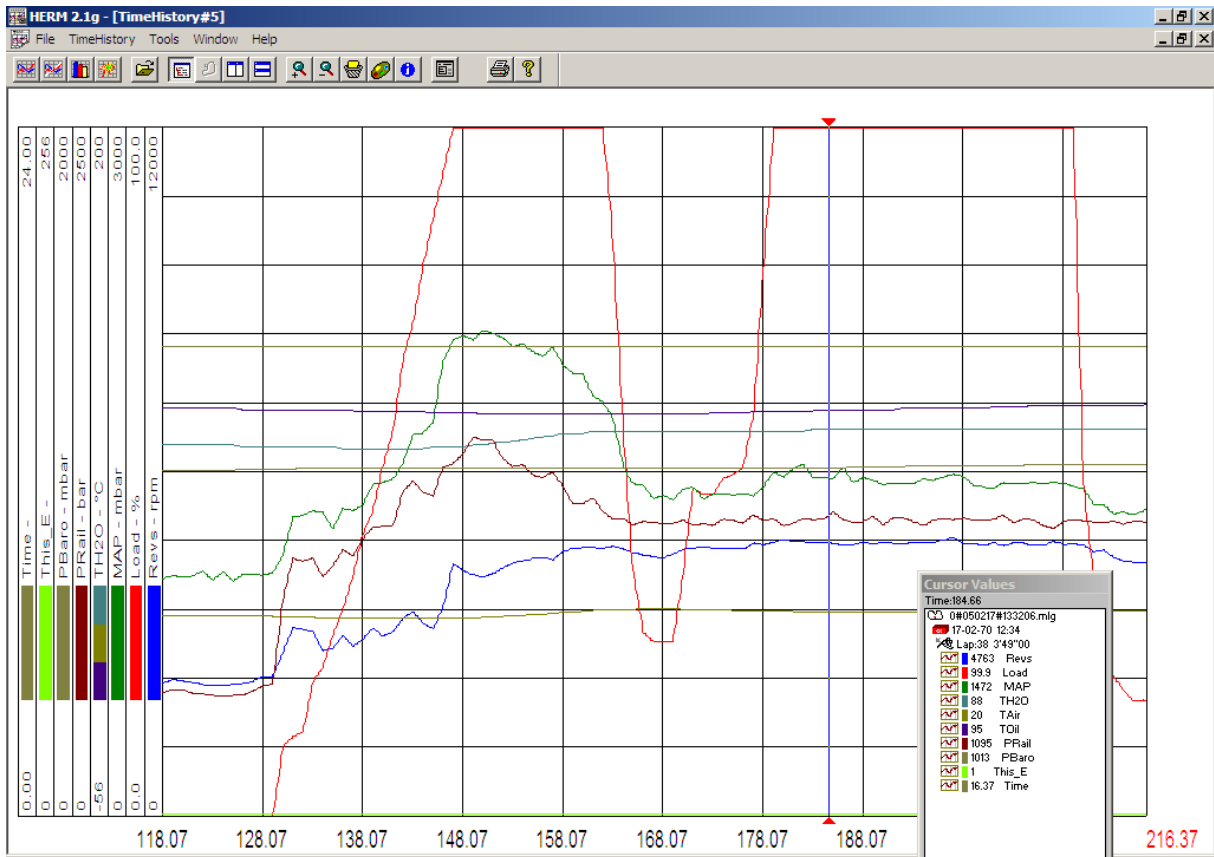
Graph 4: Motor 02-01-0408-SL01-104-0063, high engine RPMs, up to the RPM-Limiter

The data shows a very high engine speed of approximately 4780 engine RPM, the remaining injection volume is 20% of the total desired injection volume at full power. The power reduction due to overspeed is not indicated in the CED instrument. The FADEC Software Version 2,7 will have this function integrated. During overspeed stages, the power reduction caused by the overspeed will then be indicated.

This overspeed behaviour of the engine is caused by a problem with the clutch. At the point where the power increases (and the load on the clutch increases, the clutch starts slipping. The speed at the propeller will be less than the engine speed divided by the gearbox ratio. The propeller control will push the propeller from low to high pitch.

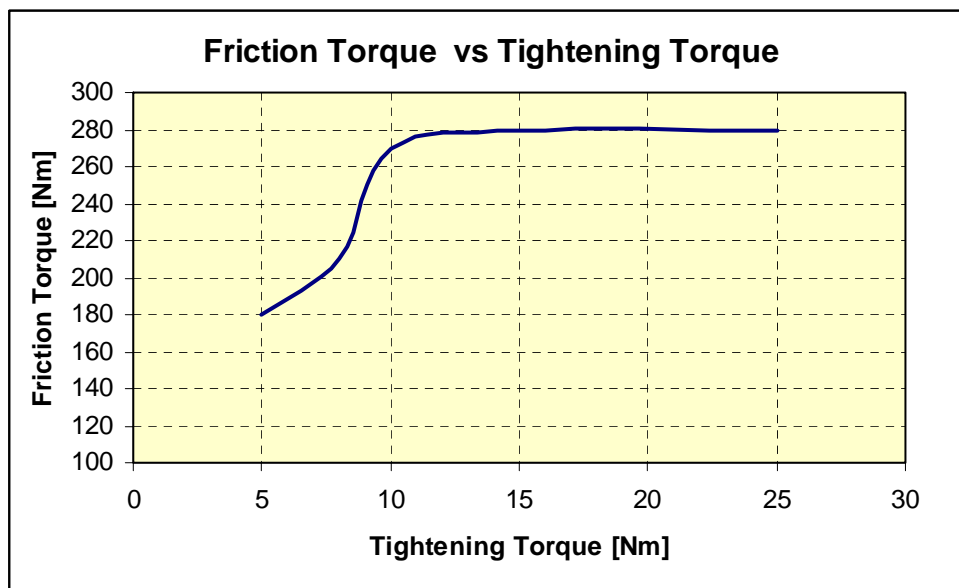
Tightening Torque	Friction torque
25 Nm	280 Nm
15 Nm	280 Nm
10 Nm	270 Nm
8 Nm	210 Nm
5 Nm	180 Nm
Tightenend by hand	160 Nm

In conclusion, the test shows that the friction torque is depending on the tightening torque.
