CA18/2/3/7919			
		SOUTH AFRICAN CIVIL AVIATION AUTHORITY ACCIDENT REPORT – EXECUTIVE SUMMARY			
Aircraft Registration	ZU-BZI	Date of Accident	16 February 2005	Time of Accident	1020Z
Type of Aircraft	Pietenpol Aircamper		Type of Operation	Private	
Pilot-in-command Licence Type	Private Pilot	Age	53	Licence Valid	Yes
Pilot-in-command Flying Experience	Total Flying Hours	355		Hours on Type	101
Last point of departure	Margate Aerodrome (FAMG)				
Next point of intended landing	Margate Aerodrome (FAMG)				
Location of the accident site with reference to easily defined geographical points (GPS readings if possible)					
Margate Aerodrome					
Meteorological Information	Wind: South-easterly at 9 knots; Visibility: Good; Temperature: 28 °C; Clouds: Scattered at 3 000 feet				
Number of people on board	1 + 1	No. of people injured	1 + 1	No. of people killed	0
Synopsis	<p>The pilot and passenger were on a pleasure flight from Margate Aerodrome to Hibberdene, and back to Margate. According to the passenger, a pre-flight was carried out and the pilot demonstrated how to use the headset to the passenger and instructed him not to touch anything. An engineer was called to swing the propeller and a

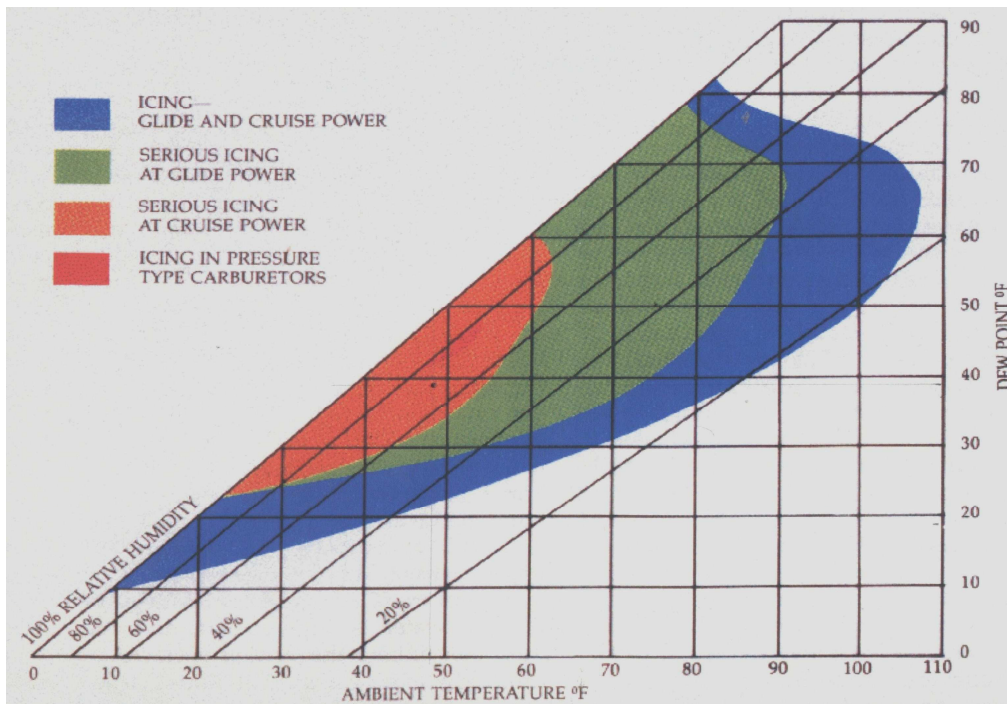
Serious Icing at 27.2°C (81.5°F) and Dew Point Temperature of 24°C

1.7.1 The above calculations (*refer to second text box only*), based on the official weather forecast report as supplied by the SA Weather Service (SAWS), depict serious icing conditions on any power setting. These were prevalent at the time of the accident.

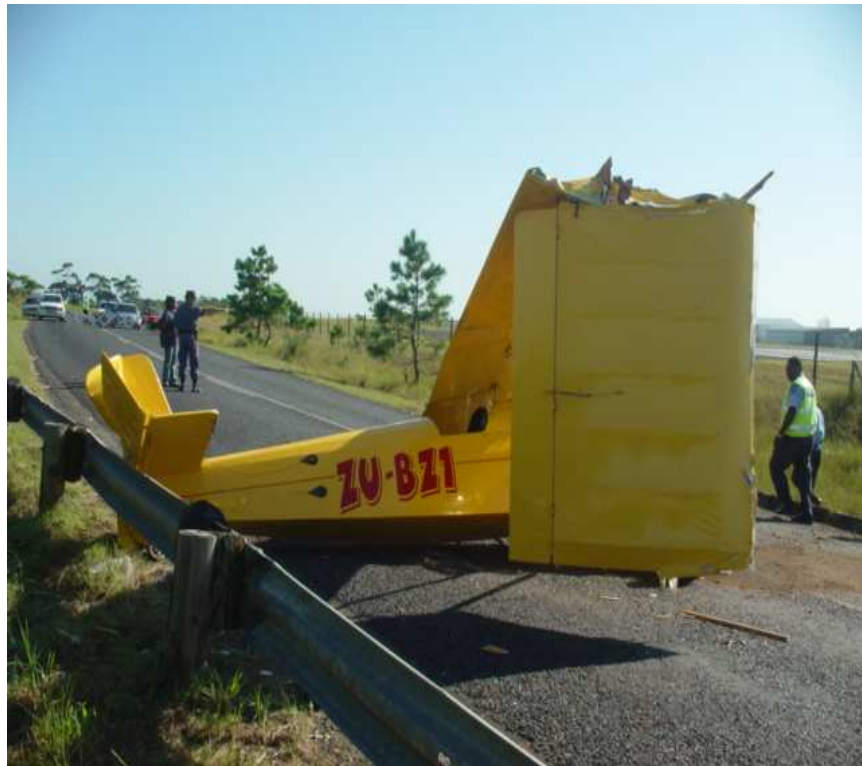
1.12.1 The aircraft stalled, the right wing dropped, and the wing tip struck the ground. Due to the high impact forces, the wing broke in the middle. This resulted in the propeller hitting the ground, which stopped the engine. The aircraft crashed in a nose-down attitude and rolled over through the aerodrome perimeter fence. The aeroplane was destroyed.

Figure 1: The wreckage after impact.

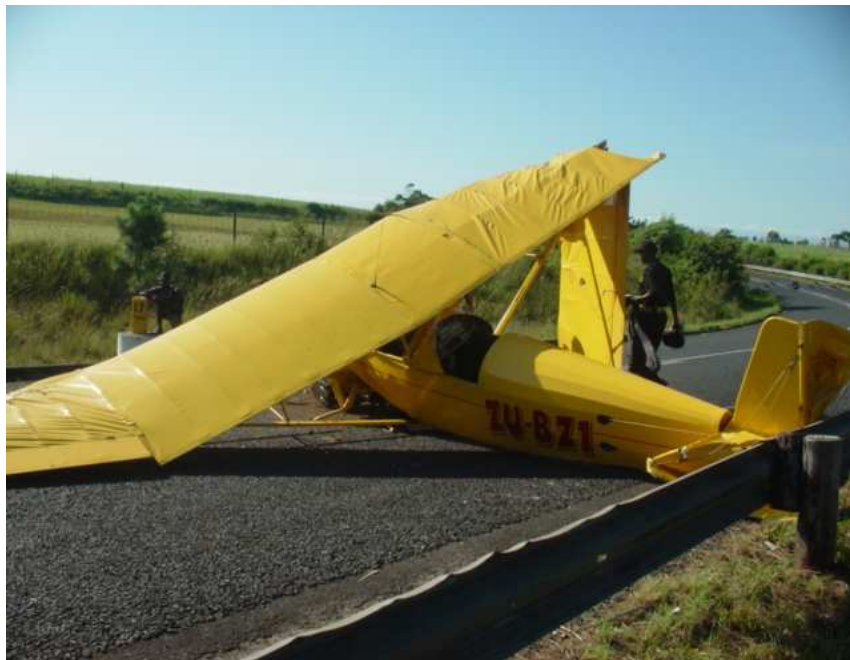
Figure 2: The wreckage seen from the opposite angle.
