AIRCRAFT ACCIDENT REPORT AND EXECUTIVE SUMMARY

Reference:	CA18/2/3/7959	
Aircraft Registration	ZU-ADJ	Date of Accident	13 May 2005	Time of Accident	1250Z	
Type of Aircraft	Windlass Trike (Microlight)		Type of Operation	Private		
Pilot-in-command Licence Type		Microlight	Age	36	Licence Valid	Yes
Pilot-in-command Flying Experience		Total Flying Hours	177.6	Hours on Type	177.6	
Last point of departure		Estcourt Ultra City, KwaZulu-Natal				
Next point of intended landing		Ficksburg Aerodrome. (FAFB)				
Location of the accident site with reference to easily defined geographical points (GPS readings if possible)						
On the R711 tar road between Clarens and Fouriesburg. Geographical position :S 28° 38.665' E 028° 16.738'						
Meteorological Information		The weather was fine with a Westerly Wind at 5kt; Temperature: 14°C; Visibility: CAVOK				
Number of people on board	1+0	No. of people injured	0	No. of people killed	1	
Synopsis						
<p>On 13 May 2005, three microlight pilots planned to fly with three microlight aircraft ZS-CMA, ZU-CDU and ZU-ADJ on a long-distance navigational flight from the Durban Area, encompassing a large part of South Africa. Two microlights departed from La M

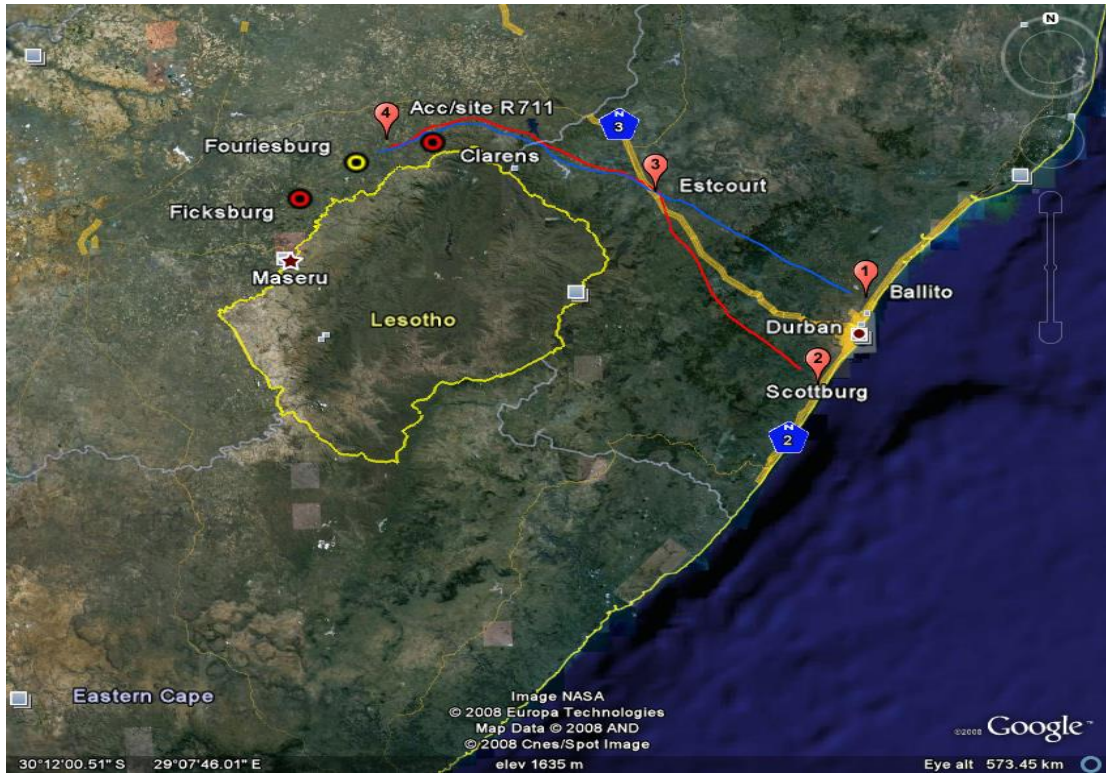
PHOTO1: THE RED LINE ON THE MAP SHOWS THE FLIGHT PATH OF ZU-ADJ FROM SCOTTBURG TO ESTCOURT WHERE HE JOINED THE OTHER 2 MICROLIGHTS THAT FLEW FROM BALLITO TO ESTCOURT (BLUE LINE). THE 3 MICROLIGHTS FLEW TOGETHER TO FICKSBURG WHEN THE ACCIDENT OCCURRED BETWEEN CLARENS & FOURIESBURG.

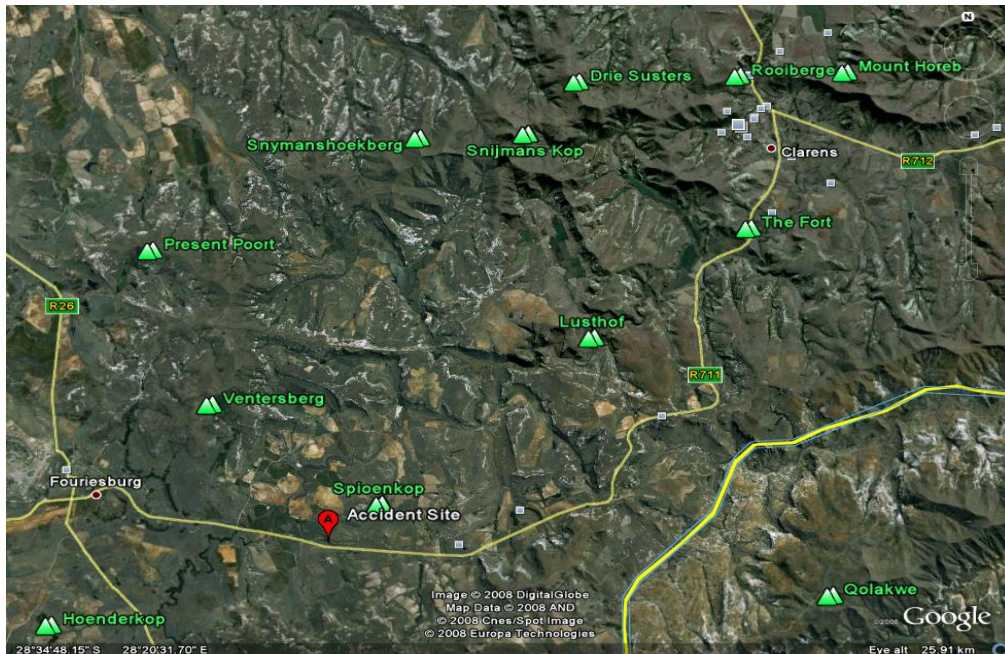
PHOTO 2: THE RED INDICATOR MARKED A ON THE MAP SHOWS WHERE THE ACCIDENT OCCURRED ON THE ROAD NEAR FOURIESBURG.

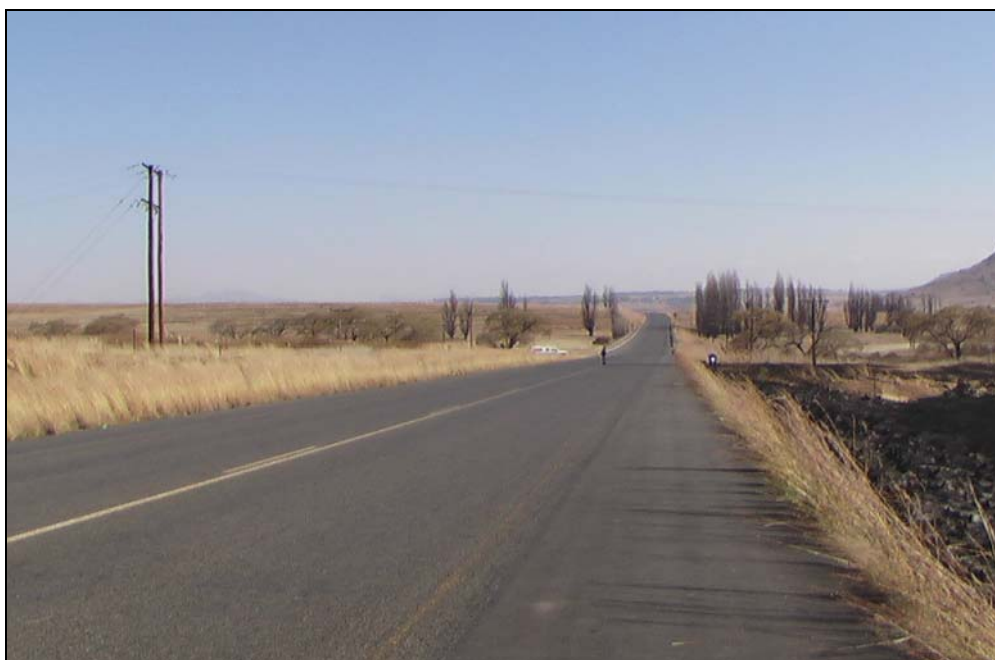
- 1.1.5 The first two microlights, ZS-CMA and ZU-CDU landed safely and turned off onto the gravel road. The pilot of the third microlight, ZU-ADJ, attempted to land on the tar road, approximately 1km behind the first two microlights, but prior to the landing, the microlight collided with high tension wires spanned across the road. The microlight then impacted the tar road and burst into flames. The pilot sustained fatal injuries and the aircraft was destroyed by the ensuing fire that erupted.

PHOTO 3 : VIEW OF ROAD THAT WAS USED FOR THE PRECAUTIONARY LANDING

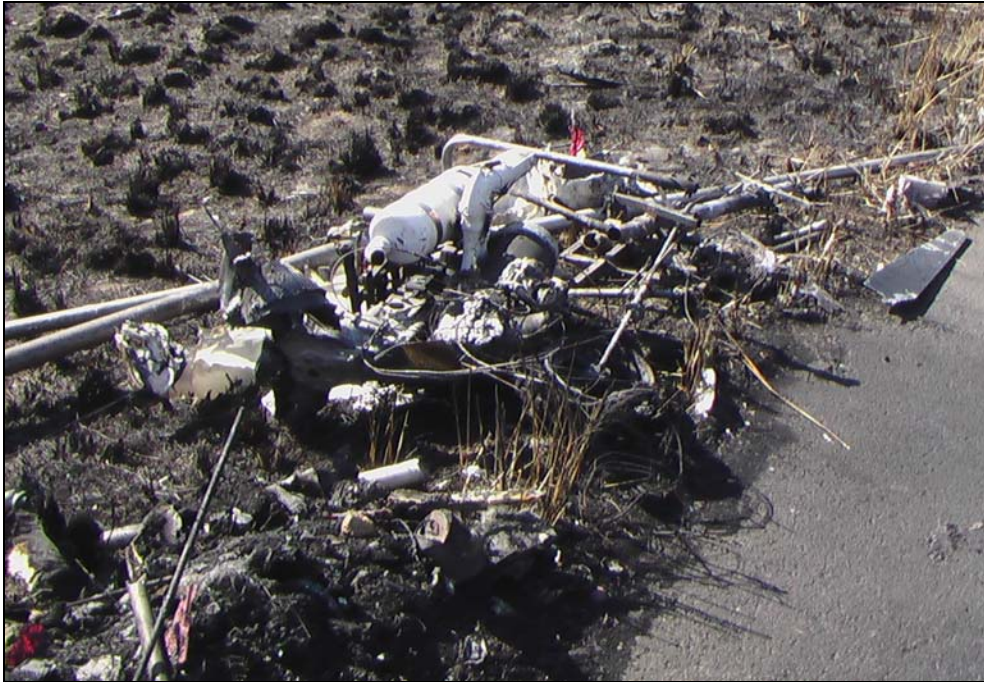
1.3.1 The microlight aircraft was destroyed during the ensuing fire after the aircraft collided with high tension wires spanned across the road.

PHOTO 4 : VIEW OF AIRCRAFT WRECKAGE DESTROYED BY ENSUING FIRE

1.12.1 The microlight aircraft collided with high tension wires spanned across the tar road in a direction of 310°. The aircraft then impacted the road surface 28.0 metres from the initial impact with the high tension wires and came to rest 6.5 metres further on. A fire erupted and the aircraft was destroyed by the ensuing fire.

1.16.1 The burnt wreckage was examined as far as possible. The wing structure was excessively burnt but it could be determined that it was intact on impact with the high tension wires and road surface. All engine components were found partially destroyed by the ensuing fire. The spark plugs were removed and the carbon deposits showed a normal mixture setting.

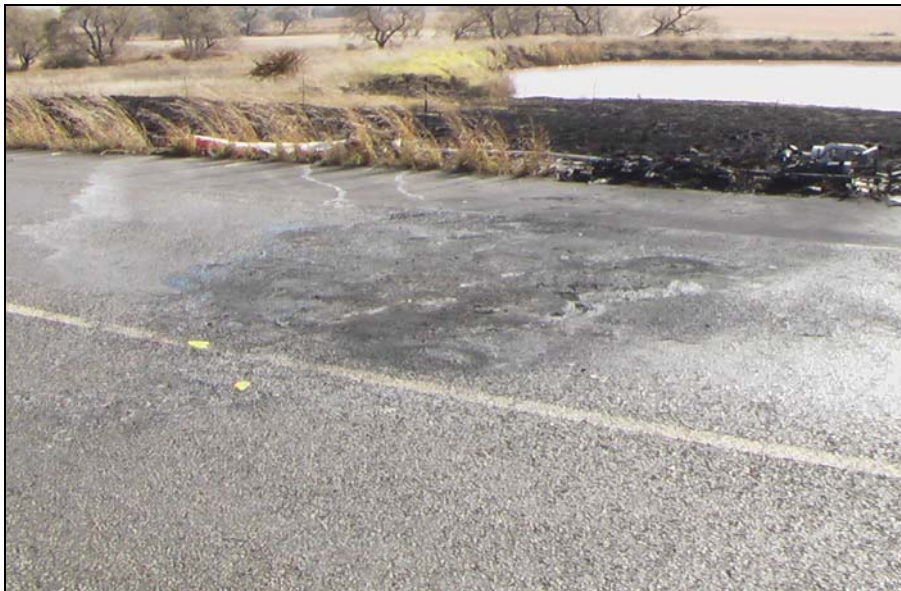
1.3.1 The high tension wires spanned across the R711 road were severed and the tar road was damaged by the fire that erupted.

PHOTO5 : VIEW OF DAMAGE TO TAR ROAD BY THE ENSUING FIRE

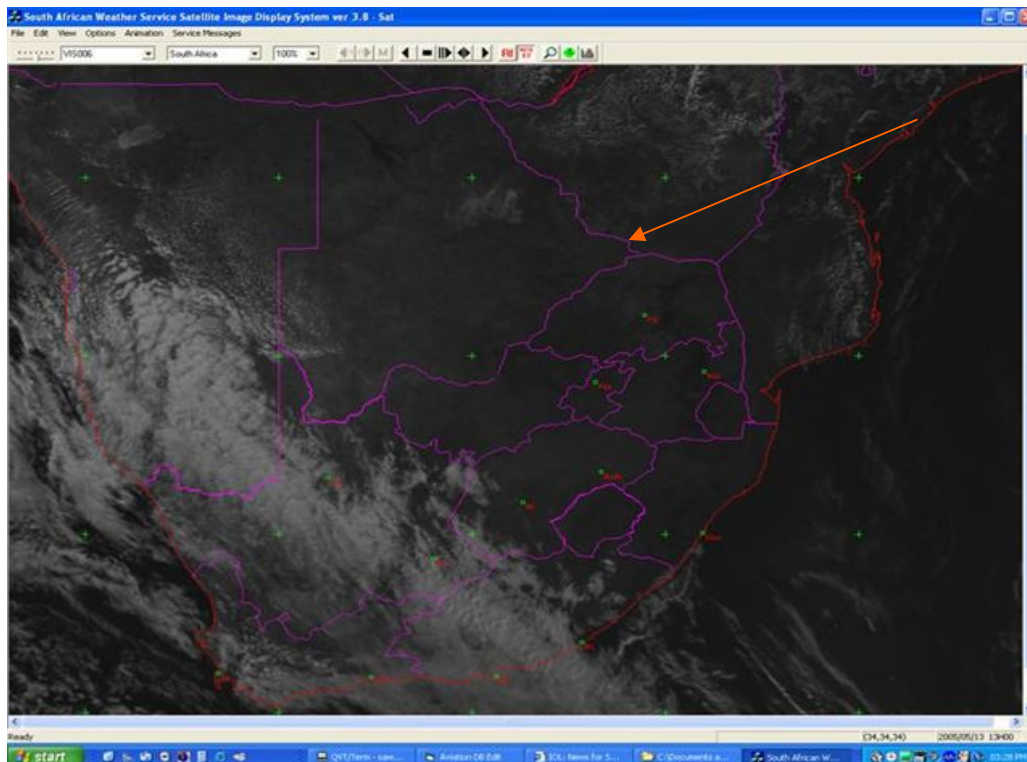
Time: 12:50Z.
Temperature: 20°C.
Dew Point: 04.0°C
Visibility: 10km+
Wind Direction: 230°
Wind Speed: 07kt.
Cloud: Nil.

PHOTO 6 : SA WEATHER SERVICES RADAR IMAGE SHOWING CLEAR WEATHER AT ACCIDENT AREA.
