AIRCRAFT ACCIDENT REPORT AND EXECUTIVE SUMMARY

Reference:	CA18/2/3/7963	
Aircraft Registration	ZU-CGF	Date of Accident	22 May 2005		Time of Accident	1415Z
Type of Aircraft	Europa 2000 Amateur Kit Built Airplane		Type of Operation		Private Flight	
Pilot-in-command Licence Type		Commercial pilot	Age	43	Licence Valid	Yes
Pilot-in-command Flying Experience		Total Flying Hours	441.8		Hours on Type	27.2
Last point of departure		Krugersdorp Aerodrome. (FAKR) Gauteng Province				
Next point of intended landing		Krugersdorp Aerodrome. (FAKR) Gauteng Province				
Location of the accident site with reference to easily defined geographical points (GPS readings if possible)						
Dwarskloof smallholding area, approximately 10km west of Randfontein.						
Meteorological Information		Temperature: 19°C, Surface Wind: 330°03kt, Clouds: Scattered clouds 5000ft. AGL				
Number of people on board	1 + 1	No. of people injured	0	No. of people killed	1 + 1	
Synopsis

AIRCRAFT ACCIDENT REPORT

Name of Owner/Operator : Amory S.M
Manufacturer : Europa Aviation Ltd.
Model : Europa Trigear
Nationality : South African
Registration Marks : ZU-CGF
Place : Dwarskloof Area (Smallholdings) near Randfontein
Date : 2

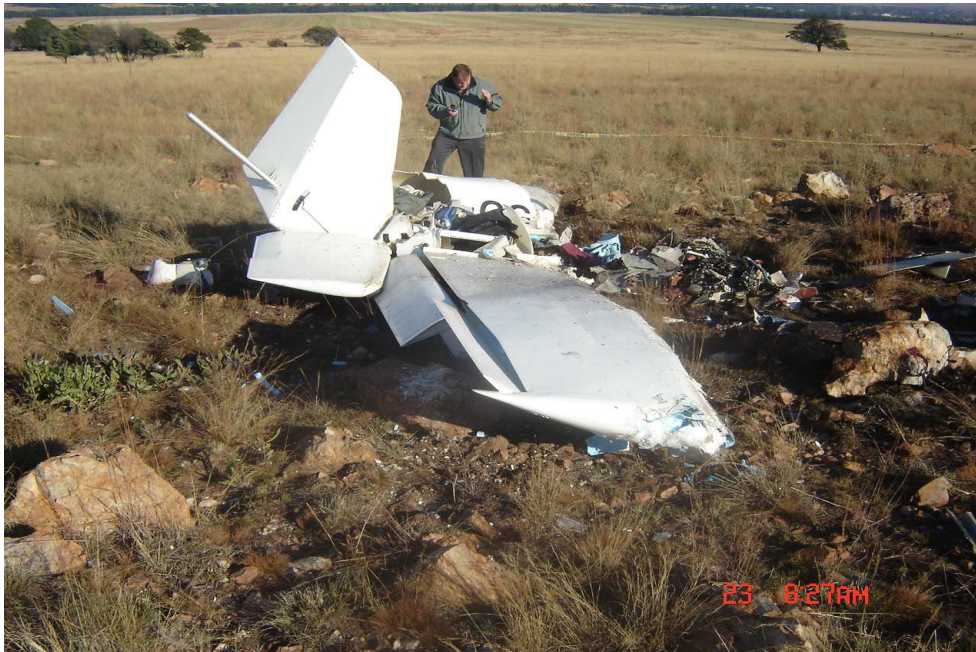
1.3.1 The aircraft was destroyed on impact with the ground surface.

FIGURE 1: VIEW OF AIRCRAFT FUSELAGE/CABIN DESTROYED ON IMPACT

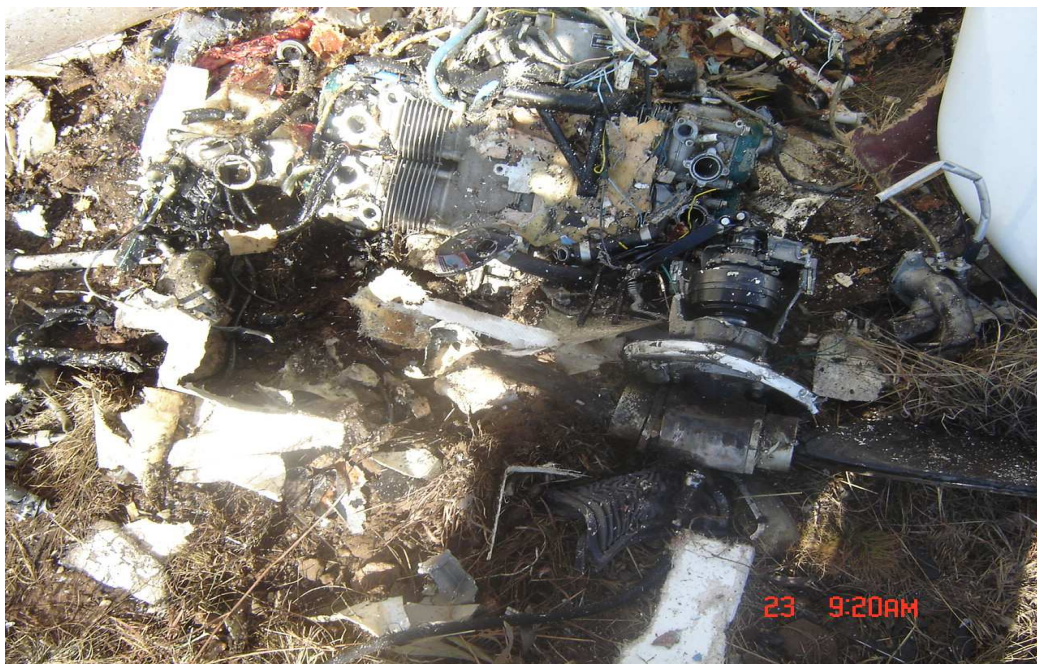
1.11.1 The aircraft flew low over his house at a smallholding as stated by the eyewitness when the aircraft pitched up sharply and the aircraft climbed for approximately 100 metres with the engine at full power. The engine stopped and aircraft then stalled and impacted with the ground at a nose- down attitude of approximately 60 degrees. The aircraft was destroyed on impact with the rocky terrain. There was no indication that the engine was running or/and that the propeller was turning on impact with the rocky ground surface.

PHOTO 2: VIEW OF FRONT SECTION & ENGINE AFTER IMPACT WITH THE GROUND

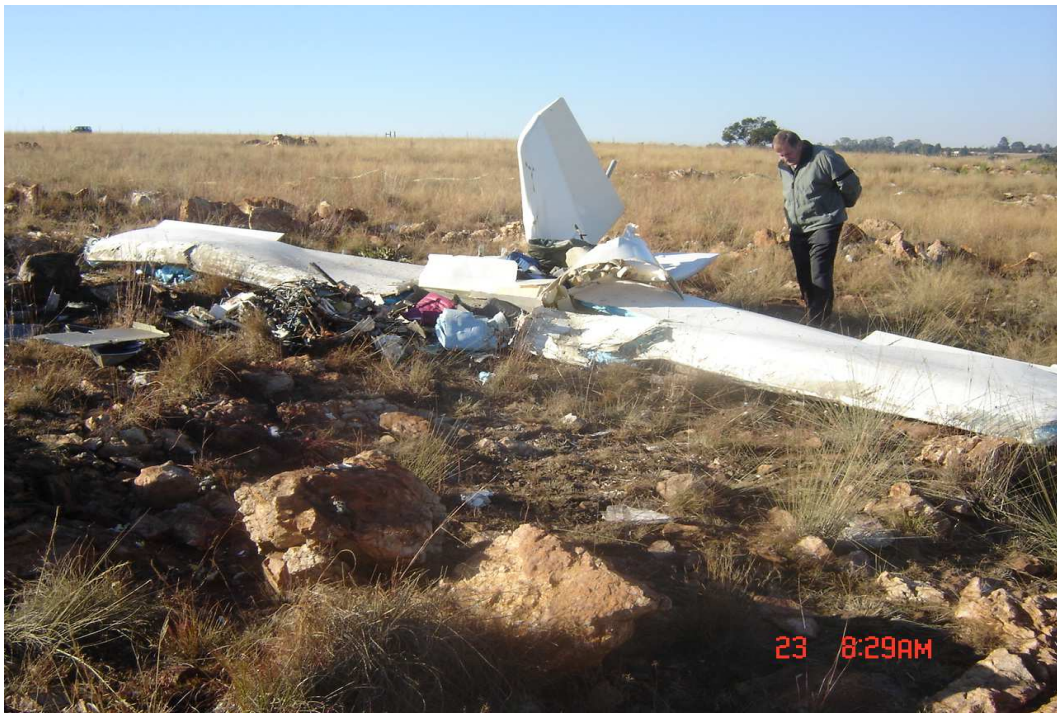
PHOTO 3: VIEW OF MAIN WRECKAGE AFTER IMPACT IN A NOSE-DOWN ATTITUDE IN ROCKY TERRAIN.

- 3.1.4 The pilot and passenger were fatally injured in the accident.
- 3.1.5 The aircraft was destroyed on impact with the rock-covered terrain.
- 3.1.6 The weather conditions were fine at the time of the accident.
