CA18/2/3/7965			
		SOUTH AFRICAN CIVIL AVIATION AUTHORITY ACCIDENT REPORT – EXECUTIVE SUMMARY			
Aircraft Registration	ZS-RDO	Date of Accident	24 May 2005	Time of Accident	1030Z
Type of Aircraft	Robinson R22 Beta	Type of Operation	Private		
Pilot-in-command Licence Type	Private	Age	50	Licence Valid	No
Pilot-in-command Flying Experience	Total Flying Hours	391.2	Hours on Type	334	
Last point of departure	Private Farm in Kanon Island				
Next point of intended landing	Farm Neus Berg (Approximately 7 km from Kakamas)				
Location of the accident site with reference to easily defined geographical points (GPS readings if possible)					
On the farm Neus Berg, 7 km from Kakamas, Northern Cape					
Meteorological Information	Wind light south-easterly 5 – 10 kts, temperature 22°C, visibility CAVOK				
Number of people on board	1 + 1	No. of people injured	0	No. of people killed	0
Synopsis	<p>The pilot, accompanied by a veterinarian, was busy counting game on the farm Neus Berg, located approximately 7 km from Kakamas in the Northern Cape.</p> <p>According to the pilot, at a height of approximately 100 – 200 ft above ground level (AGL), he executed a tight right-hand turn to follow a Gemsbok (

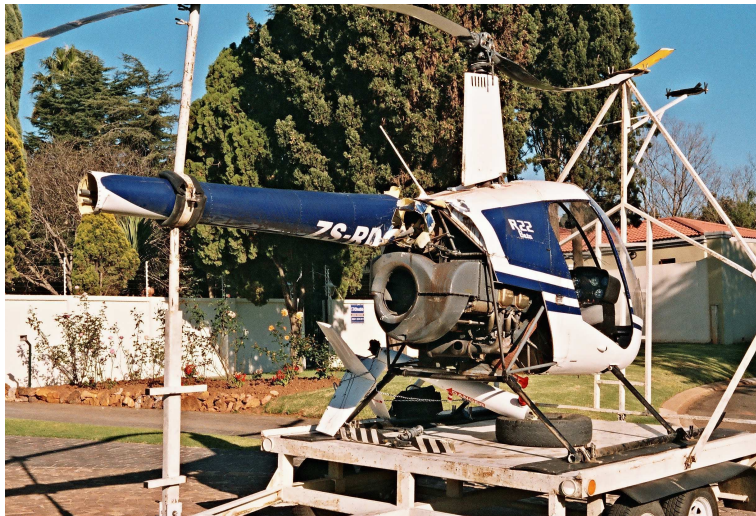
- 1.3.1 The aircraft sustained damage to the tail rotor assembly, tail boom, main rotor blades and the skids.

Figure 1: Damage to the helicopter

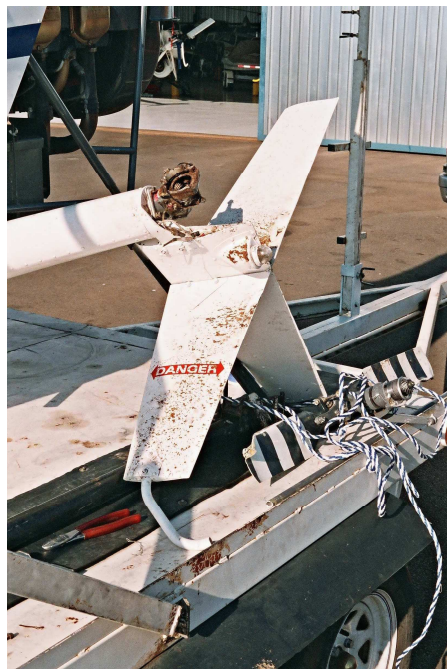
Figure 2: Damage to the tail rotor

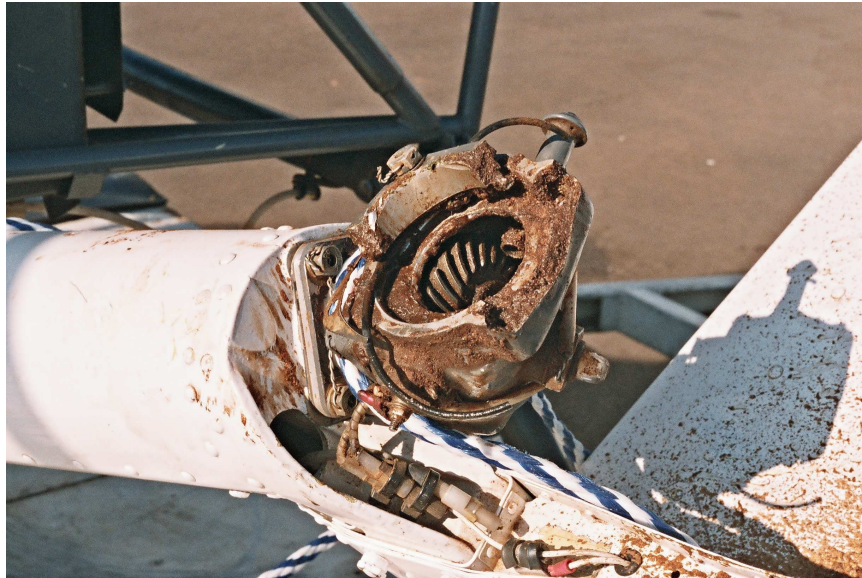
Figure 3: Damage to the tail rotor gearbox

1.16.2 The metallurgical report concluded that the tail rotor gearbox failed as a result of almost instantaneous brittle fracture caused by impact loading, most probably on impact with the ground. No evidence of gradual crack propagation was observed. Damage to the tail rotor blades implied that the tail rotor repeatedly hit a large, solid object. This impact probably resulted in the brittle failure of the gearbox.

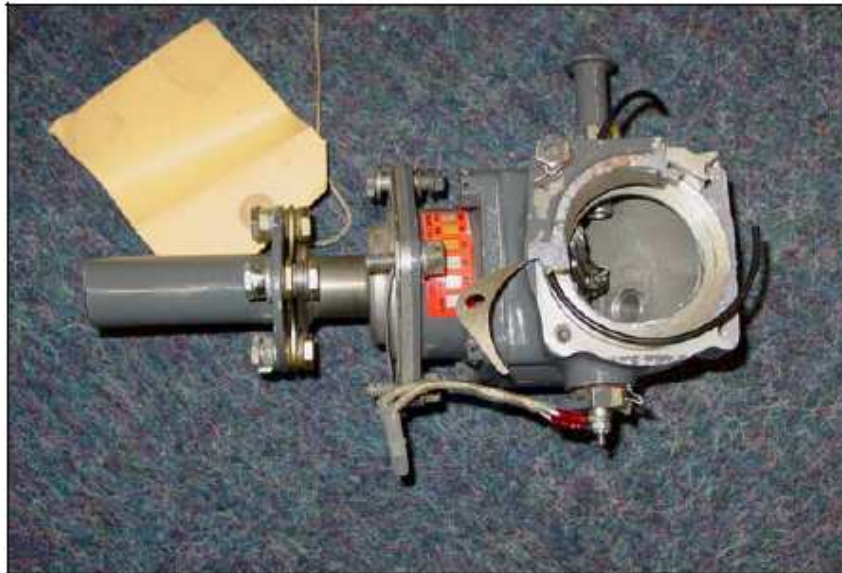
A photograph of the failed gearbox in the as-supplied condition is shown in Figure 4, and enlarged views of the fracture surfaces in Figures 5 (a) and (b). As demonstrated in Figure 5, the fracture surfaces are coarse and granular in appearance. Little plastic deformation is evident in the vicinity of the fracture sites (precluding ductile overload failure as fracture mode), and no evidence of gradual crack propagation (such as fatigue beach marks or localised discolouration of the fracture surface) was observed. These observations suggest that the gearbox failed as a result of brittle fracture under impact loading conditions.

Figure 4: The fractured tail rotor gearbox in the as-supplied condition.
Magnification: approximately 0,35x.

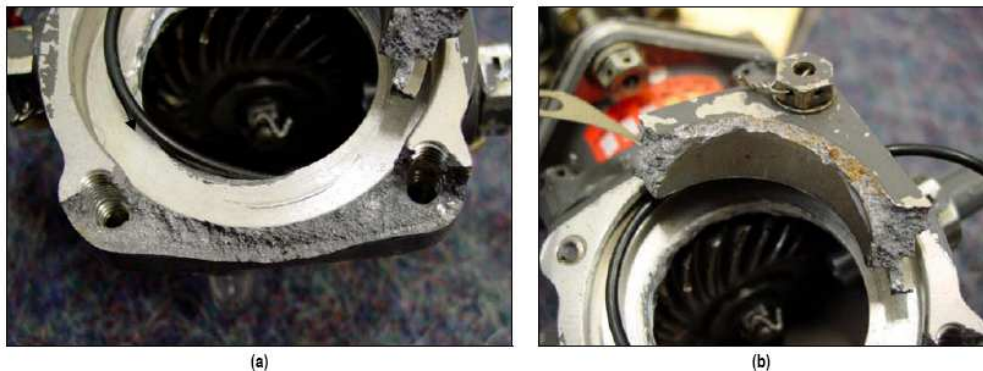
Figure 5: Enlarged views of the fracture surfaces on the tail rotor gearbox.
Magnification: approximately 0,85x.

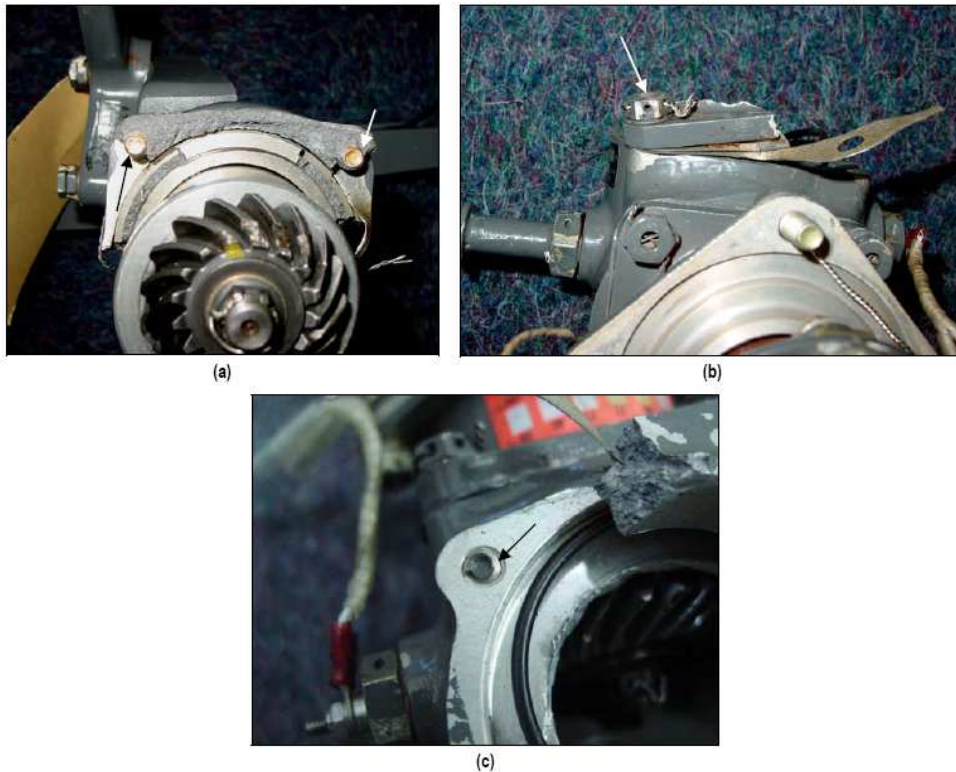
All four bolts used to connect the gearbox to the tail rotor assembly were recovered in their original positions. Two of these bolts, shown in Figure 6 (a), appear virtually undamaged. As shown in Figure 5 (a), fracture of the gearbox also caused minimal damage to the screw thread in the corresponding bolt holes, and the fracture surface appears to be fairly symmetrical around the bolt holes. The remaining two bolts on the opposite side of the gearbox apparently underwent significant bending during the accident. One of these bolts is still intact, although severely bent (Figure 6 (b)), whereas the last bolt fractured (Figure 6 (c)). Examination of the fracture surface of this bolt confirms that it fractured only after significant bending had taken place.

Figure 6: The bolts (highlighted by the arrows) used to connect the gearbox to the tail rotor assembly. Magnification: approximately 1x.

Since the crack propagated through the bolt holes shown in Figure 6(a), these bolts and the corresponding bolt holes incurred minimal damage. The remaining two bolts were apparently still in position when the two parts of the gearbox started separating subsequent to the brittle fracture, causing both bolts to bend. A number of the gear teeth were observed to be chipped, but no evidence of overheating or excessive abrasive wear damage was observed. This suggests that damage to the gear teeth was probably caused by debris created as a result of the brittle fracture of the gearbox.

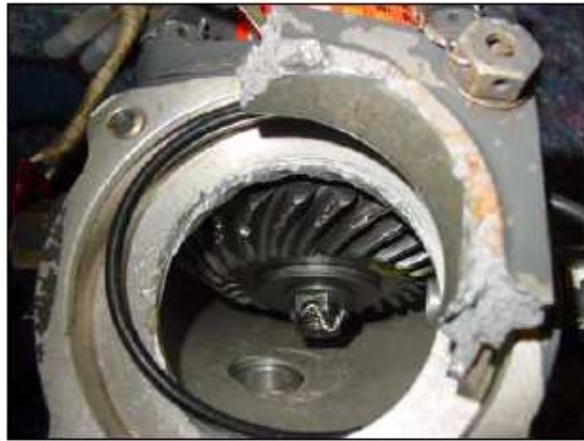
Figure 7: Chipped gear teeth. Magnification: 0,7x.

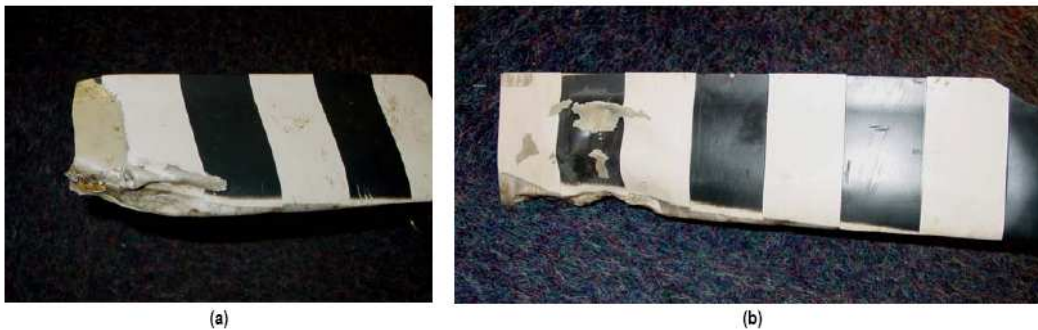
The results of this examination suggest that the gearbox failure was caused by impact. Figures 8 (a) and (b) display photographs of the tail rotor in the as-supplied condition. Both blades are deformed and severely damaged, with most of the deformation concentrated near the ends. The damage observed appears to indicate that the blades experienced repeated impact with a hard, solid object. This impact probably caused the brittle failure of the alluminium gearbox, compounded by the low impact toughness of alluminum alloys in general. Unless the helicopter was involved in a midair collision, the results suggest that the impact damage occurred while the helicopter was on the ground or close to the ground during take-off or landing.

Figure 8: Damage observed on the tail rotor blades.
Magnification: approximately 0,26x.
