## AIRCRAFT ACCIDENT REPORT AND EXECUTIVE SUMMARY

| | | | | Reference: | <b>CA18/2/3/7968</b> | |
| <b>Aircraft Registration</b> | ZU-AKE | <b>Date of Accident</b> | 01 June 2005 | | <b>Time of Accident</b> | 1300Z |
| <b>Type of Aircraft</b> | Piper PA 22-150 | | <b>Type of Operation</b> | Training | | |

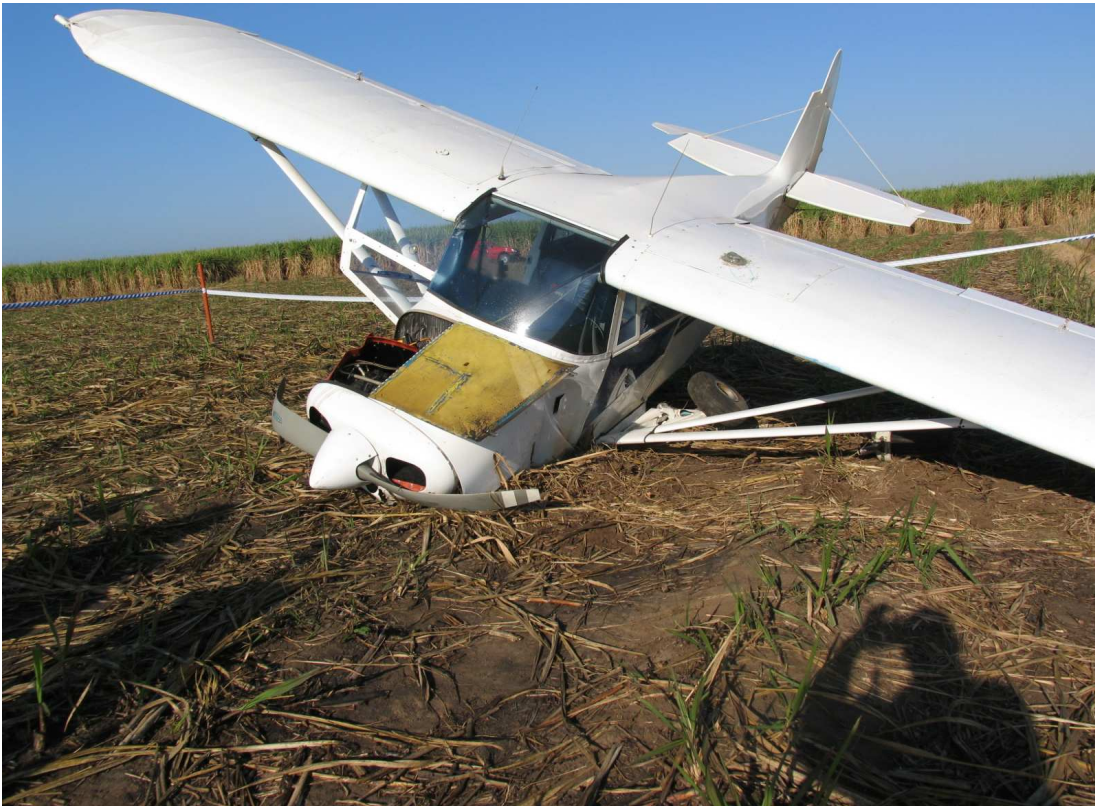
1.3.1 The aircraft sustained damage to the nose wheel, main landing wheels, propeller, engine mountings and cowling, fuselage and both the wings.

Figure 1: Damage to the aircraft

1.12.1 On landing, the aircraft impacted an irrigation ditch, bounced, and swung around through 90° before it came to rest in a westerly heading.

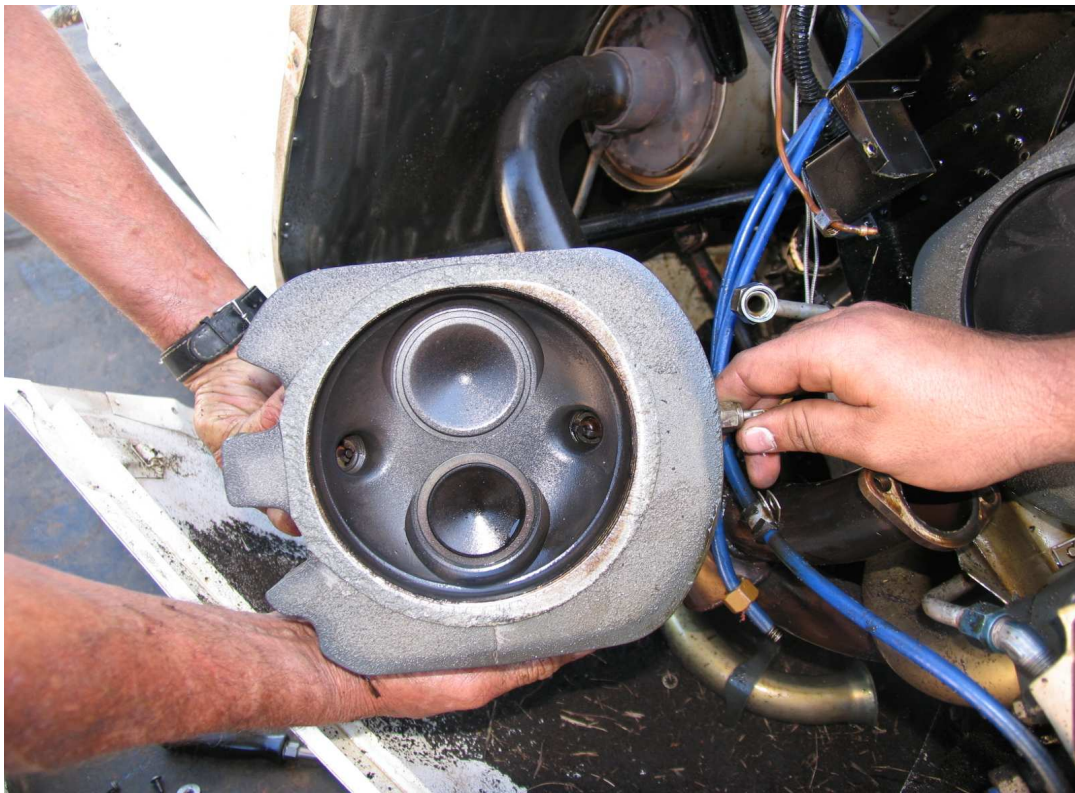
1.16.1 The on-site investigation found that the number 2 cylinder head had failed due to a fatigue crack.

**Figure 2:** Fractured no. 2 cylinder head

1.16.2.1 The available evidence suggests that the cylinder head failed as a result of fatigue, caused by the presence of a cyclic tensile stress during service. Although it is difficult to accurately gauge the appropriate age of the fatigue crack in cast components, the smooth appearance of the fracture surface and the amount of grained debris suggest that the crack had been present in the component for a significant period of time prior to final catastrophic failure. The observation that one of the fatigue cracks propagated through virtually the entire wall thickness before final failure suggests that crack propagation occurred under low-stress conditions. This seems to confirm the conclusion that the crack had been present for an extended amount of time before final failure. Early crack detection using non-destructive testing techniques would have been complicated by the location of the crack and the geometry of the component.

2.2 The cause of the engine failure was found to be the number 2 cylinder head, which had failed. The failed cylinder head was taken for metallurgical analysis and the results suggested that the cylinder head had failed as a result of fatigue, caused by the presence of a cyclic tensile stress during service. The smooth appearance of the fracture surface and the amount of grained debris suggested that the crack had been present in the component for a significant period of time prior to the final catastrophic failure.

- 4.1 It is recommended that the Commissioner for Civil Aviation should monitor cylinder head failures in order to establish any trend in terms of the revision of maintenance requirements and standards.
- 4.2 It is recommended that the Commissioner for Civil Aviation enhances and reviews the safety oversight requirements and adequacy of requirements associated with owner type conversion training and certification.
