**Uncontained engine failure during take-off**  
with a Fly Air Airbus A300-B4, registration TC-FLF,  
Amsterdam Airport Schiphol, June 29, 2005

The Hague, may 24, 2007, Occurrence number 2005094

Failure analysis of broken CF6-50 fan blade

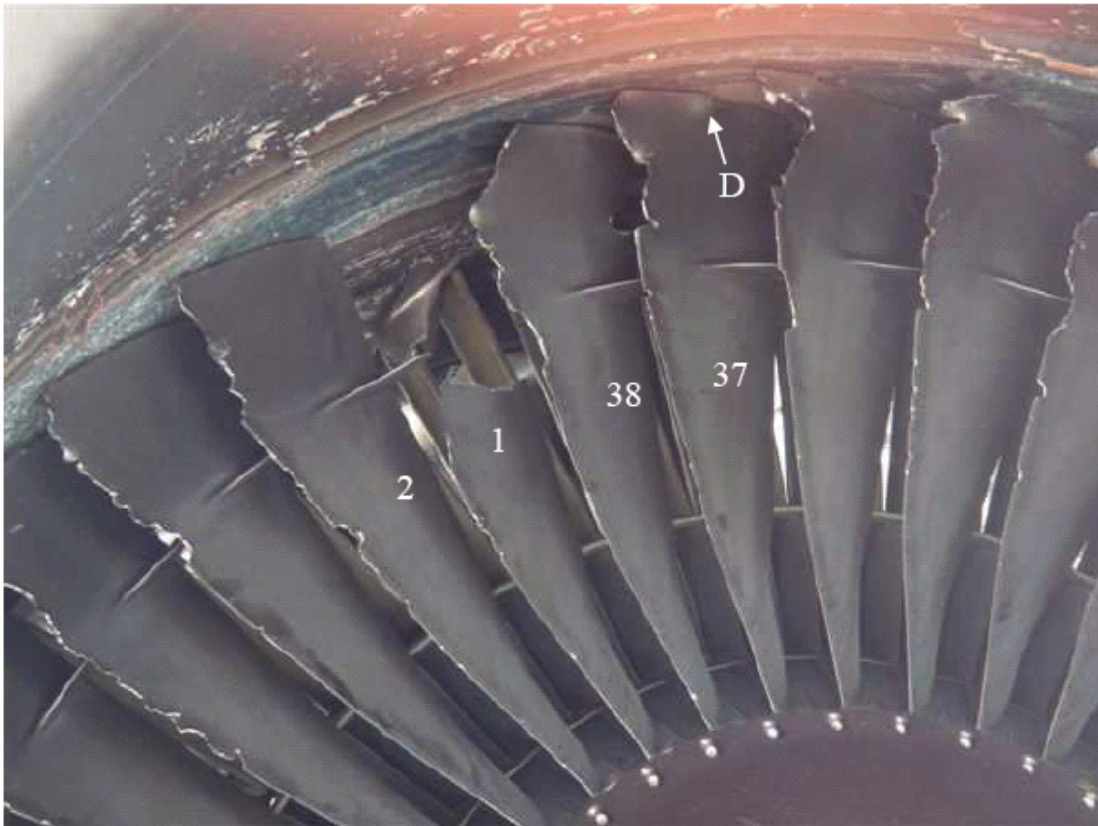
*Figure 1: The broken fan blade – labelled 1 - and adjacent blades (seen from the engine inlet)*

The fan of a General Electric CF6-50 engine consists of 38 blades. Generally, the blade labelled as blade 1 was broken off. All other blades were severely damaged, see figure 1. The fan blades starting from number 2 anti-clockwise through blade 28 were found in a shingled condition<sup>2</sup>. The blades 29 through 38 were not in a shingled condition but did have evidence of shingling damage. The concave side of blade 38, blade 1 (failed) and blade 2 do not show shingling damage, see also appendix A page 19 table 1 of the metallurgical report. Also no print of the hard face<sup>3</sup> of the mid-span shroud from blade 1 was found on blade 2.

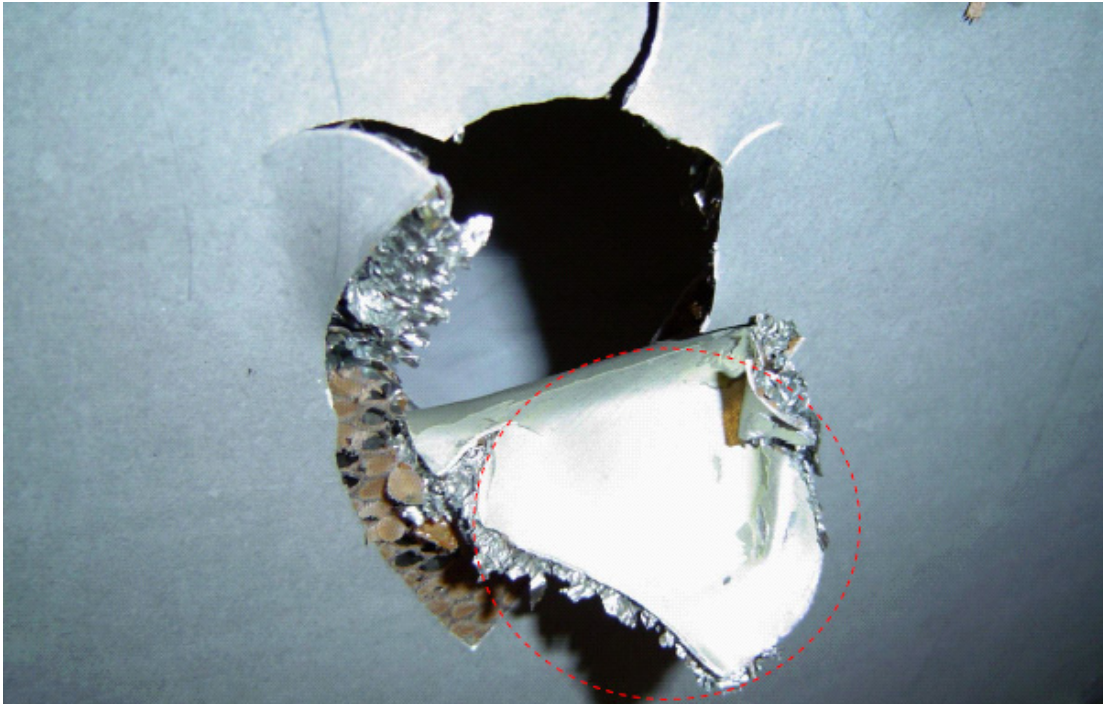
Figure 2: Hole in fan cowling as seen from outside. The encircled area was investigated with EDX

The Safety Board supervised the inspection and together with investigators from Airbus and representatives from Fly Air and General Electric the opportunity was taken to have a better look at the engine. The acoustic lining in front of the fan rotor was completely missing and fan blade debris was found embedded in the fan inlet duct. The engine inlet flange was distorted at approximately 10 o'clock position (forward looking aft). A piece of the flange appeared to be missing. In that area there was a hole in the fan cowling.

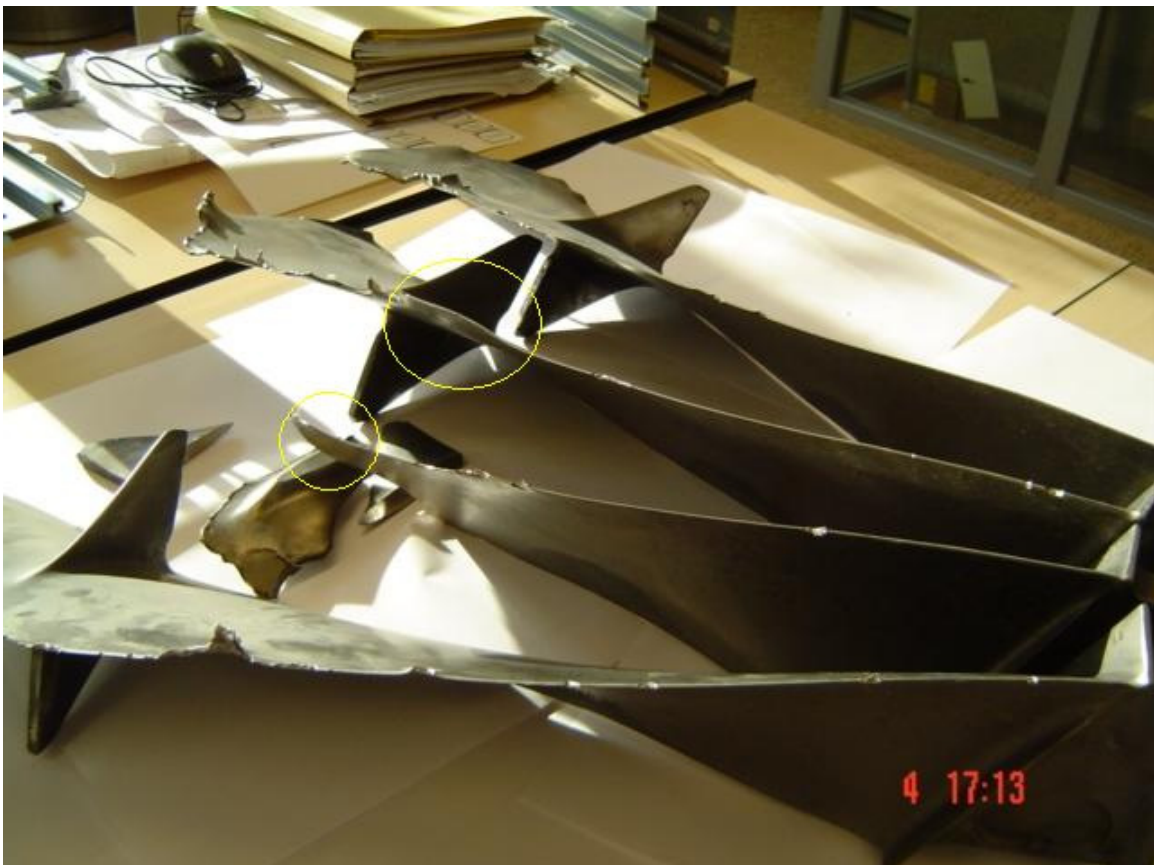
Figure 3: Cusps in leading edges of fan blades 1 and 38

The leading edges of the broken fan blade and its neighbouring blades were examined to identify possible ingested objects. The broken blade and its neighbour #38 show cusps, see figure 3. According to an engine accident specialist (see 1.3.7) hard objects may create cusps, but only under low engine speed (RPM) conditions at random locations on the fan rotor.

A gas turbine accident investigator course instructor was consulted by showing him pictures of the damaged fan rotor and the broken and adjacent blades in particular. He points at the cusps of the broken blade and the neighbouring blade (38) in a cascaded fashion. His analysis reveals that a single soft body object weighing less than a pound hit the fan rotor, the size comparable to that of a pigeon. Pre-existing notches in the leading edge may allow that even cusps caused by a small bird cause a fan blade to fracture. Evidence for this may be seen provided the original fracture is still intact.

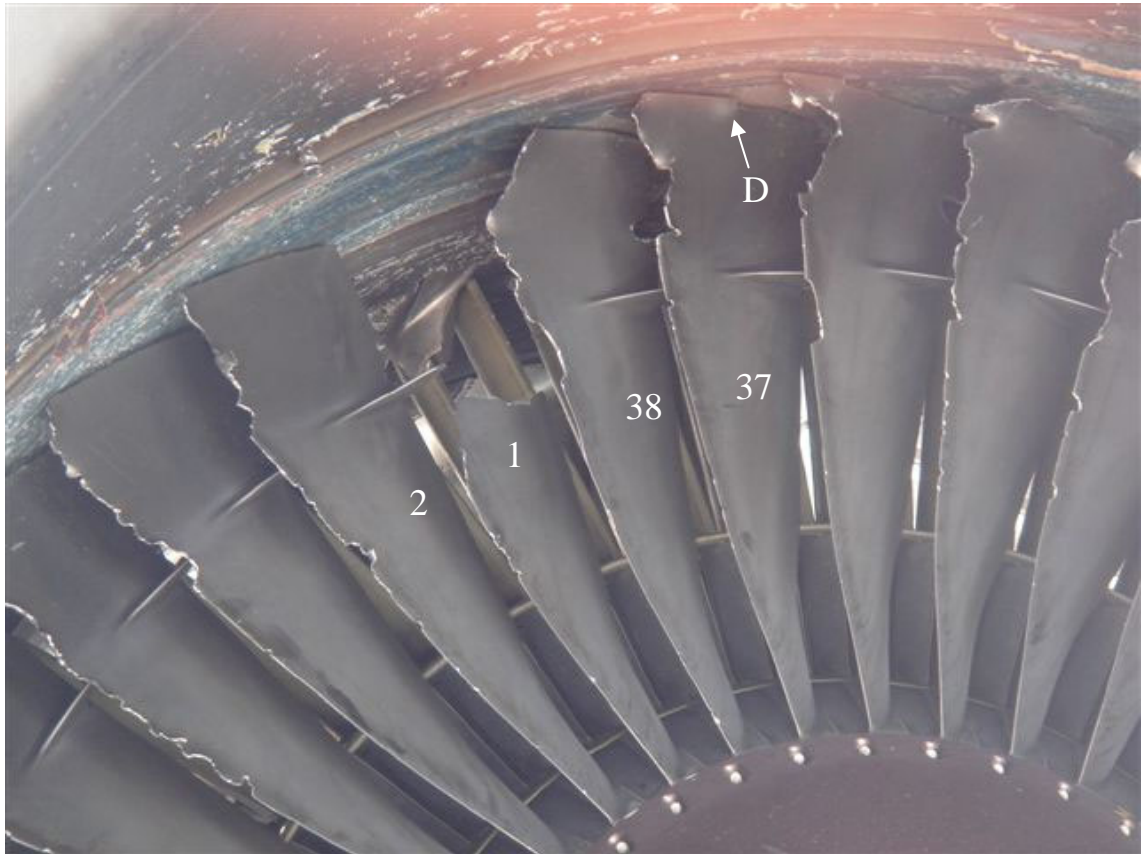
Fig. 1 The broken fan blade – labelled 1 - and adjacent blades (courtesy of the Dutch Safety Board) seen from the engine inlet

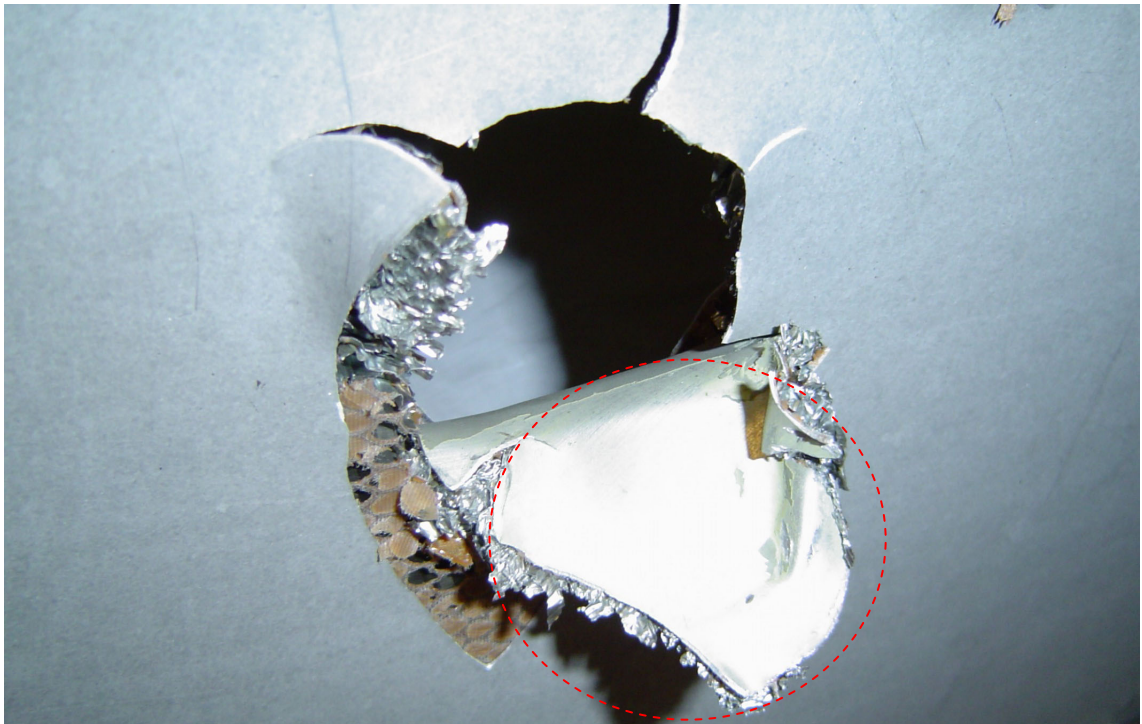
Fig. 2 Hole in fan cowling as seen from outside (courtesy of the Dutch Safety Board). The encircled area was investigated with EDX

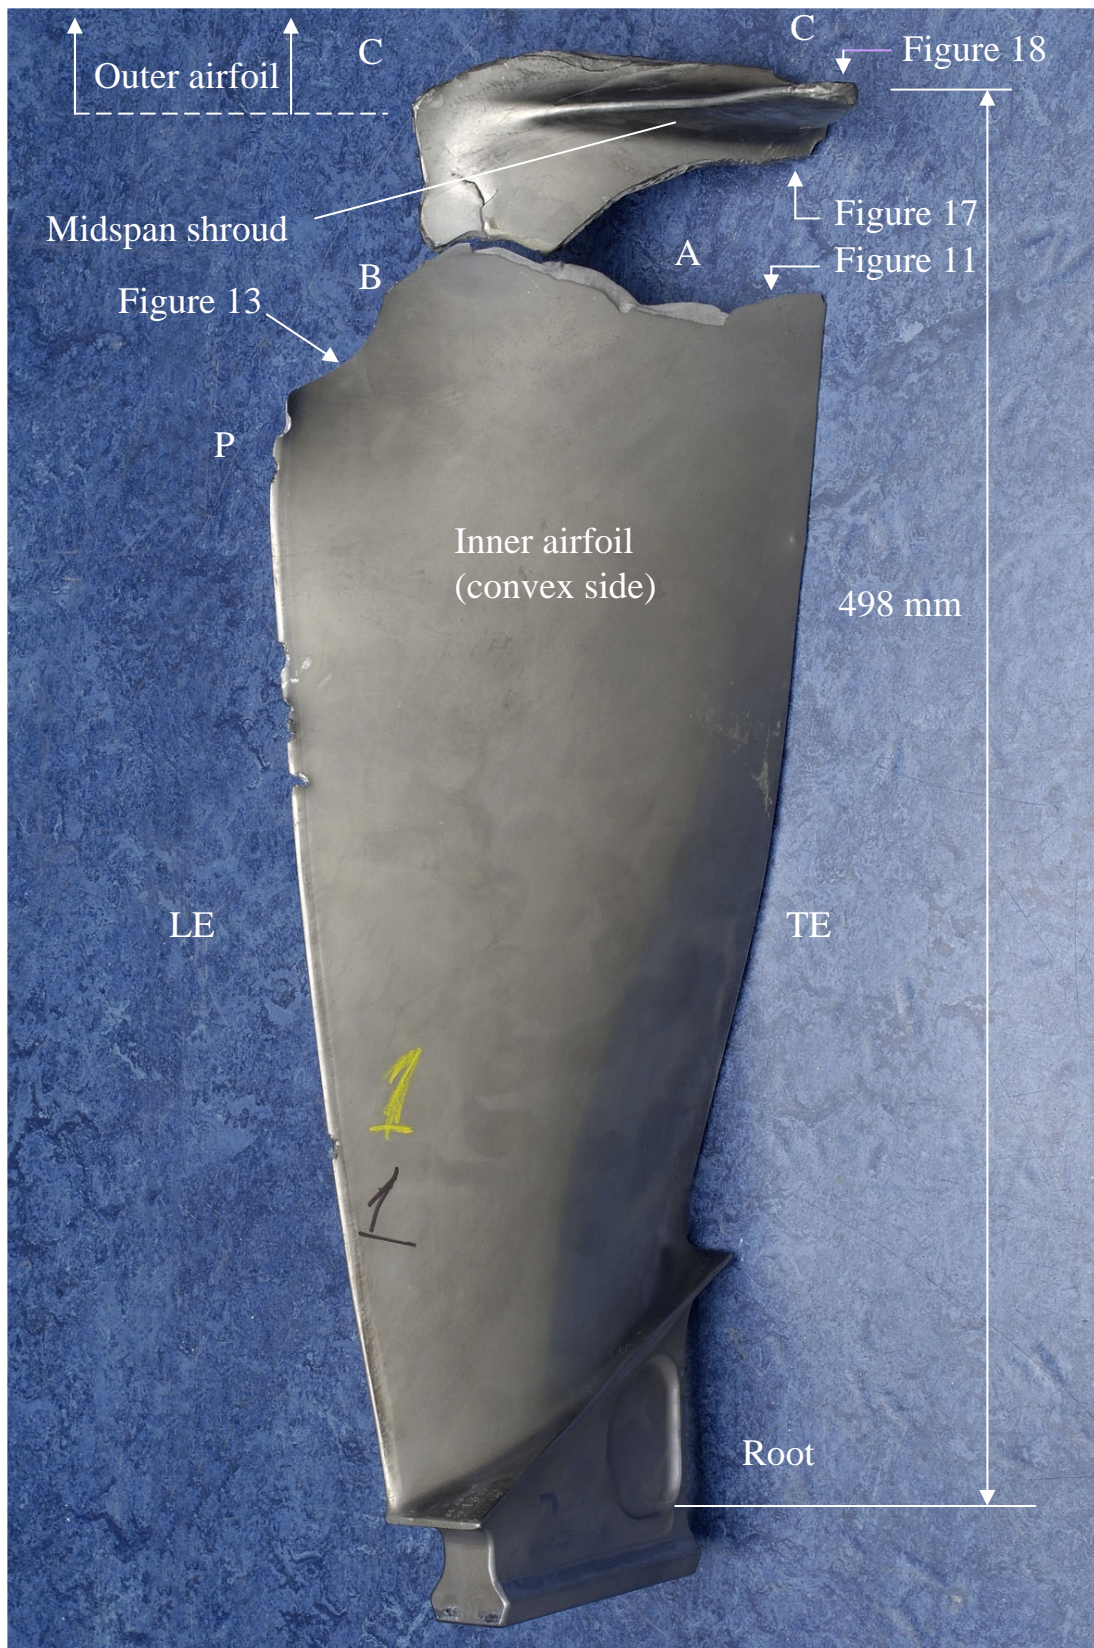
Fig. 3 Macroscopic view of the broken blade. The missing outer airfoil has a length of 168 mm

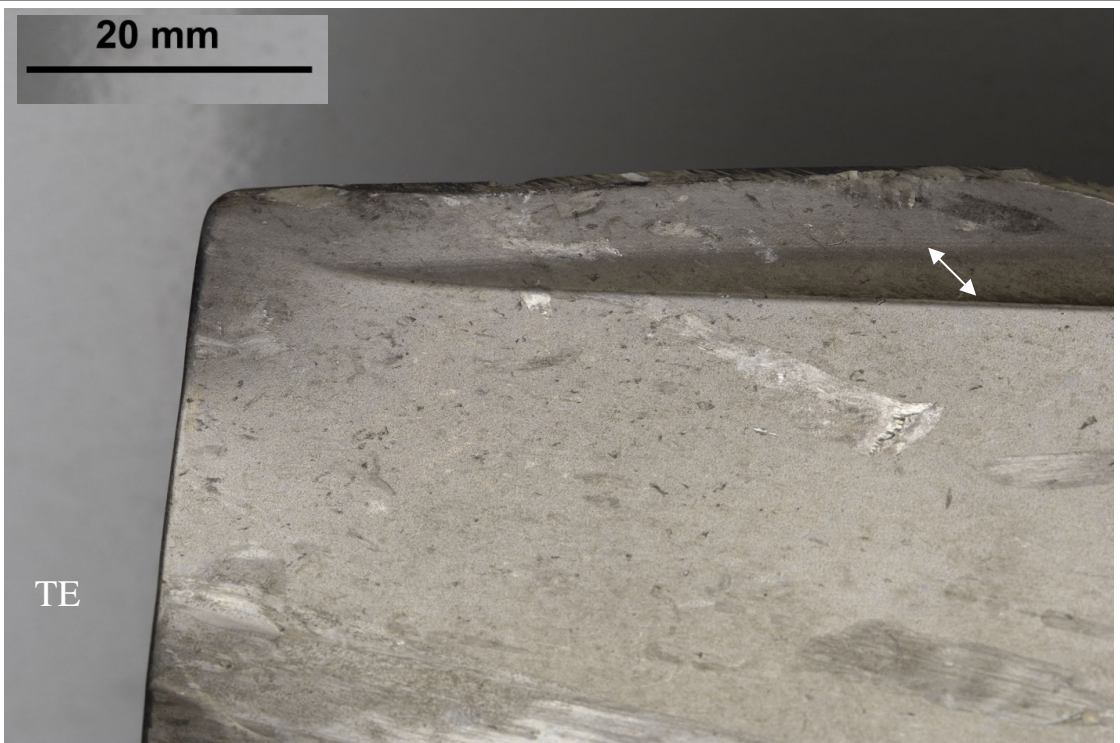
Fig. 4 Part of the tip at the concave side of blade37. Note the absence of severe tip rub and the blade thickness step (arrowed) at the very tip

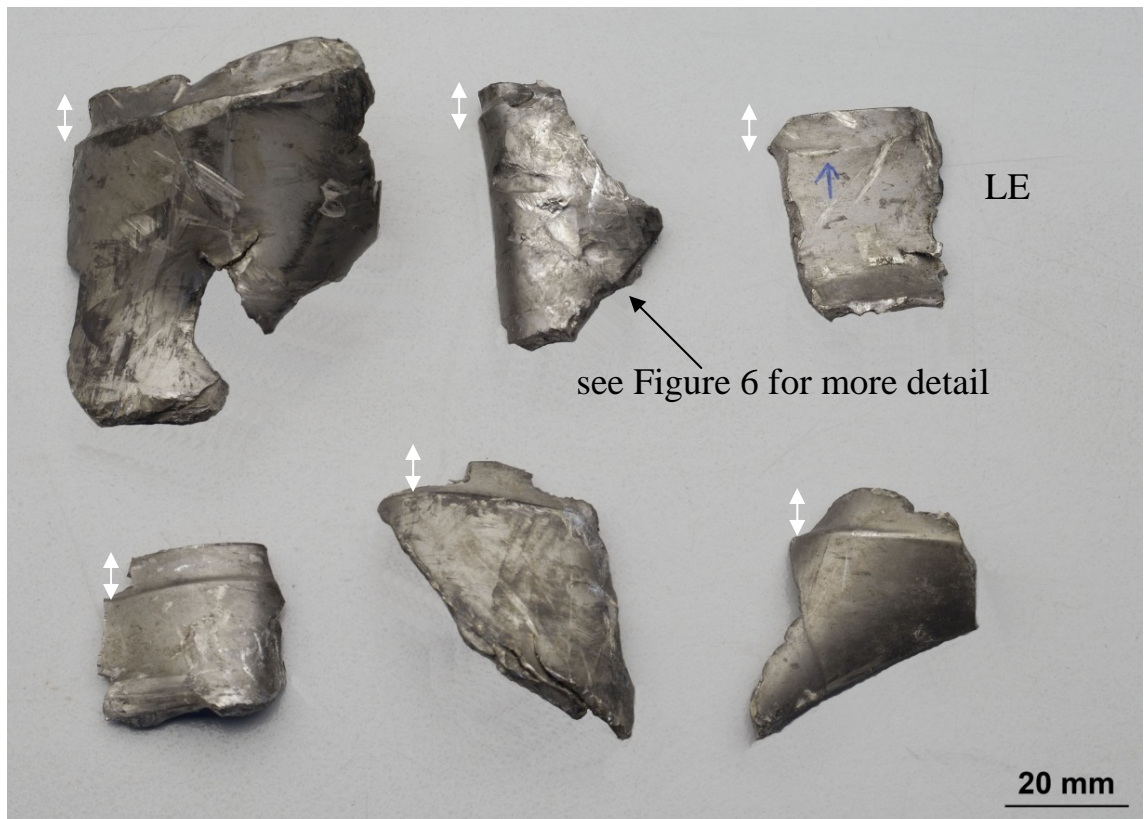
Fig. 5 Fragments recognizable as tip segments because of the thickness jump (compare with Fig. 4). White arrows indicate the tip segment with reduced thickness (that is exemplified in Fig. 4)

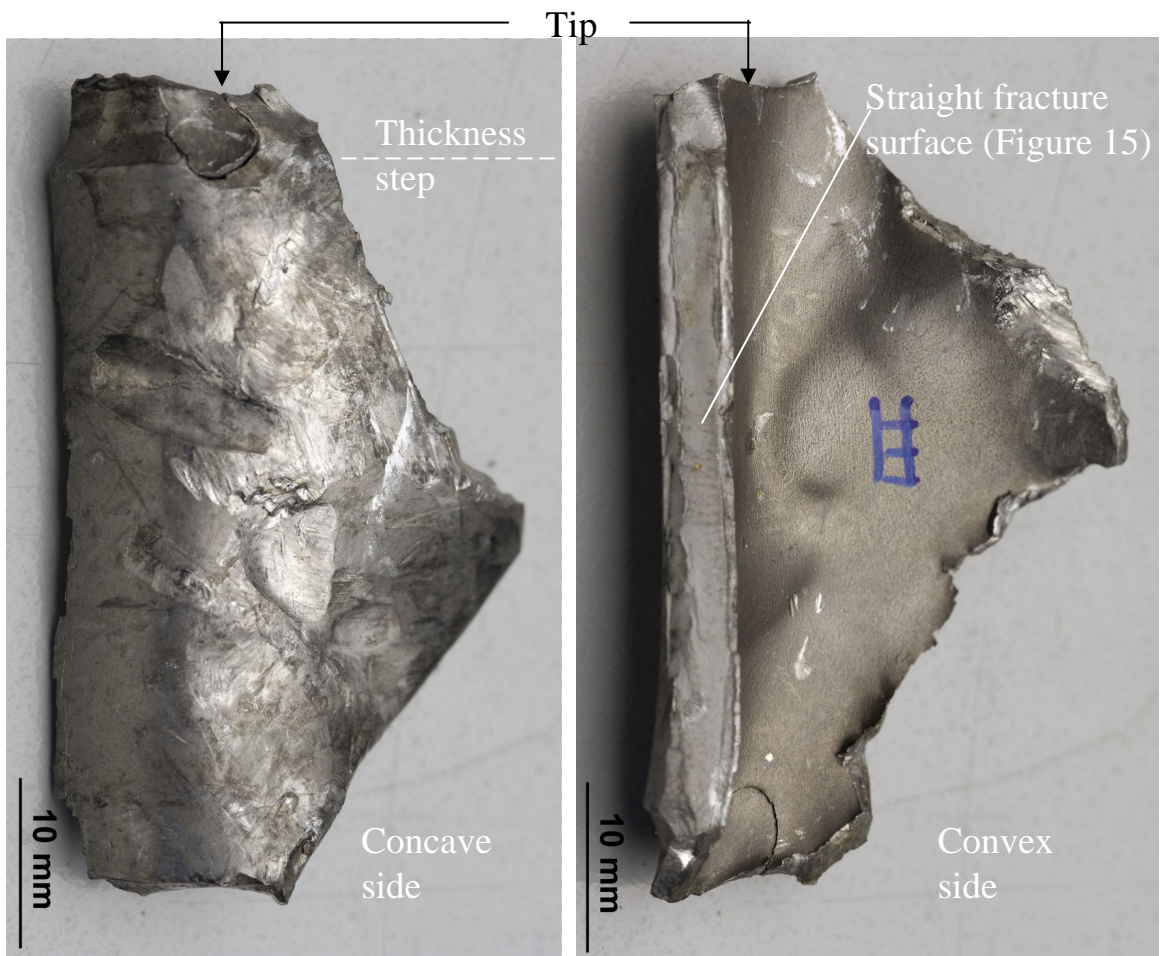
Fig. 6 One of the tip fragments in figure 5 seen from both sides. Considering the curvature of the fragment, it might be thought that the left hand photograph shows the convex side. This curvature (found for all tip segments) is, however, a consequence of the severe deformation of the fragment: the thickness step in the left hand photograph proves that the concave side of the airfoil is involved

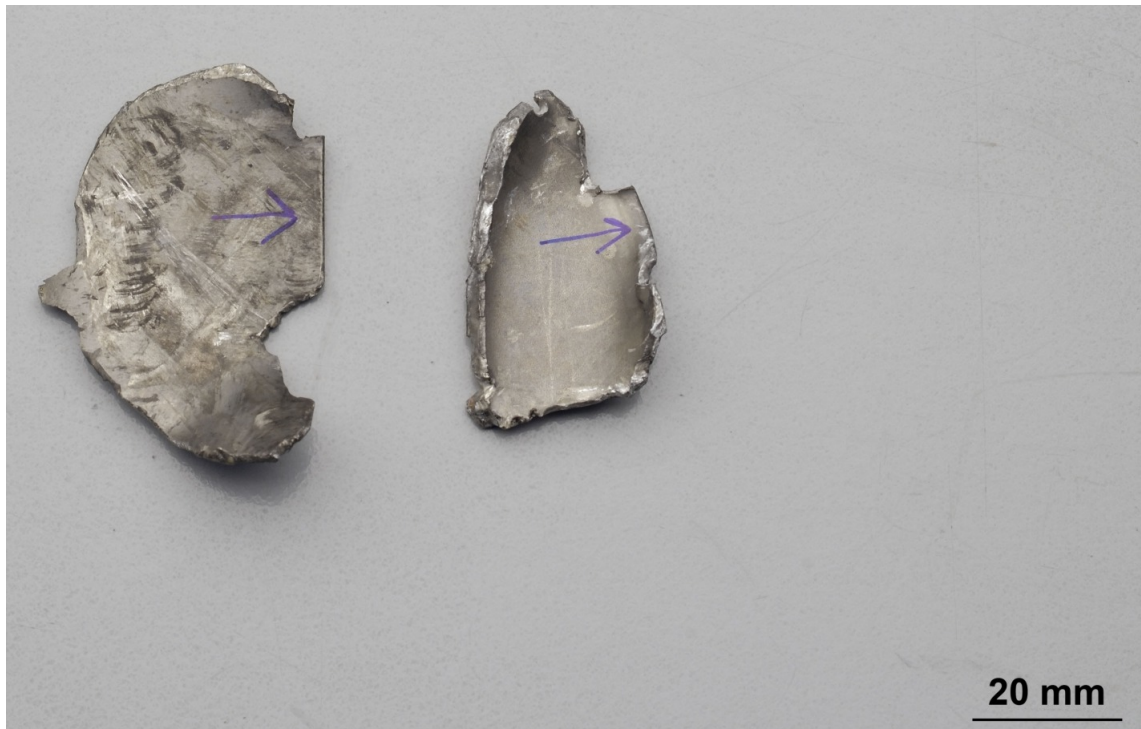
Fig. 7 The only two fragments exhibiting a recognizable LE or TE

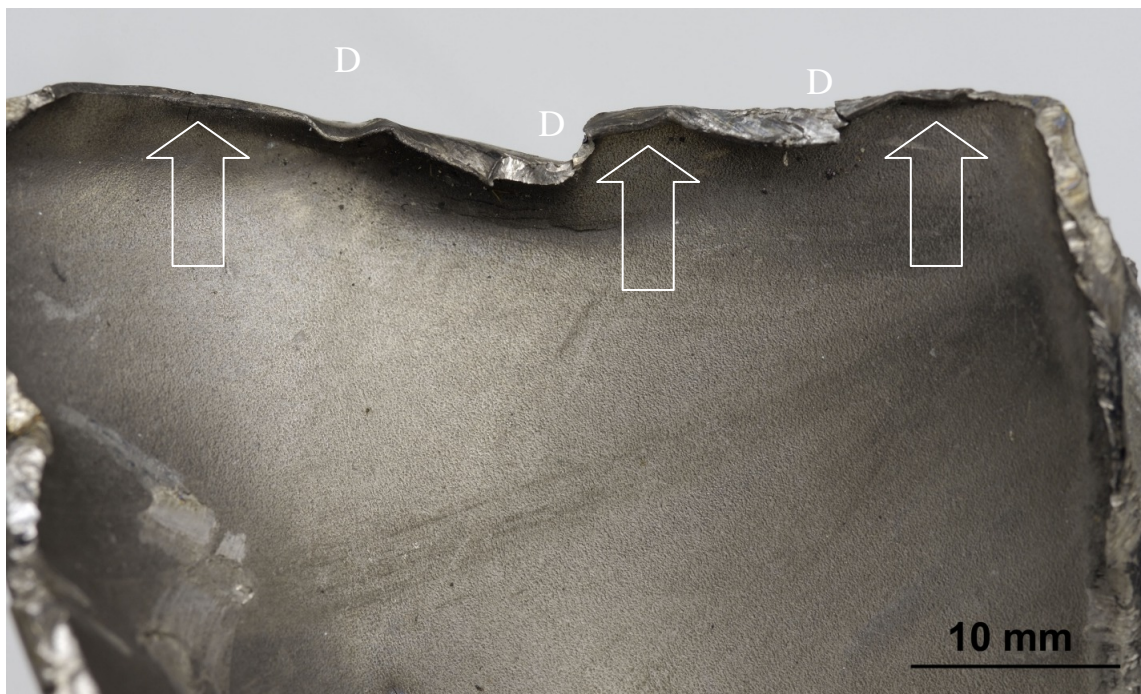
Fig. 8 Tip fragment of broken blade exhibiting both tip rub (the arrowed overhanging lips) and dents D. For other blades dents like D are also present and can be explained by debris that got stuck between the rotating blades and the duct. However, for this fragment of the broken blade this would imply that debris was present before the blade broke and hence dents D were probably formed either by a Foreign or Domestic Object or by collisions after the blade failure

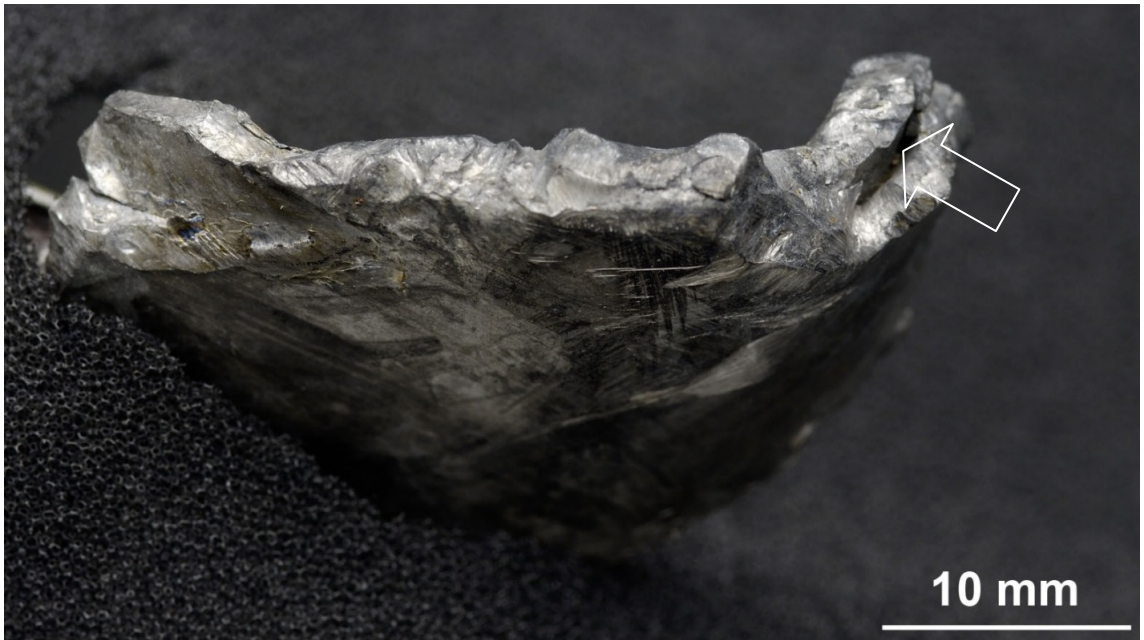
Fig. 9 Detail of fragment of debris. Note the arrowed feature

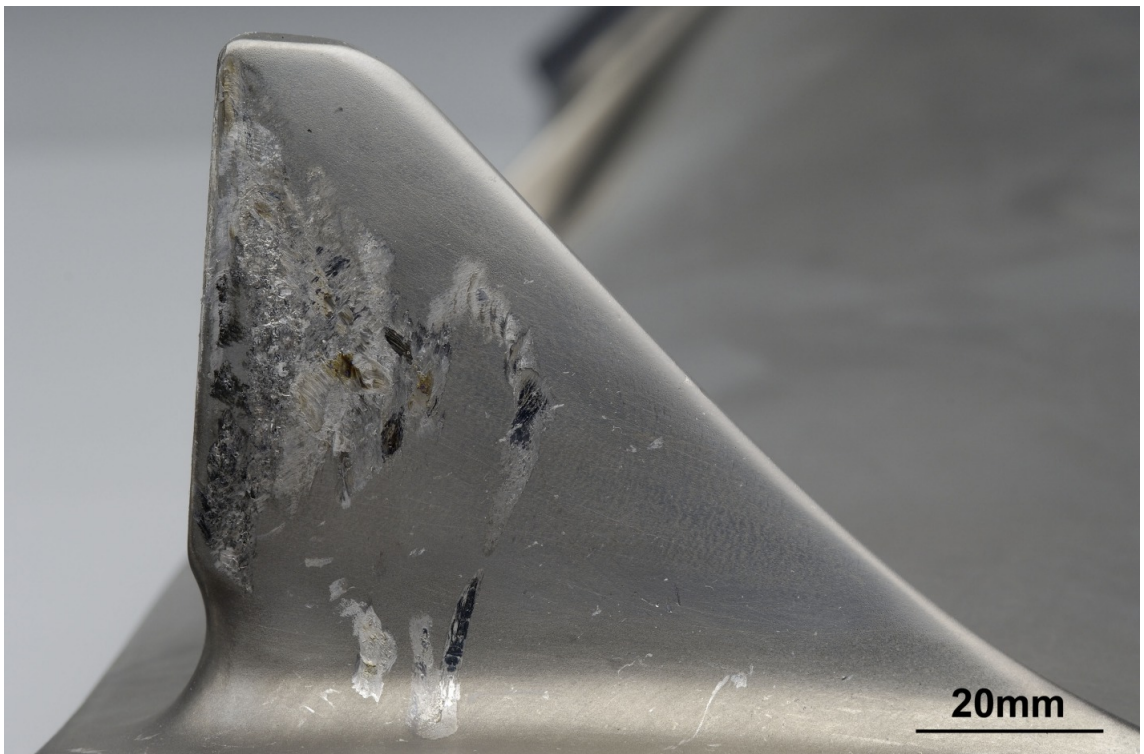
Fig. 10 Example of shingling damage of a midspan shroud (convex side of blade 13)

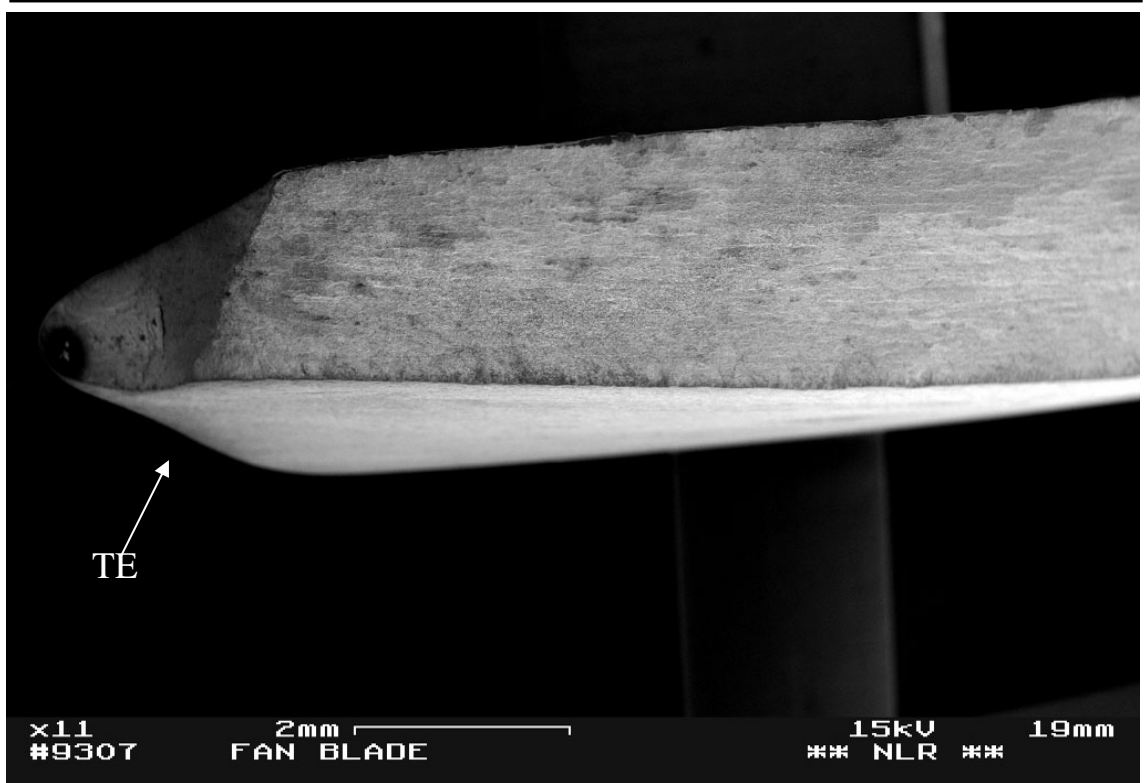
Fig. 11 Overview of fracture surface indicated in figure 3 (SEM)

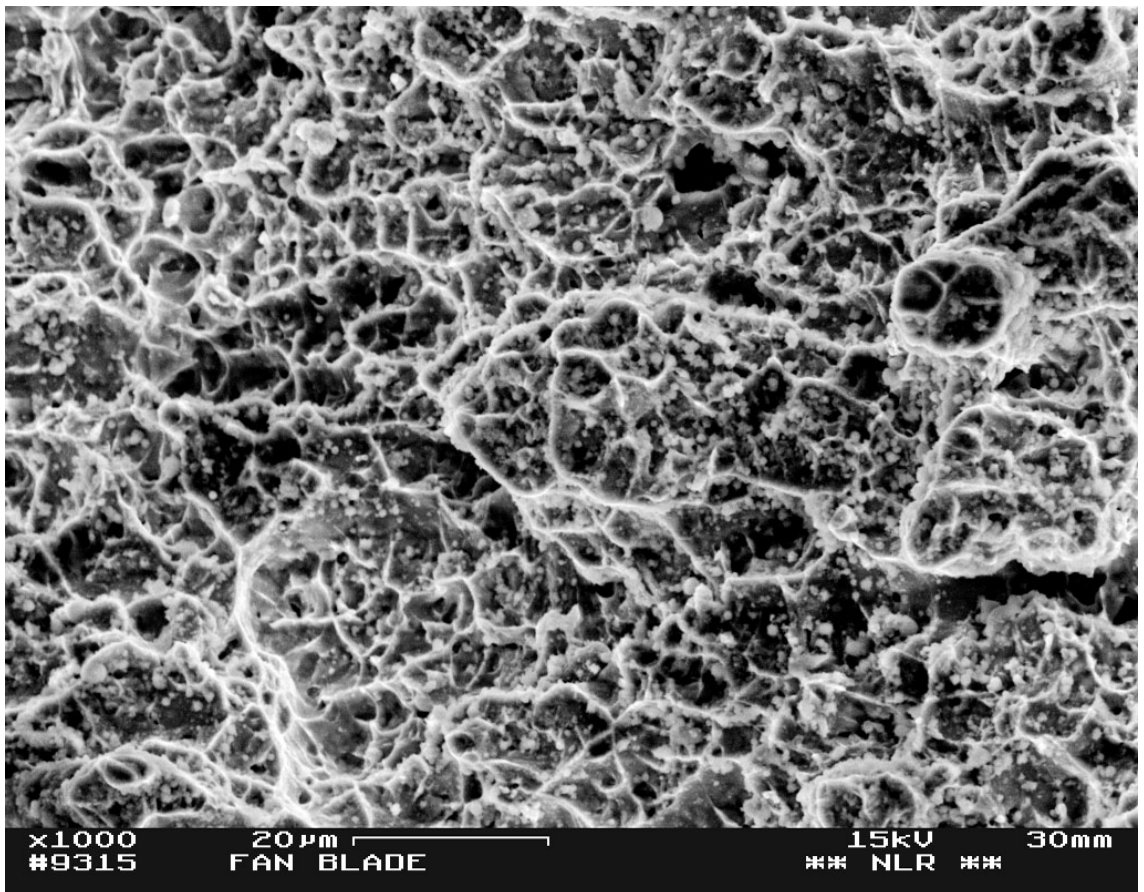
Fig. 12 Detail of figure 11, showing dimples characteristic for overload (SEM)

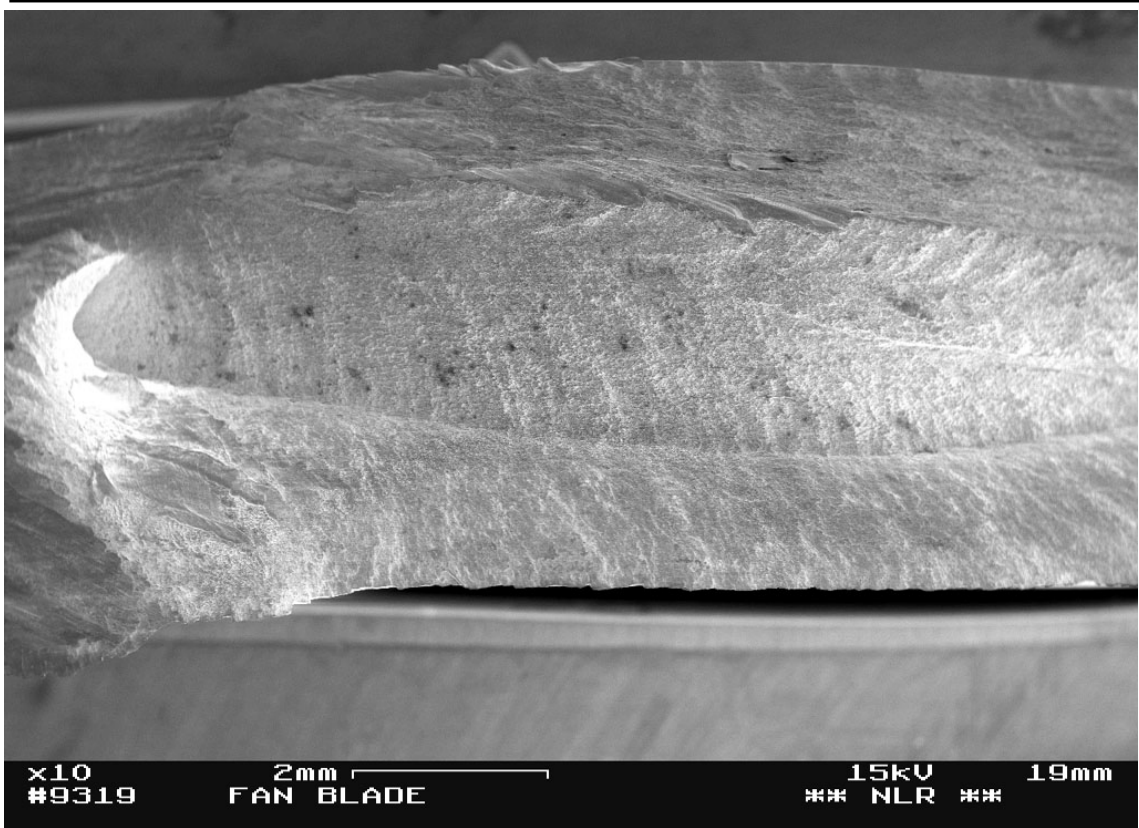
Fig. 13 Overview of fracture surface indicated in figure 3 (SEM)

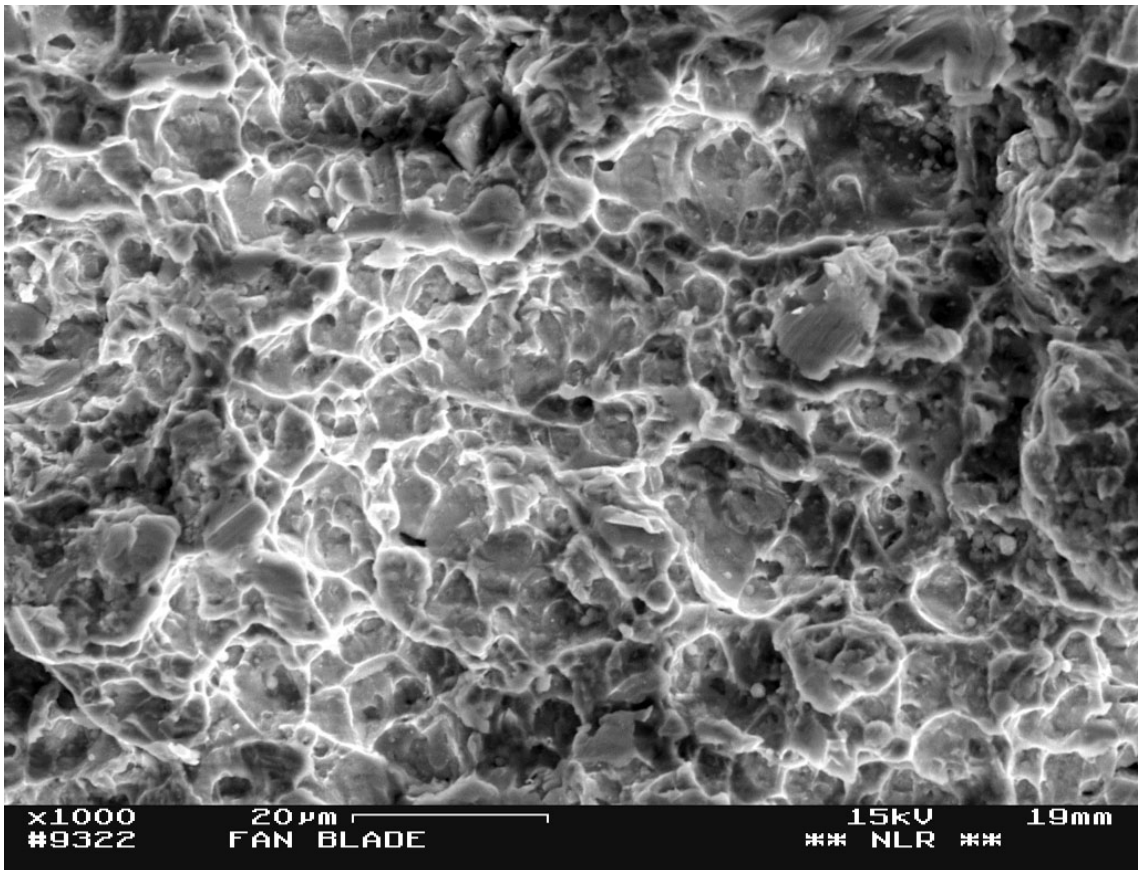
Fig. 14 Detail of figure 13, showing dimples characteristic for overload (SEM)

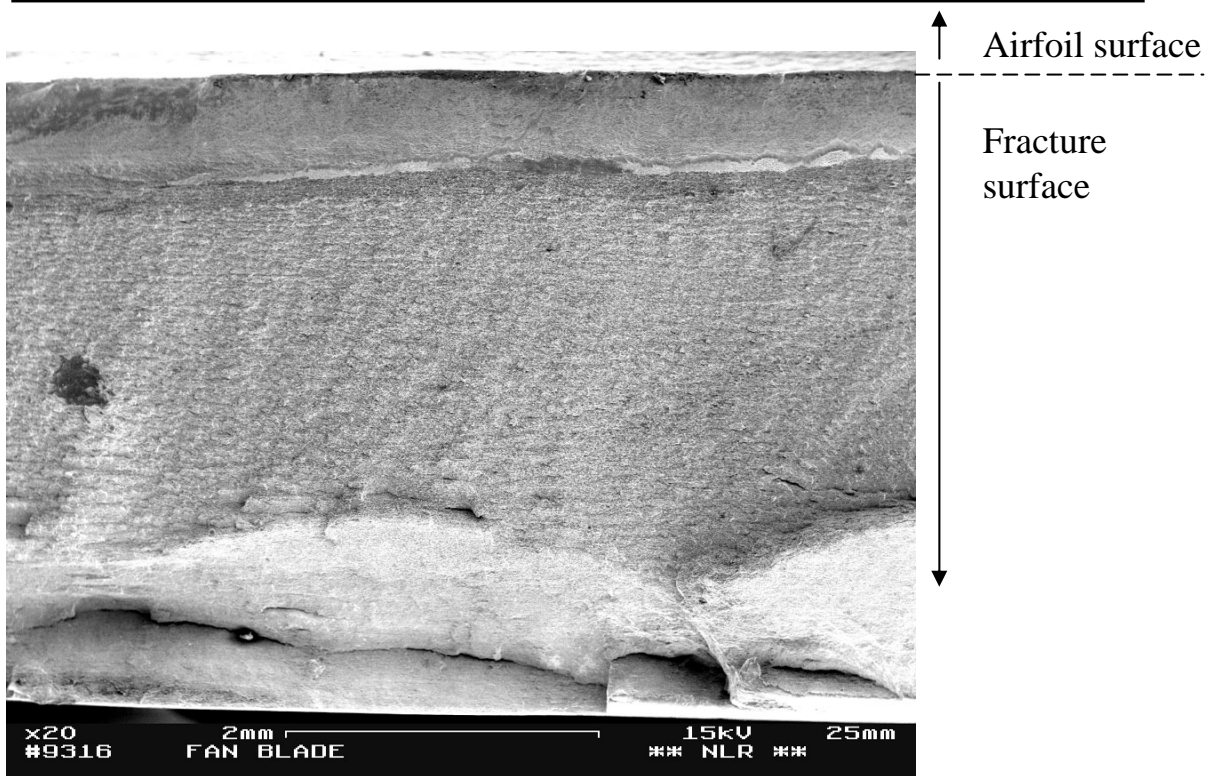
Fig. 15 Overview of straight fracture surface indicated in figure 6 (SEM)

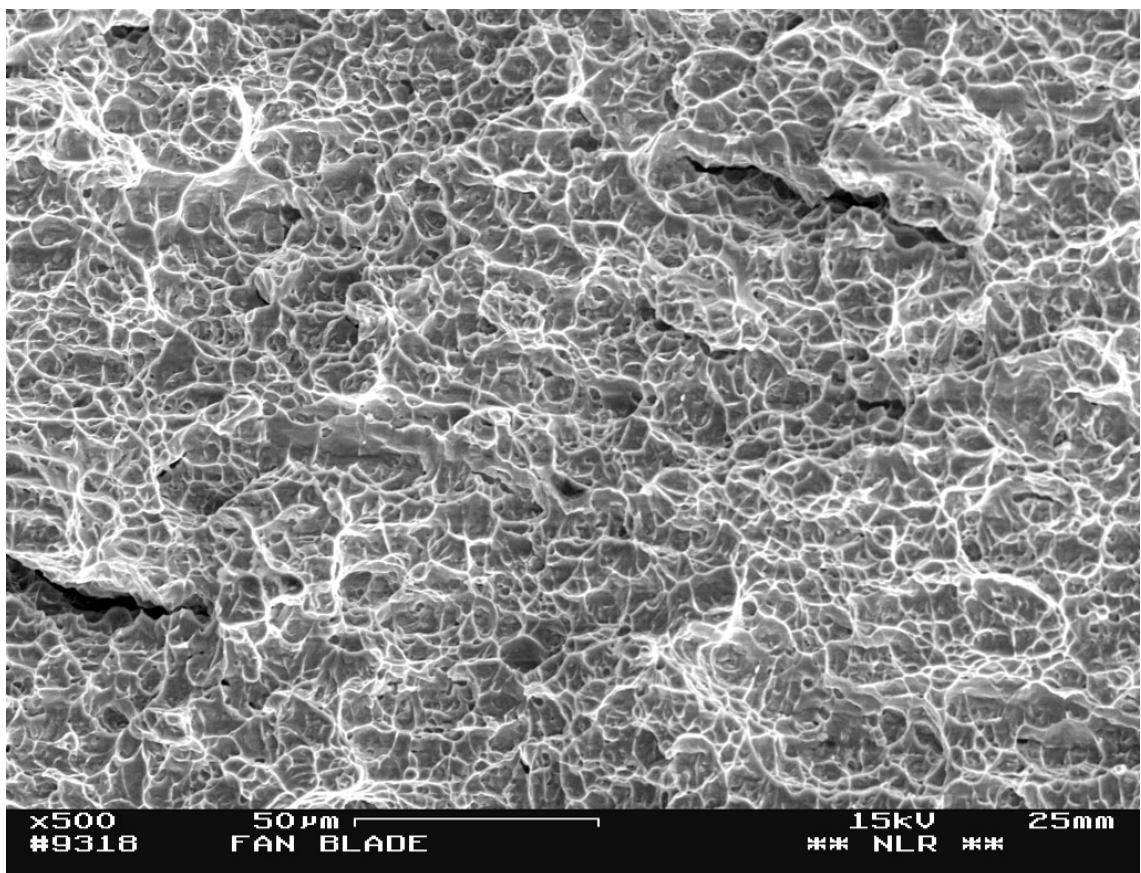
Fig. 16 Detail of figure 15 showing dimples characteristic for overload (SEM)

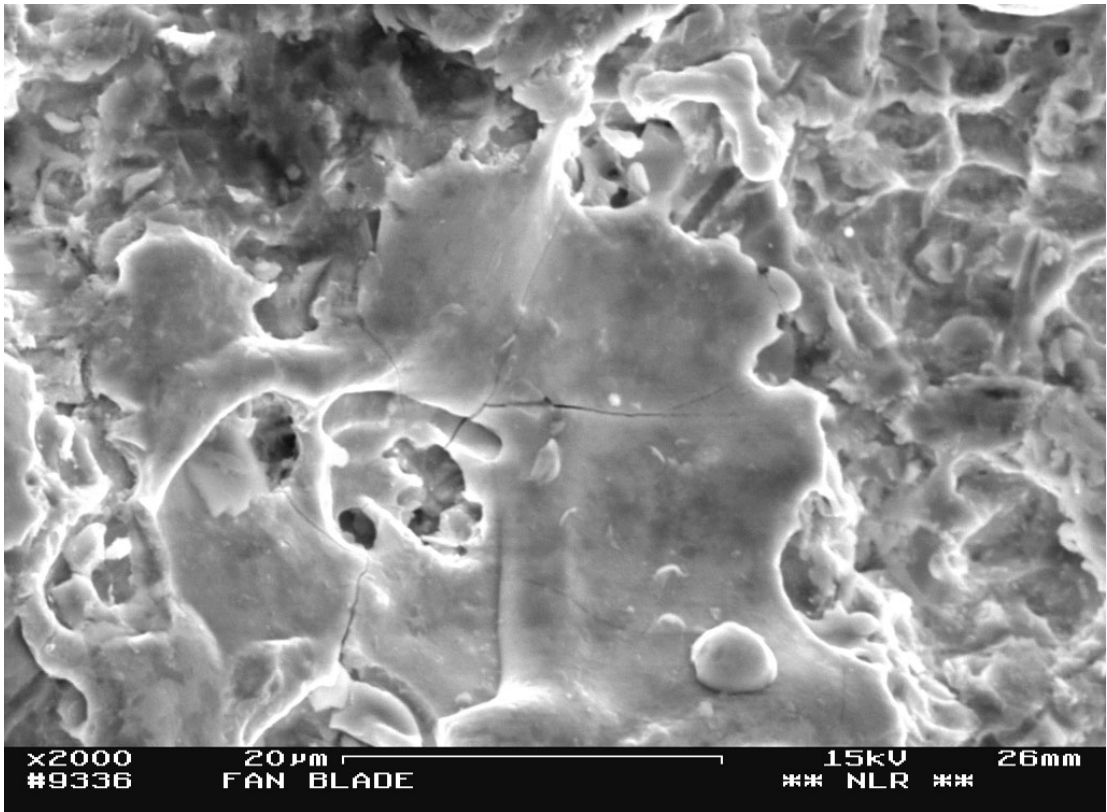
Fig. 17 Detail of the fracture surface between midspan shroud and inner airfoil (SEM)

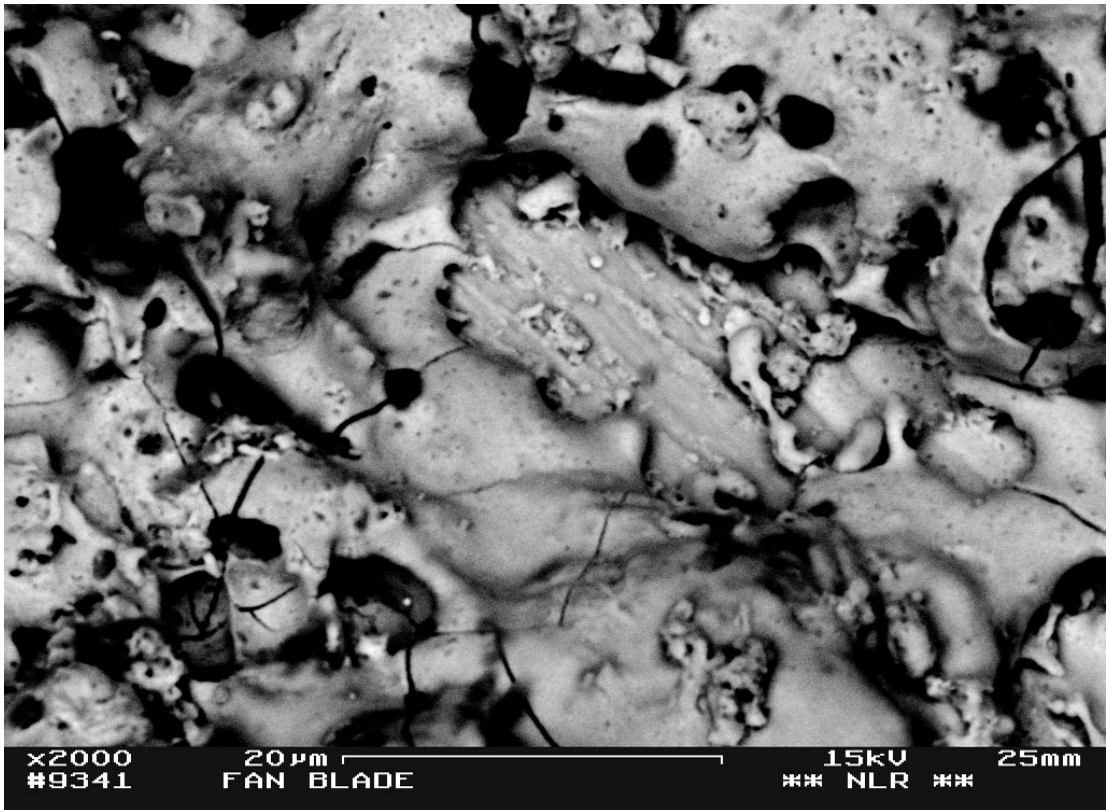
Fig. 18 Detail of the fracture surface between midspan shroud and outer airfoil (SEM)

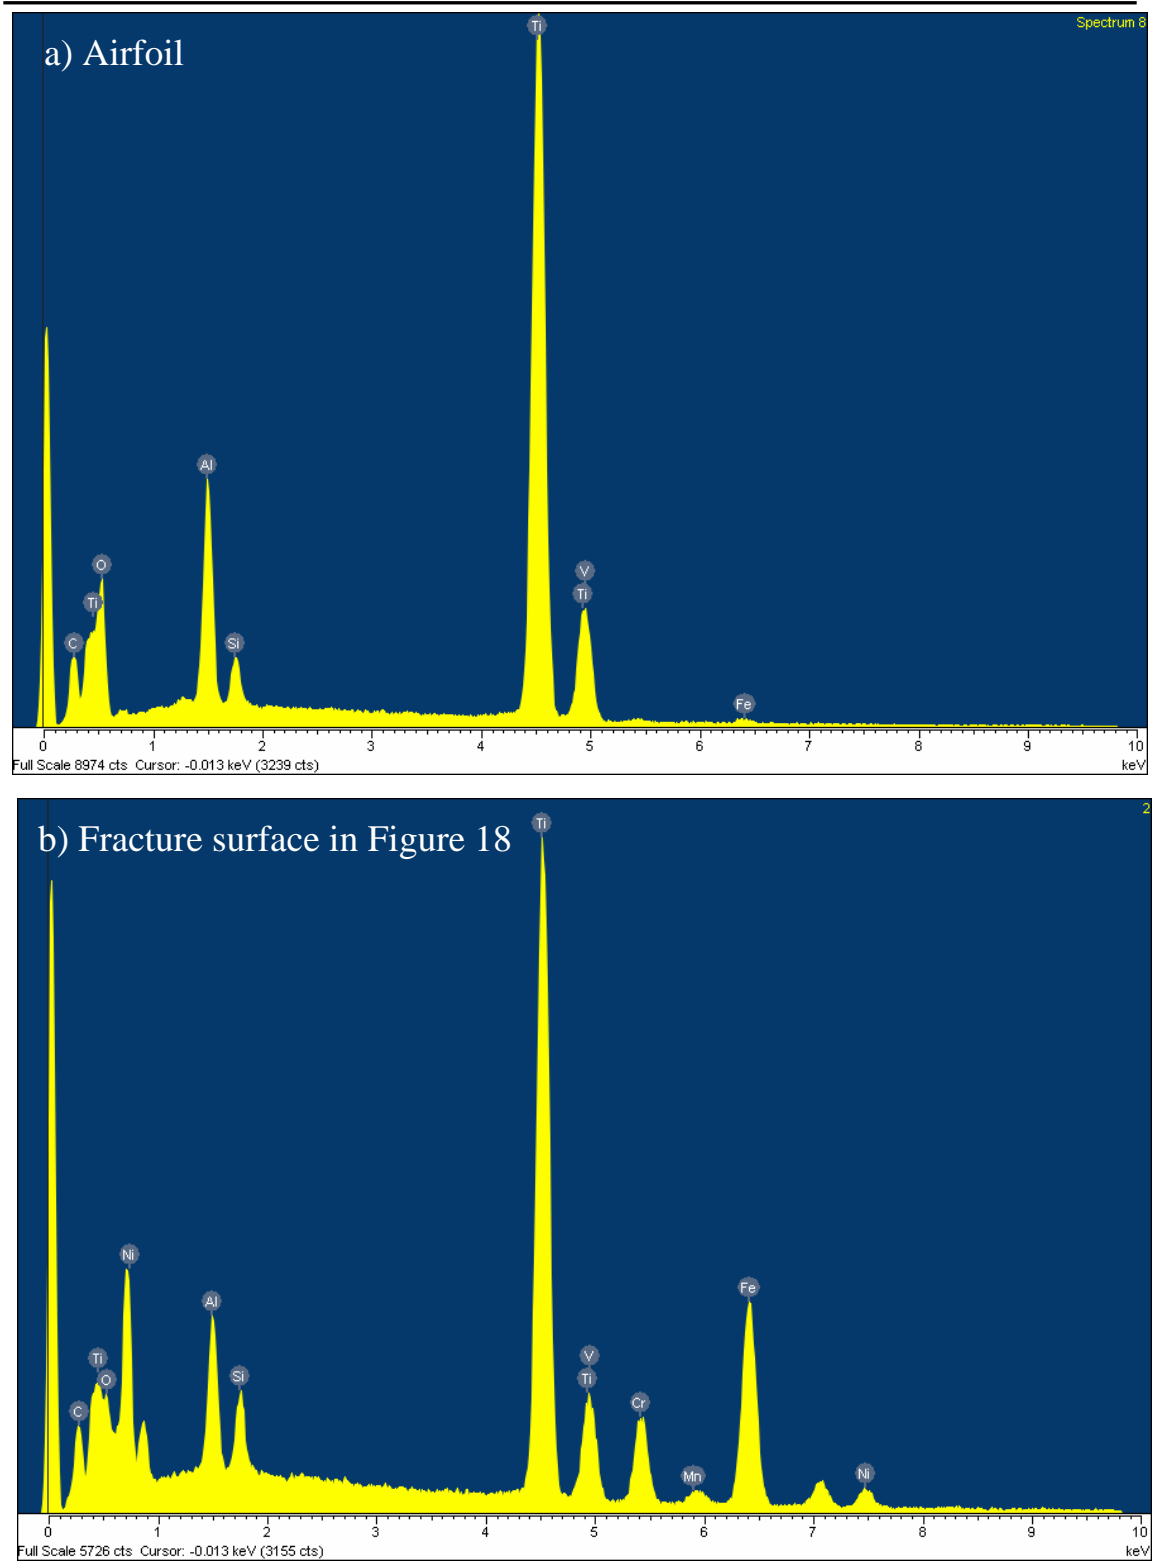
Fig. 19 EDX spectra at/near midspan shroud. Note the high Si and Fe peaks and the presence of Ni and Cr peaks in the lower figure as compared with the upper figure
