**Uncontained engine failure during take-off**  
with a Fly Air Airbus A300-B4, registration TC-FLF,  
Amsterdam Airport Schiphol, June 29, 2005

The Hague, may 24, 2007, Occurrence number 2005094

Failure analysis of broken CF6-50 fan blade

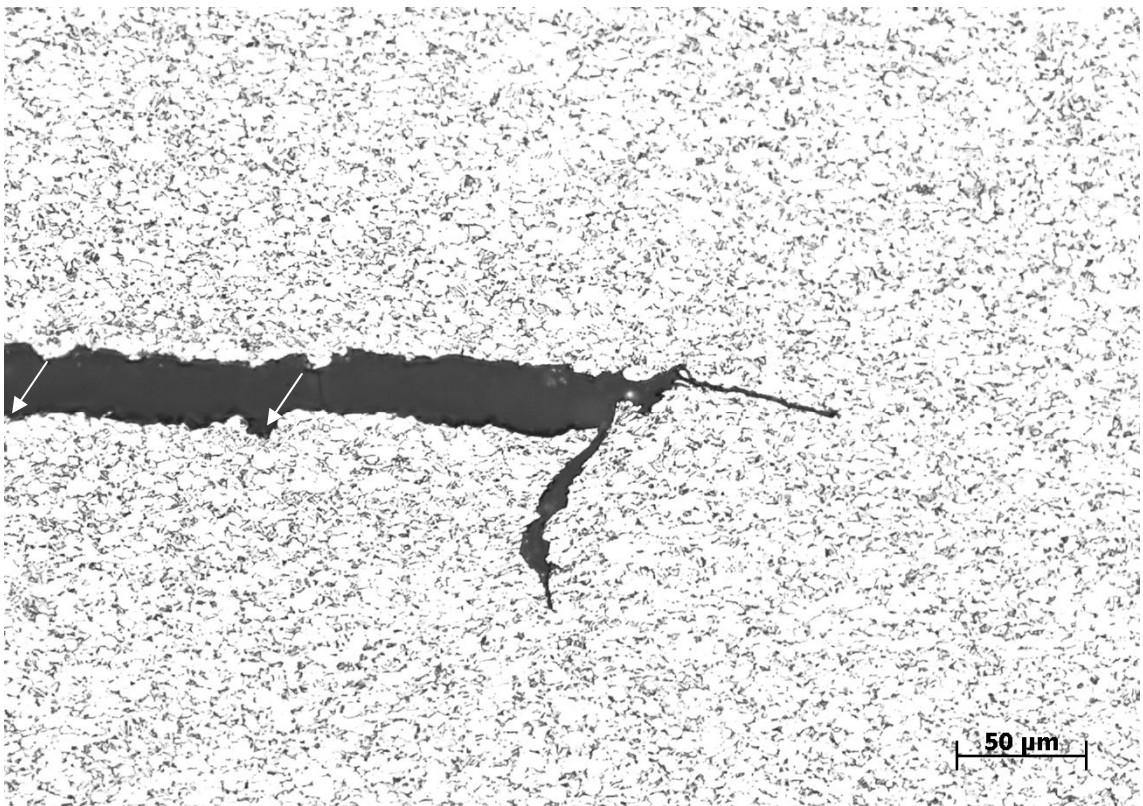
Fig. 21 Cross-section through the feature seen in figure 9 (OM). Note that the two fracture surfaces of the main crack seem to match (arrowed), that the fracture surfaces are rough and that the crack tips are sharp

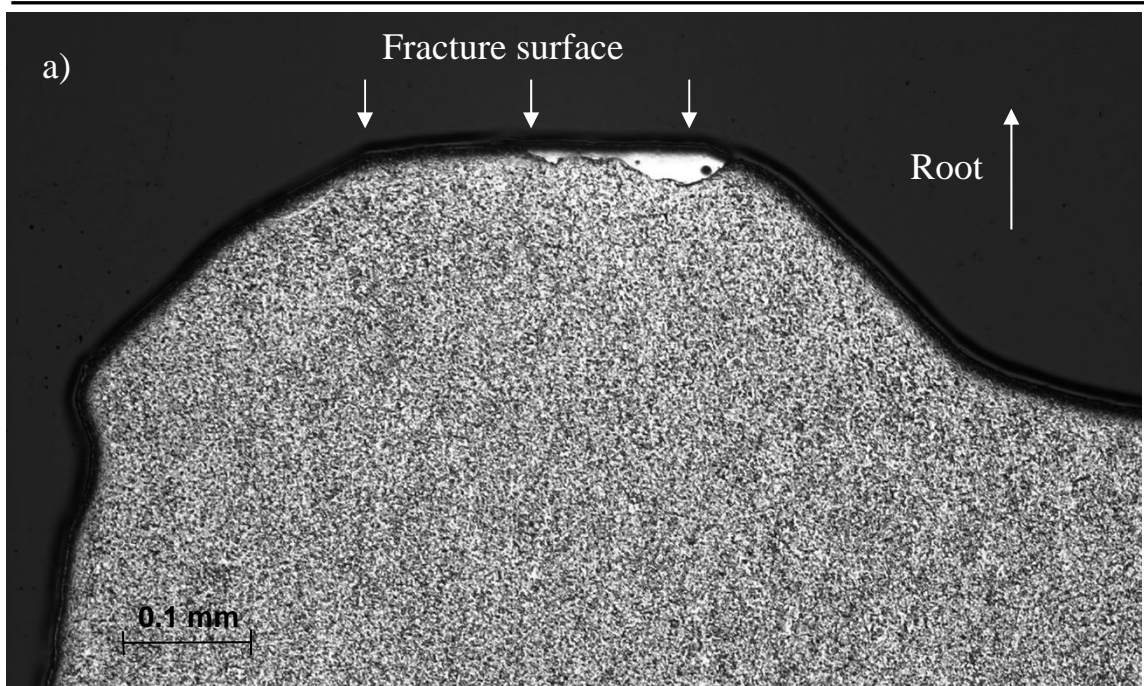
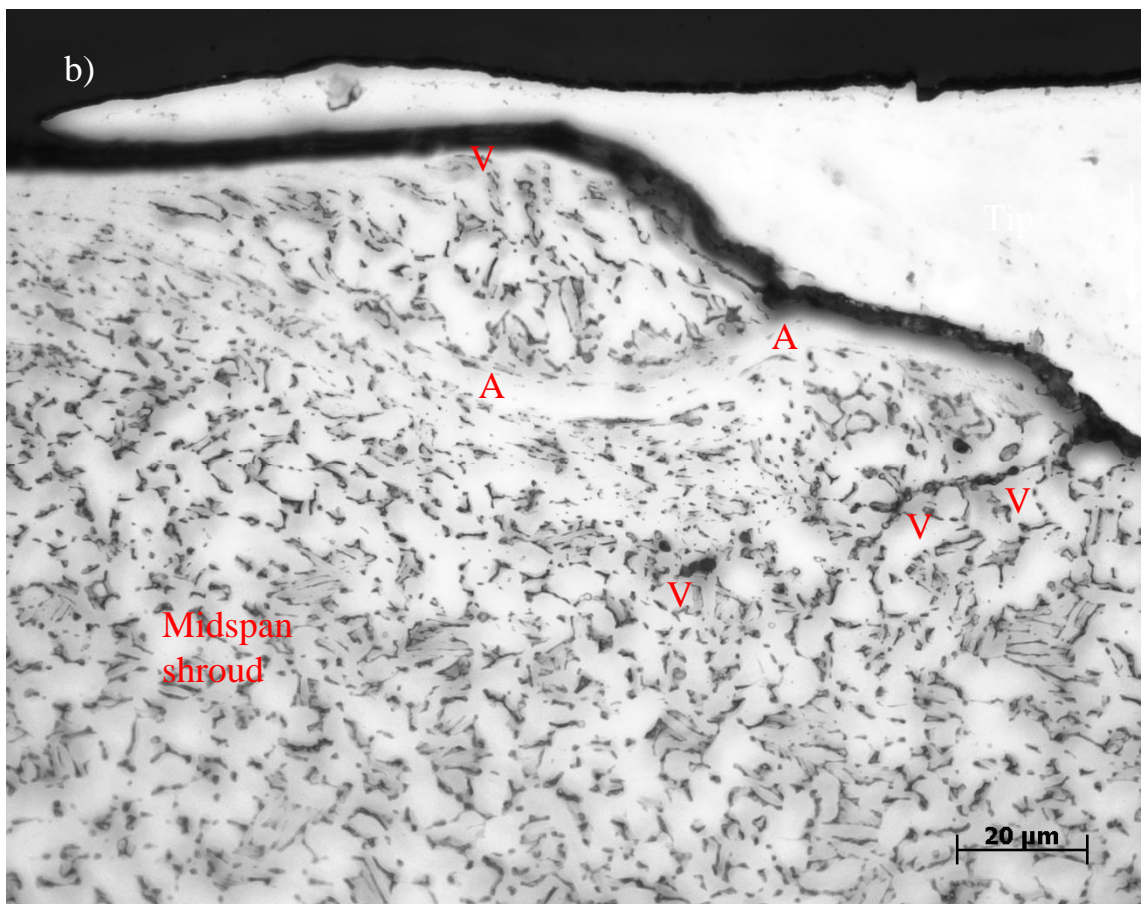
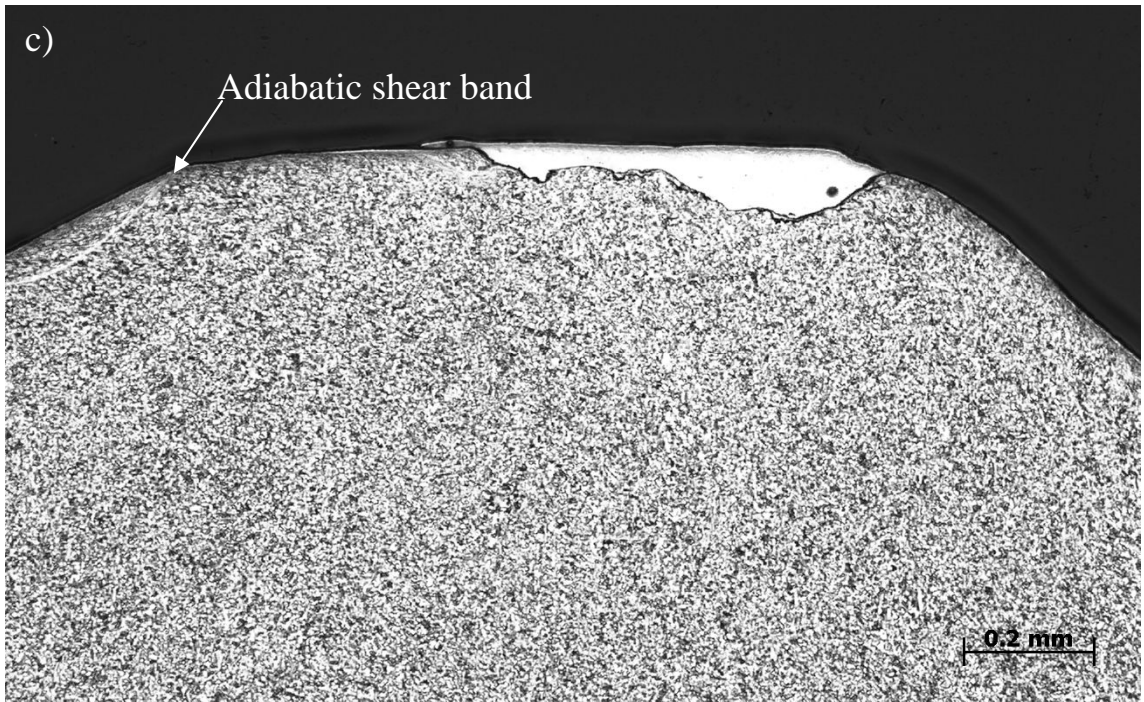
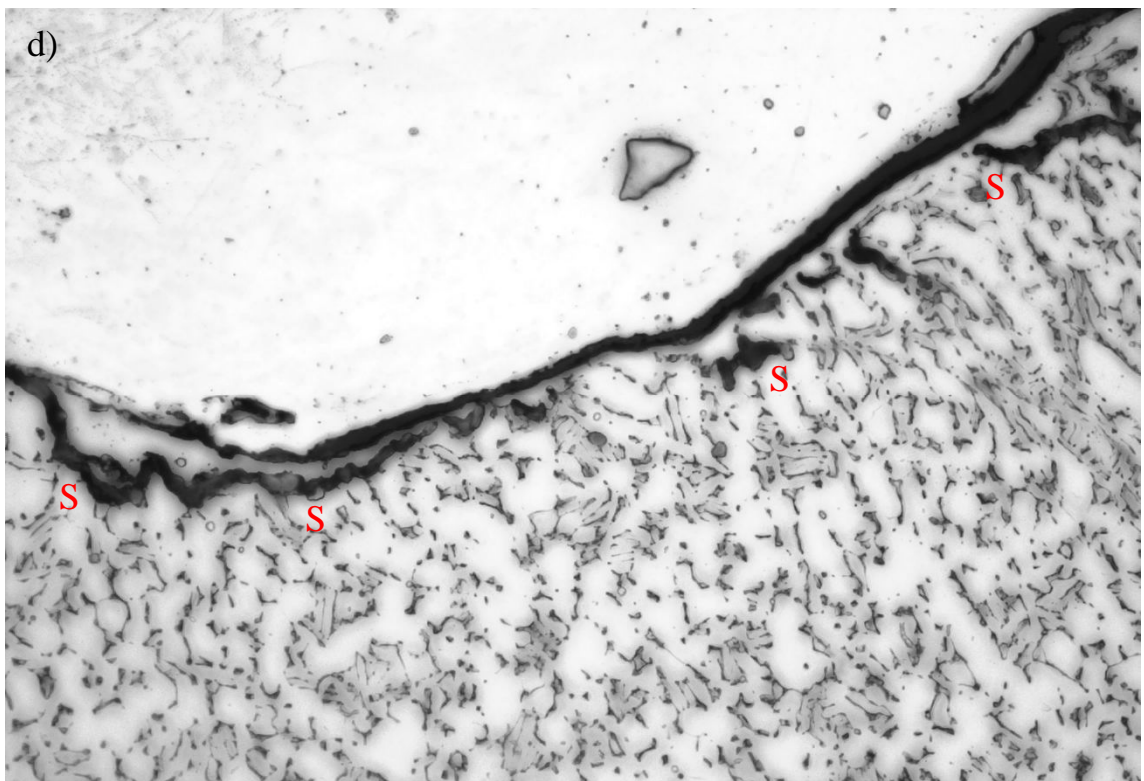
Fig. 22 Cross-section through the fracture surface in figure 18 (OM).  
a) is an overview; b) –d) are details.  
(continued on the next page)

Fig. 22 (continued)  
A: adiabatic shear band;  
S: cracks thought to be caused by shock waves  
V: voids;

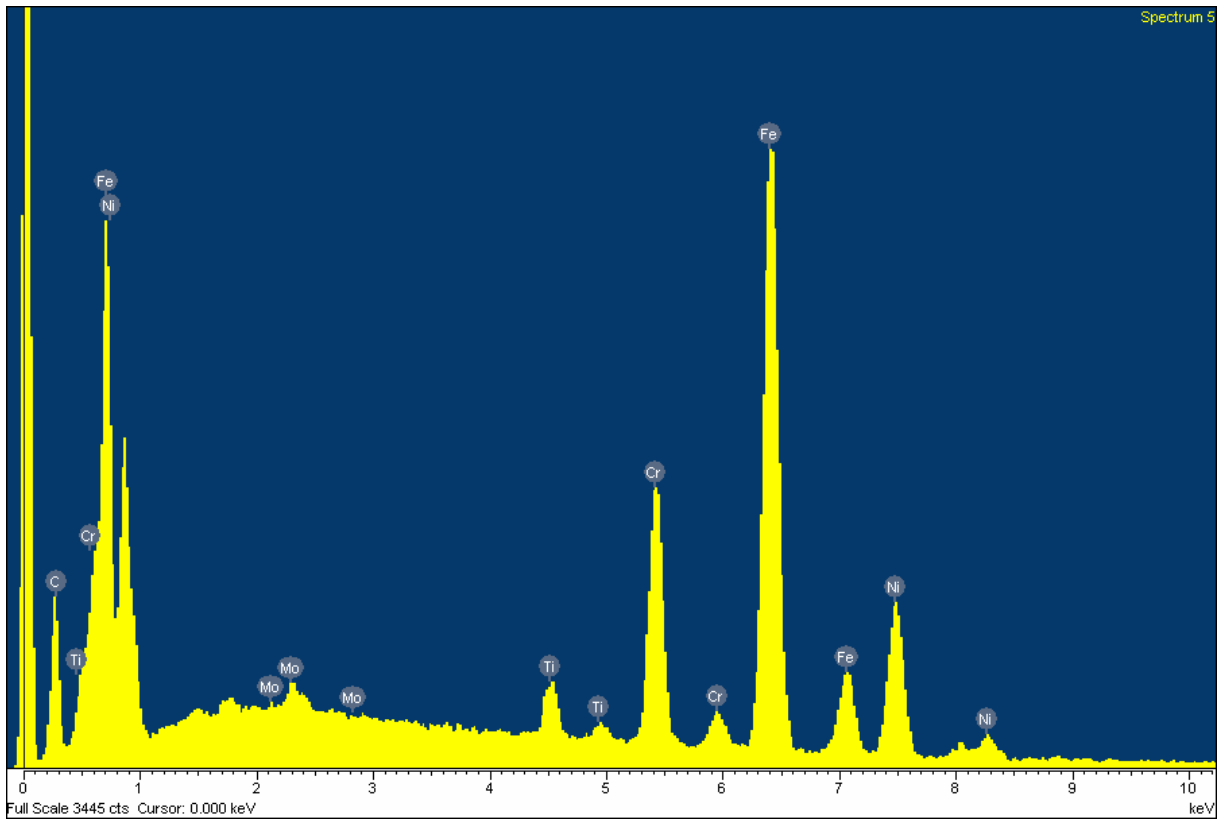
*Fig. 23 Example of EDX spectrum of the white layer in figure 22a  
The origin of carbon (C) is a carbon coating that was sputtered onto the specimen in order to prevent the charging of the cross-section by the electron beam*
