## AIRCRAFT ACCIDENT REPORT AND EXECUTIVE SUMMARY

Reference:	CA18/2/3/7997	
<b>Aircraft Registration</b>	<b>ZU-DRS</b>	<b>Date of Accident</b>	29 July 2005	<b>Time of Accident</b>	1350Z	
<b>Type of Aircraft</b>	Sonex		<b>Type of Operation</b>	Private		
<b>Pilot-in-command Licence Type</b>		PPL	<b>Age</b>	67	<b>Licence Valid</b>	Yes
<b>Pilot-in-command Flying Experience</b>		Total Flying Hours	232.9	Hours on Type	Unknown	
<b>Last point of departure</b>		Rand Aerodrome (FAGM)				
<b>Next point of intended landing</b>		Rand Aerodrome (FAGM)				
<b>Location of the accident site with reference to easily defined geographical points (GPS readings if possible)</b>						
Rand Aerodrome dumping area. GPS position: S 26°14. 606' E 028°08.394'						
<b>Meteorological Information</b>	The weather was fine.					
<b>Number of people on board</b>	1 + 1	<b>No. of people injured</b>	0	<b>No. of people killed</b>	1 + 1	
<b>Synopsis</b>						
<p>The pilot, accompanied by a passenger (also a pilot), took off from runway 29 at Rand Aerodrome (FAGM) with the intention of practising circuits and landings. During the second touch-and-go, as they became airborne, the engine stopped and the aircraft crashed

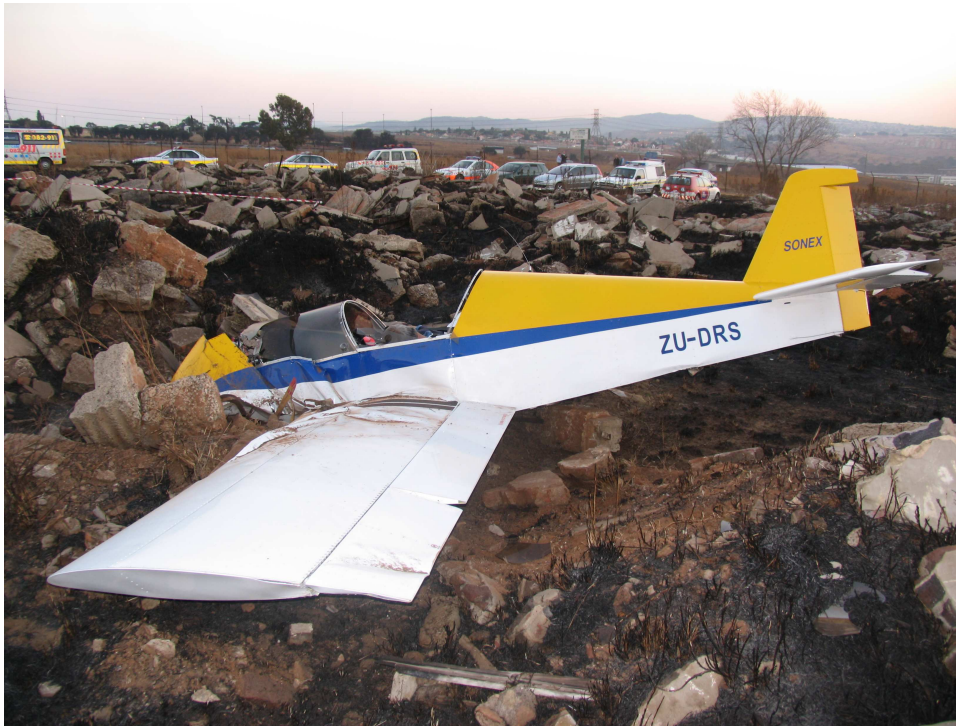
1.3.1 The aircraft was substantially damaged.

Figure 1. Side view of the wreckage.

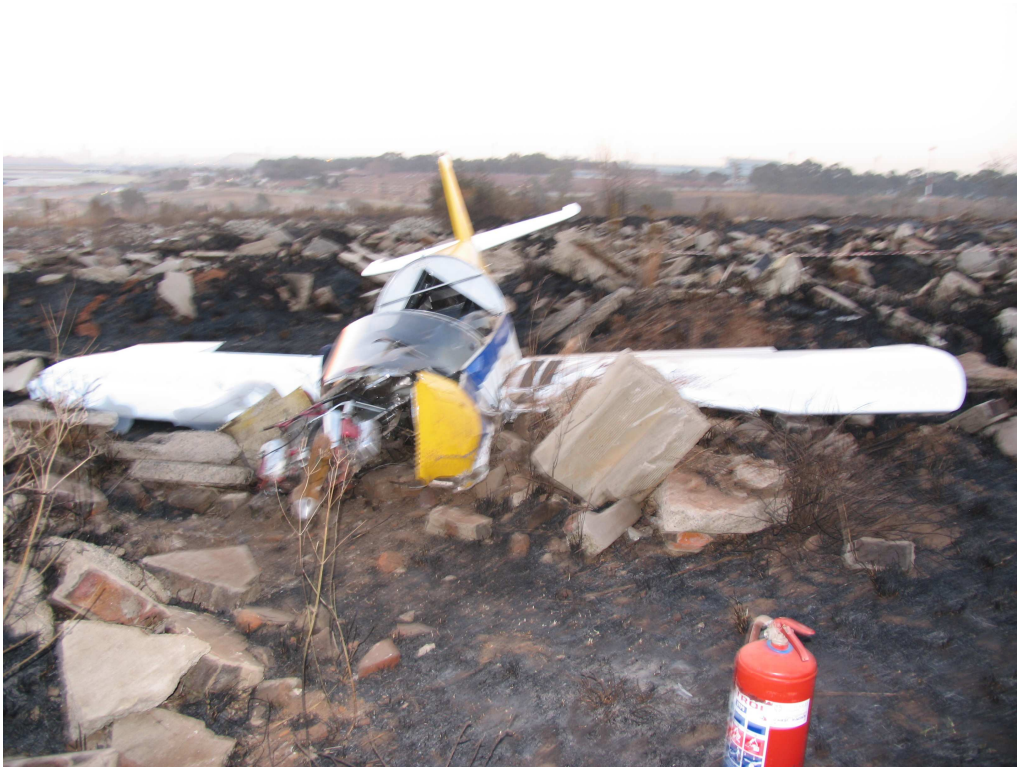
1.12.2 The impact largely destroyed the engine compartment and cockpit. The fuselage aft of the pilot's seat remained relatively intact. The wings and tail section were still attached to the fuselage. Pre-impact integrity of the flight controls was positively established.

1.12.3 Evidence from the wreckage position indicated that the aircraft had a very high rate of descent at the time of impact.

**Figure 2.** Front view of the wreckage.
