AIRCRAFT ACCIDENT REPORT AND EXECUTIVE SUMMARY

Reference:	CA18/2/3/8010	
Aircraft Registration	ZS-RRB	Date of Accident	3 September 2005		Time of Accident	0935Z
Type of Aircraft	Agusta Westland 109-K2		Type of Operation	Commercial		
Pilot-in-command Licence Type		Commercial	Age	34	Licence Valid	Yes
Pilot-in-command Flying Experience		Total Flying Hours	2 640.0		Hours on Type	320.0
Last point of departure		National Port Authority helipad, Richards Bay				
Next point of intended landing		National Port Authority helipad, Richards Bay				
Location of the accident site with reference to easily defined geographical points (GPS readings if possible)						
Crashed into the sea, Richards Bay Harbour (GPS position: South 28° 48.751' East 032° 06.012')						
Meteorological Information		Surface wind; 030°/12 to 24 knots; Temperature; 27.5°C, Visibility; +10 km				
Number of people on board	2 + 1	No. of people injured	1 + 1	No. of people killed	1	
Synopsis

AIRCRAFT ACCIDENT REPORT

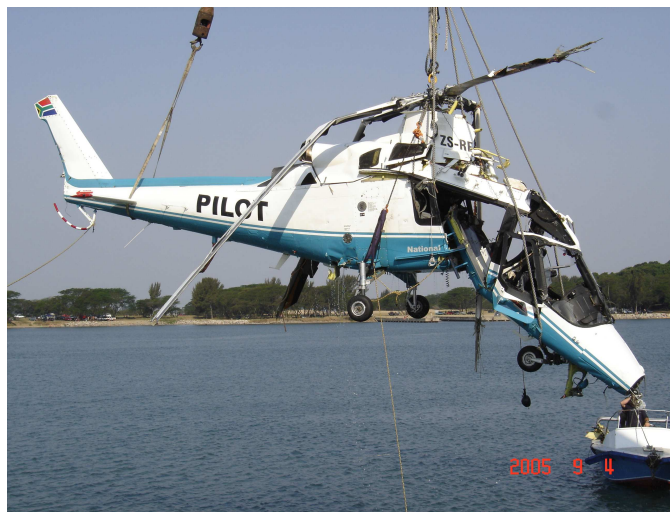
1.3.1 The helicopter was extensively damaged and found at the bottom of the sea.

A view of the wreckage being lifted out of the sea by a crane.

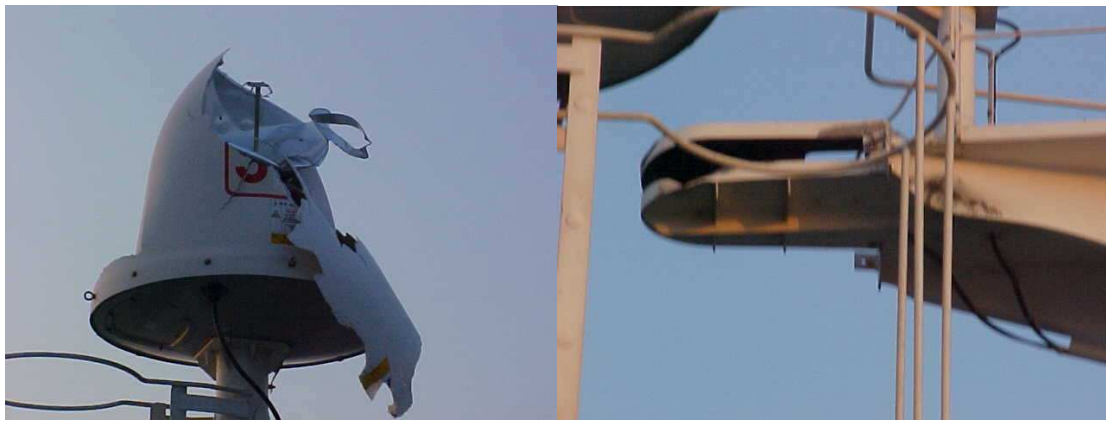
1.4.1 The cargo ship suffered some structural damage caused by several main rotor blade strikes to the structure. The Inmarsat B antenna was destroyed in the process.

The Inmarsat antenna visible on the left and the main mast impact markings visible on the right of the picture.

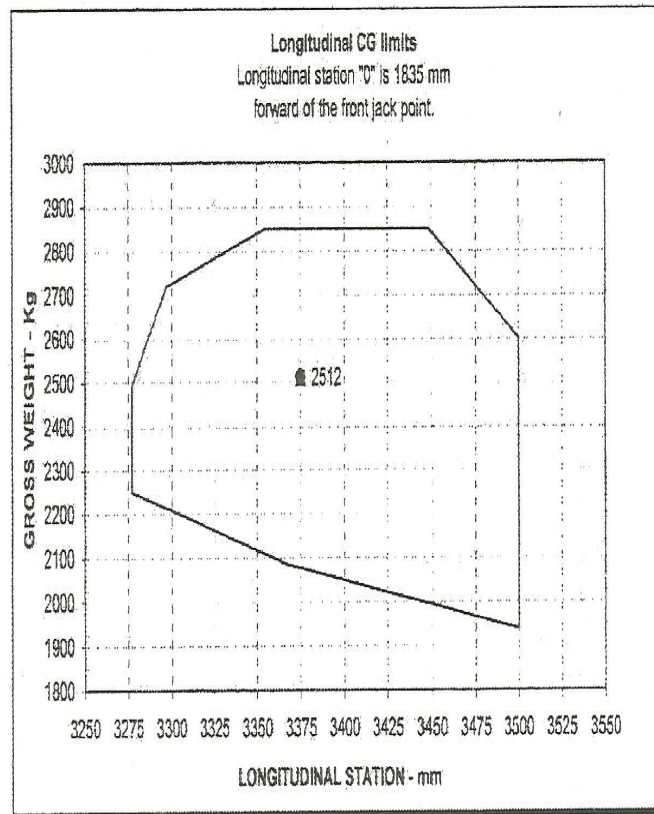
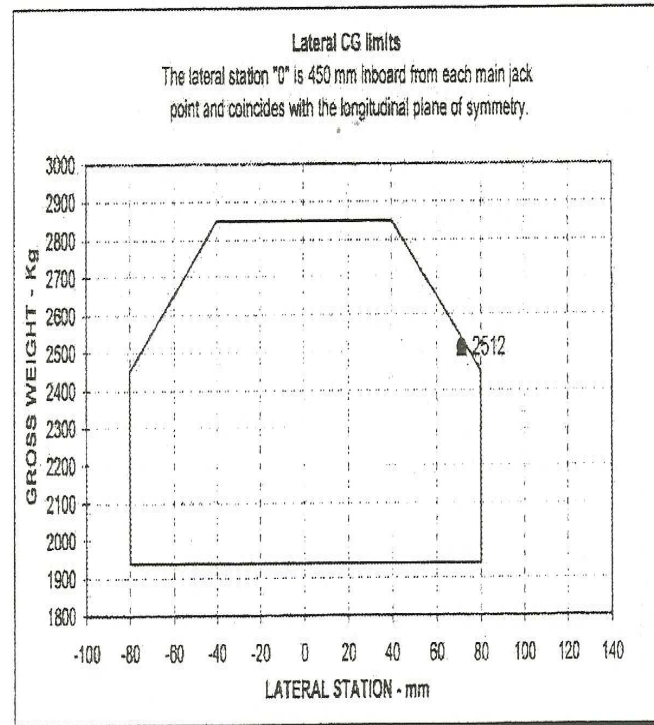
From the CG table below, it is evident that the calculated mass was well inside the

longitudinal envelope and well within limits, with the lateral table being on the edge of the allowable limit for non-hoisting operations.

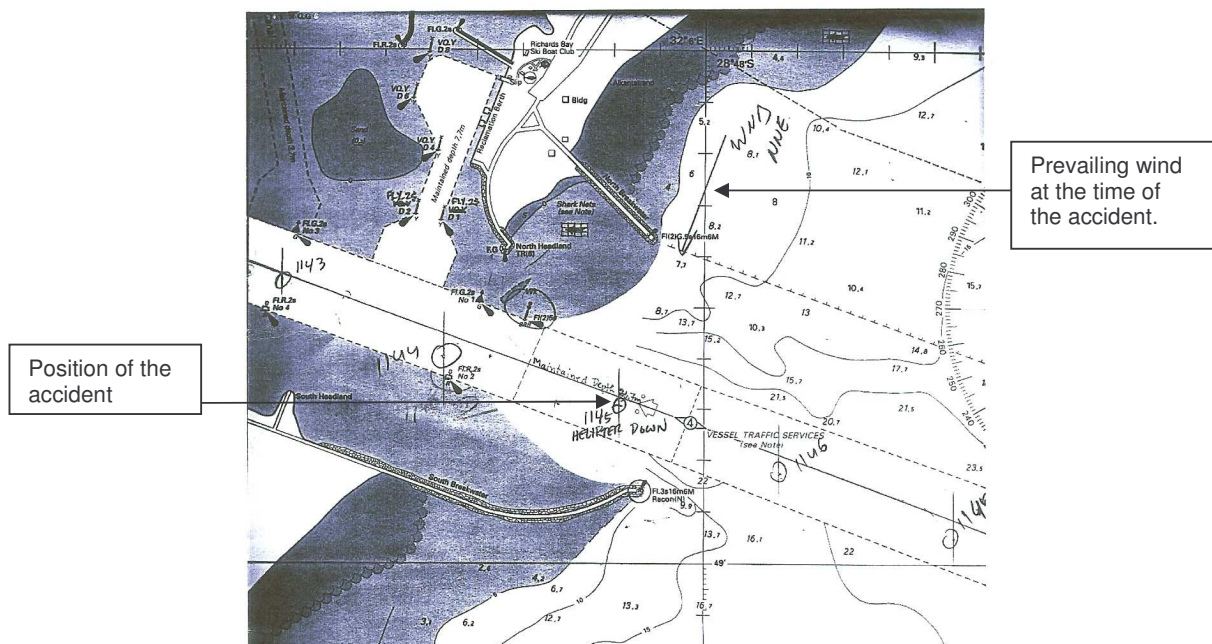
1.12.1 The right rear section of the fuselage of the helicopter from behind the main landing gear impacted with the Inmarsat B satellite communications antenna of the cargo ship. The main rotor blade contacted with the main mast five to seven metres above the antenna and impacted with various objects on the cargo ship before the helicopter ditched on the starboard side of the cargo ship. The helicopter yawed towards the right through 40° to 90° from the initial blade contact to water impact.

Illustration of accident position relative to the harbour channel.

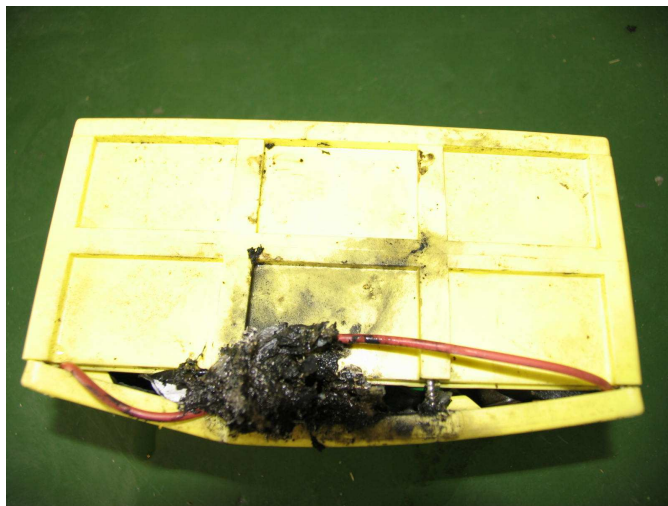
The ELT on this helicopter was located within the tail boom, as called for in Service Bulletin BT109K-41. The unit, however, was unable to survive the impact forces and was found to have burst open, as can be seen in the photo below. The activation selection button on the unit was also found to be in the off position, which rendered the unit of no value.

A view of the ELT as it was found after recovery of the wreckage.

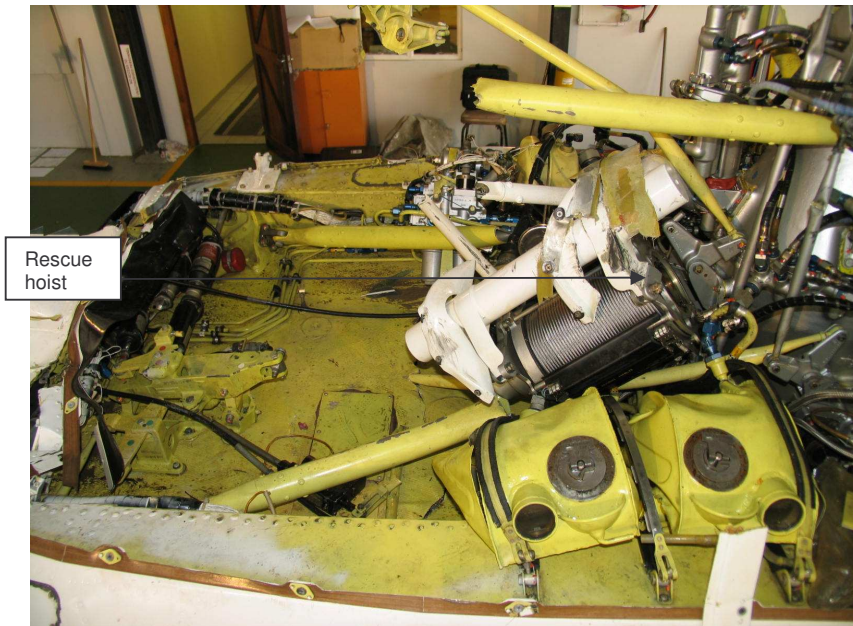
1.12.4 The rescue hoist had separated from the attachment points at some stage during the accident and was found on top of the helicopter when recovered. This was due to impact with the cargo ship or severely distorted main rotor blade impact. Two point six five metres of the cable was still unreeled. The hoist cable and hook mechanism was found undamaged.

View of rescue hoist lying on top of the roof structure of the helicopter as recovered.

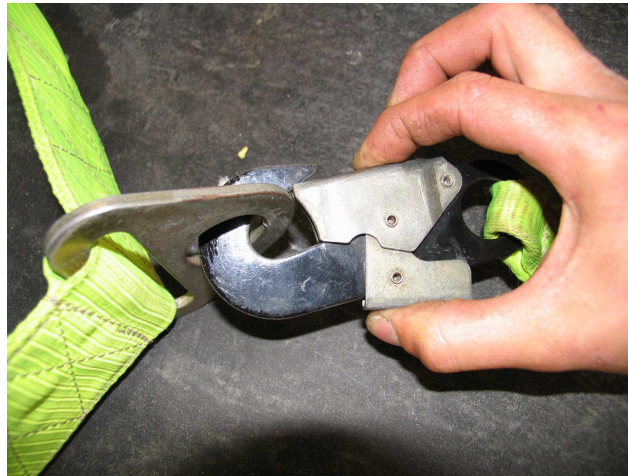
- 1.18.14 The quick release mechanism on the specific harness was located behind the hoist operator's back. It furthermore necessitates that both levers be depressed simultaneously (as can be seen in the photo below); once that was achieved it still needed to be unhooked from the harness that was secured around the person's waist before the person could be detached from the airframe.

Safety harness: quick release mechanism that was worn by the hoist operator.

The body harness (waist harness) buckle was of the insertion type and also requires time and effort before it can be released.

It is therefore recommended that the operator (and all other helicopter operators making use of the extended safety harness) comply to the same standard by making use of an approved safety harness that is equipped with a quick release mechanism that is safe and easily accessible and in the case of an emergency can be released without undue effort. The USCG (U.S. Coast Guard) would be a good
