AIRCRAFT ACCIDENT REPORT AND EXECUTIVE SUMMARY

Reference:	CA18/2/3/8021	
Aircraft Registration	ZS-KUB	Date of Accident	09 October 2005		Time of Accident	0945Z
Type of Aircraft	Maule M-5-210T (Aeroplane)		Type of Operation		Private	
Pilot-in-command Licence Type		Private	Age	50	Licence Valid	Yes
Pilot-in-command Flying Experience		Total Flying Hours	415		Hours on Type	62
Last point of departure		Krugersdorp Aerodrome (FAKR)				
Next point of intended landing		Krugersdorp Aerodrome (FAKR)				
Location of the accident site with reference to easily defined geographical points (GPS readings if possible)						
Approximately 1km North of Krugersdorp Aerodrome: GPS S26°04.51' E027°43.31'						
Meteorological Information		Surface wind, 320°/10kt, Temperature, 27°C, Clouds Nil.				
Number of people on board	1 + 1	No. of people injured	0	No. of people killed	0	
Synopsis						
<p>The pilot embarked on a pleasure flight from Krugersdorp Aerodrome (FAKR). According to the pilot, immediately after take-off the engine started to run very rough and he immediately cycled the throttle and mixture controls and set fuel selector to both tanks. The engine continued to run very rough and was not produci

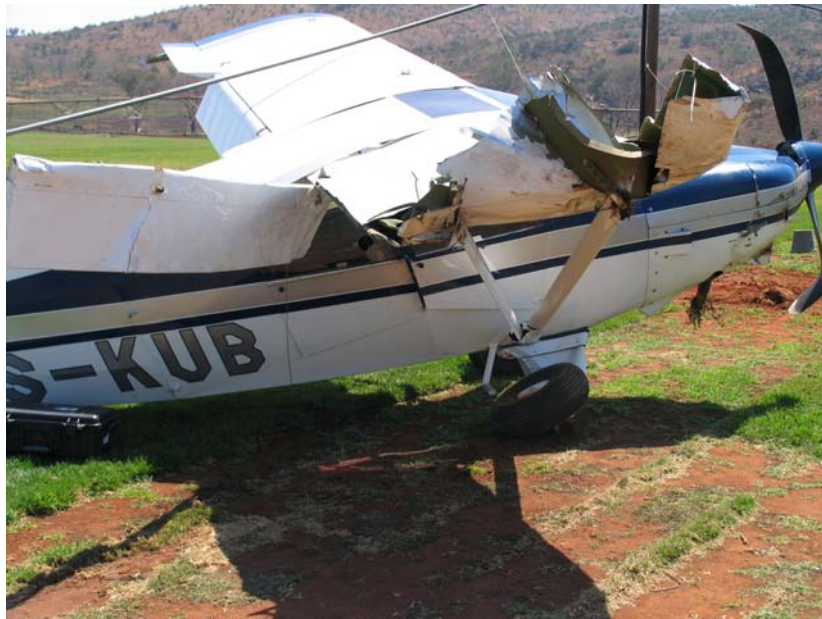
Photo 1

1.3.1 The aircraft sustained damage to the right wing, right landing gear, nose section and propeller.

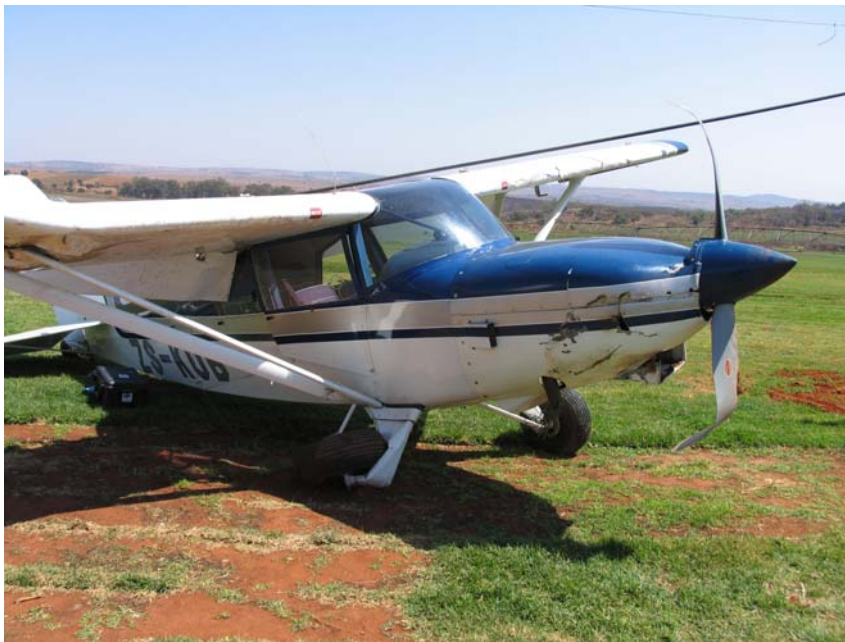
1.12.1 The aircraft approached the landing area at a fairly high speed and yawed violently to both the left and right before landing hard on the right-hand gear. This resulted in the failure of the right main gear and wing, impacting with the ground, resulting in the failure of the right out board wing. It continued for approximately 15 metres before impact with the sprinkler systems cable and pole, where it came to rest. See Photo 2 below.
