AIRCRAFT ACCIDENT REPORT AND EXECUTIVE SUMMARY

Reference:	CA18/2/3/8024	
Aircraft Registration	ZS-PIK	Date of Accident	18 October 2005		Time of Accident	1300Z
Type of Aircraft	Air-Tractor 401B		Type of Operation	Agricultural		
Pilot-in-command Licence Type		Commercial Pilot	Age	31	Licence Valid	Yes
Pilot-in-command Flying Experience		Total Flying Hours	1 299,1		Hours on Type	771,9
Last point of departure		Farm Vrede at Riviersonderend				
Next point of intended landing		Farm Vrede at Riviersonderend				
Location of the accident site with reference to easily defined geographical points (GPS readings if possible)						
14 km west of Riviersonderend in the Western Cape						
Meteorological Information		Wind: South-west at 3 to 5 knots; Temperature: 21 °C; Visibility: CAVOK				
Number of people on board	1 + 0	No. of people injured	1 + 0	No. of people killed	0	
Synopsis						
<p>The pilot, while conducting an agricultural spraying detail, was in the process of taking off after uplifting 1 200 litres of insecticide to spray a field.</p> <p>The pilot stated that he took off at an indicated air speed of 80 mph with 30° flaps on a gravel runway approximately 600 metres long. After a downwi

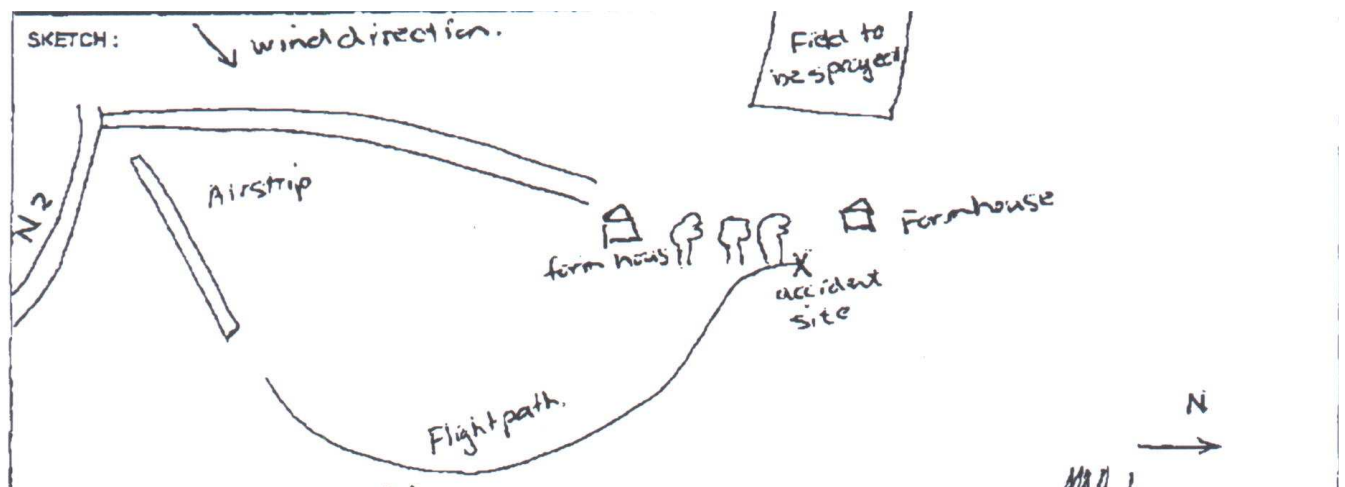
1.18.2 Sketch obtained from the pilot questionnaire indicating the flight path.

- 2.4 The pilot took off downwind on a relatively short runway (600m) with an overweight aircraft at too slow an airspeed, a situation that was aggravated by the pilot's turning the aircraft to the left after take-off. Moreover, he had to clear a stand of trees before flying to the field to be sprayed. While he was attempting to do this, the aircraft stalled and collided with the trees.
