AIRCRAFT ACCIDENT REPORT AND EXECUTIVE SUMMARY

Reference:	CA18/2/3/8055	
Aircraft Registration	ZU-DVX	Date of Accident	6 January 2006		Time of Accident	1000Z
Type of Aircraft	Ekolot JK-05 Junior		Type of Operation	Private		
Pilot-in-command Licence Type		Microlight	Age	45	Licence Valid	Yes
Pilot-in-command Flying Experience		Total Flying Hours	126.6		Hours on Type	126.6
Last Point of Departure		Saldanna-Vredenburg Aerodrome (FASD), Western Cape Province				
Next Point of Intended Landing		Saldanna-Vredenburg Aerodrome (FASD), Western Cape Province				
Location of the Accident Site with Reference to Easily Defined Geographical Points (GPS readings if possible)						
Saldanna-Vredenburg Aerodrome (GPS position: S32°57' 59" E017°8' 0"), elevation 50 ft above mean sea level (AMSL)						
Meteorological Information		According to the official weather report, fine weather conditions prevailed at the time and place of the accident.				
Number of People on Board	1 + 1	No. of People Injured	0	No. of People Killed	2

Name of Owner/Operator : Paul GG
Manufacturer : PPHU EKOLOT
Model : JK-05-Junior
Nationality : South African
Registration Marks : ZU-DVX
Place : Saldanna–Vredenburg Aerodrome
Dat

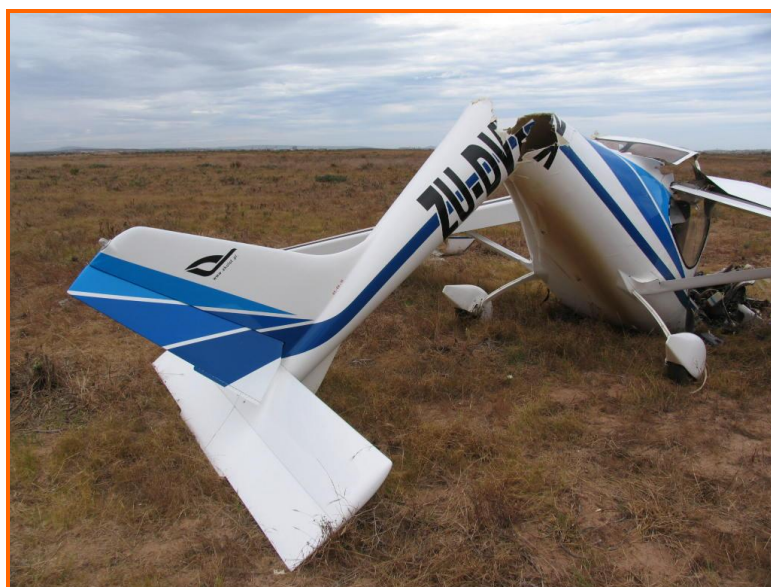
Figure 1: The main wreckage, showing the broken fuselage

1.12.2 During impact with terrain, the fuselage broke in two just behind the cabin area.

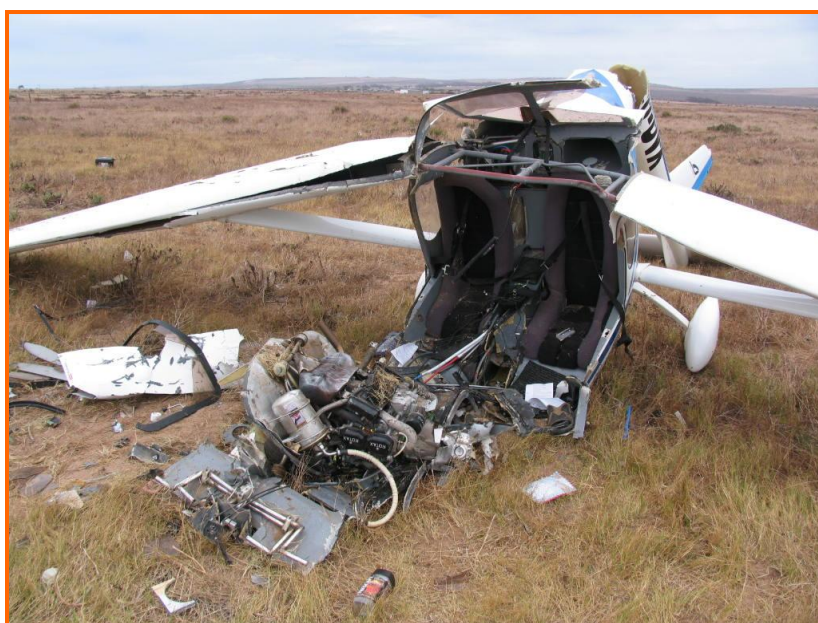
Figure 2: The main wreckage, viewed from the front

1.12.1 The aircraft drifted to the left of the runway following lift-off and nose-dived into the ground with a steep nose-down attitude, some 30 m from the runway edge.

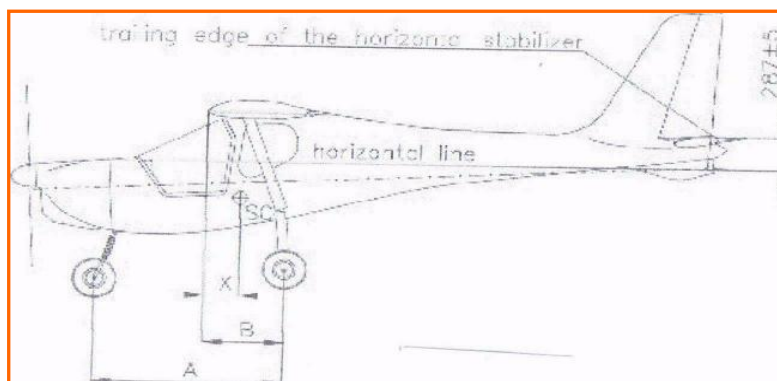
Figure 3: Diagram showing reference points on aircraft for determining mass and balance

A (mm)	1 515
B (mm)	627
X (mm)	240.4 mm
$X = B - (WN * A) / WT$	
Note	<i>X has to be between 233.4 mm and 304.3 mm</i>

Item	Weight (kg)
Empty Weight of Aircraft	301
Fuel (60 l) (Density: 1 l = 0.9 kg)	54
Pilot and Passenger (seats are side by side): Pilot = 170 kg and Passenger = 100 kg	270
Aircraft Mass at Time of Take-off	625
MTOW = 472.5 to 550 kg

From the above calculation it is clear that the aircraft was overweight by a minimum of 75 kg.

2.2 According to weight and balance calculations, the CG of the aircraft was within the prescribed limits of the manufacturer but was overloaded by at least 75 kg. The leading edge of the wing is used as a datum point when calculating the CG position of the aircraft. Both the fuel tanks, as well as the seats are situated just slightly behind the datum point. From the above, it is noted that it is not possible to exceed the limitations of the CG if the aircraft is loaded within the weight capacity of the aircraft.

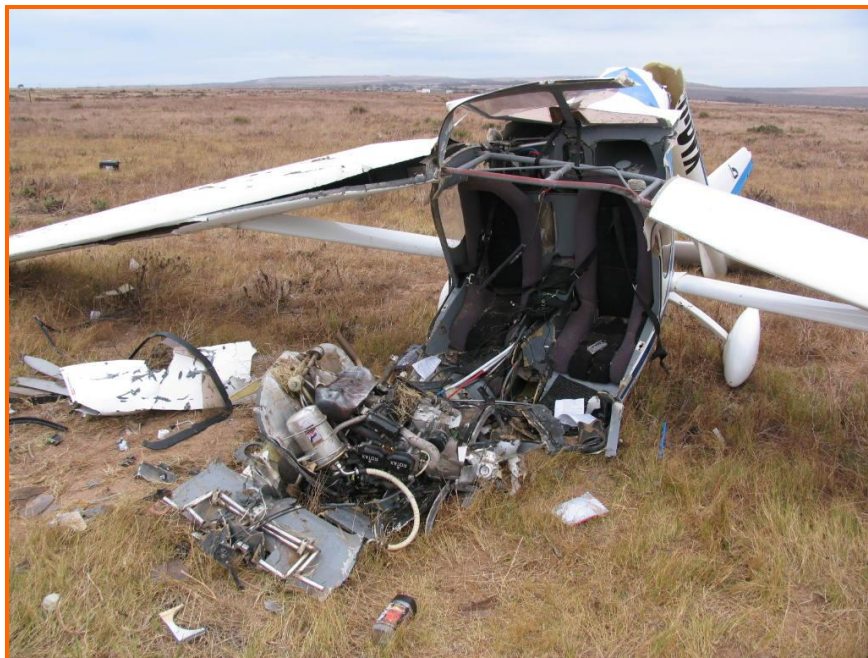
1.12.3 The cabin/cockpit area was destroyed during the accident sequence.

Figure 4: The cabin/cockpit area was destroyed during the accident sequence

1.15.1 The severity of the impact, as illustrated by the severe break-up of the cockpit area, rendered this accident to be unsurvivable.

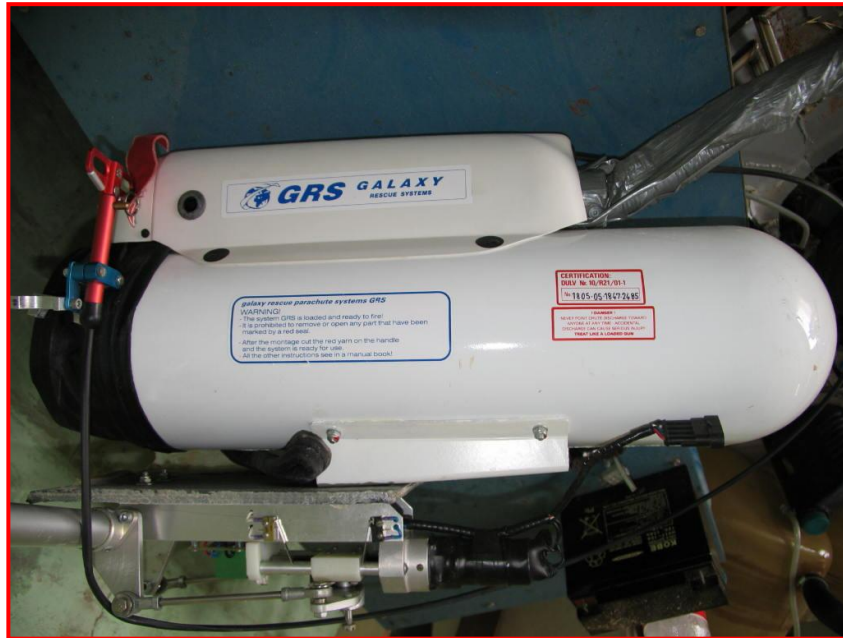
1.12.5 The aircraft was equipped with a ballistic parachute but the parachute was not activated, although serviceable.

Figure 5: The ballistic parachute fitted to the aircraft

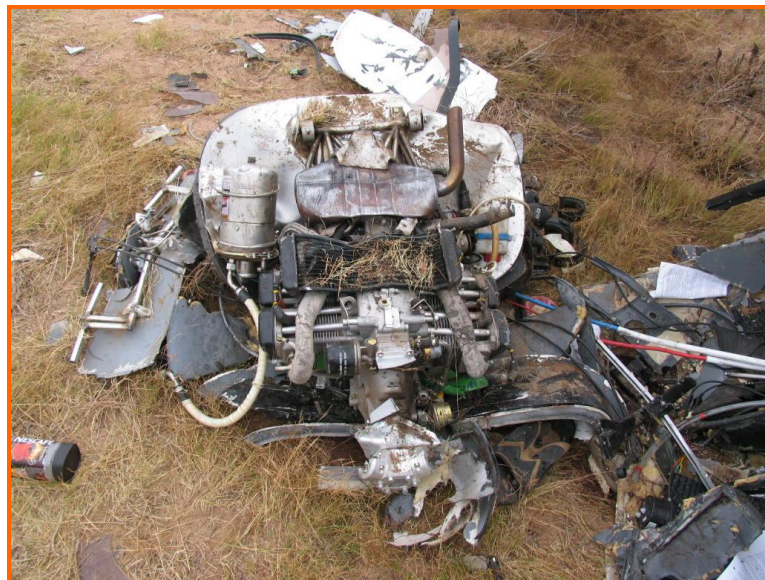
1.16.1 Due to extensive impact damage, it was not possible to perform a bench test on the engine. A partial teardown inspection of the engine revealed no mechanical reasons that could have caused the engine to fail during the take-off.

Figure 6: The engine directly ahead of the main wreckage

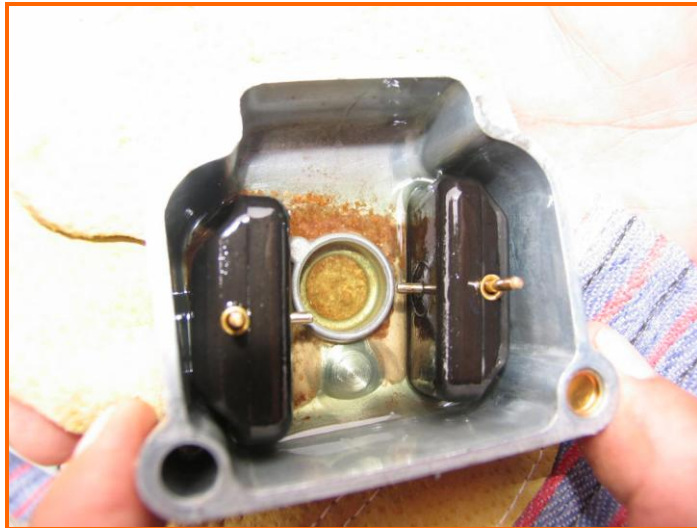
1.16.2 Examination of the fuel system revealed severe contamination in the carburettor fuel bowls and inside the fuel tank.

Figure 7: Contamination in the carburettor fuel bowl

3.2.1 The aircraft failed to gain height because the engine failed to produce full power during take-off due to fuel contamination.

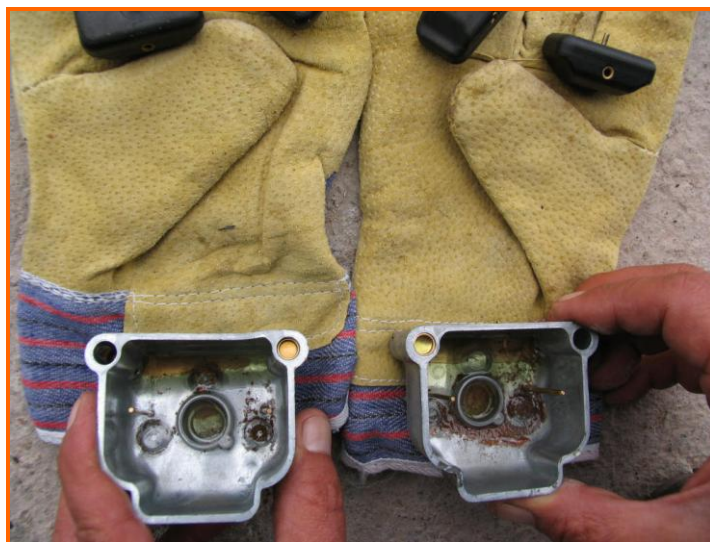
Figure 8: The carburettor fuel bowls, showing severe contamination

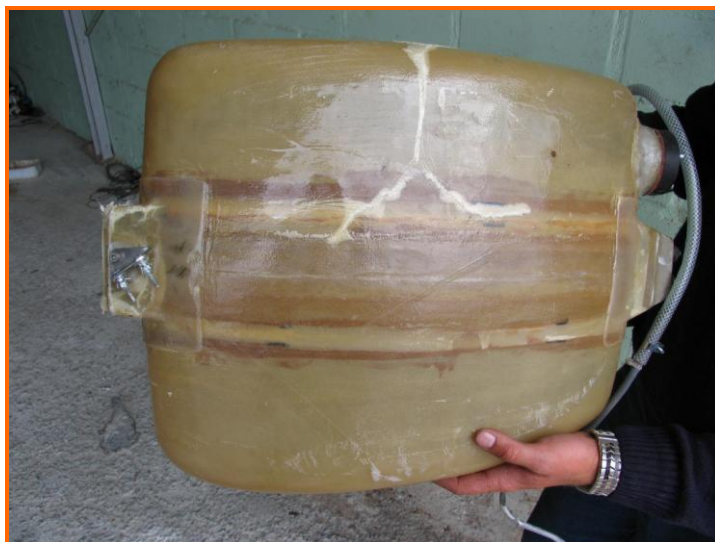
Figure 9: The fuel tank, showing contamination inside.

- 3.1.9 The aircraft examination revealed that the fuel system of the aircraft was severely contaminated.
