## AIRCRAFT ACCIDENT REPORT AND EXECUTIVE SUMMARY

Reference:	CA18/2/3/8097	
<b>Aircraft Registration</b>	ZU-ACF	<b>Date of Accident</b>	2 April 2006		<b>Time of Accident</b>	0840Z
<b>Type of Aircraft</b>	Kitfox iv		<b>Type of Operation</b>	Private		
<b>Pilot-in-command Licence Type</b>		Private	<b>Age</b>	37	<b>Licence Valid</b>	No
<b>Pilot-in-command Flying Experience</b>		Total Flying Hours	176.2		Hours on Type	31.2
<b>Last point of departure</b>		Bela-bela (Warmbaths), Limpopo Province: FAWA				
<b>Next point of intended landing</b>		Kitty Hawk Aero Estate Aerodrome, Gauteng Province: FAKT				
<b>Location of the accident site with reference to easily defined geographical points (GPS readings if possible)</b>						
GPS position S 24° 56.359' E028° 17.948', near the town of Bela-bela (Warmbaths)						
<b>Meteorological Information</b>		Clear skies were reported with light and variable wind conditions and the temperature at approximately 25°C at the time and place of the accident.

**Name of Owner/Operator**    : Pretorius P.S.  
**Manufacturer**                : Skystar Aircraft Company  
**Model**                         : Kitfox iv  
**Nationality**                 : South Afri

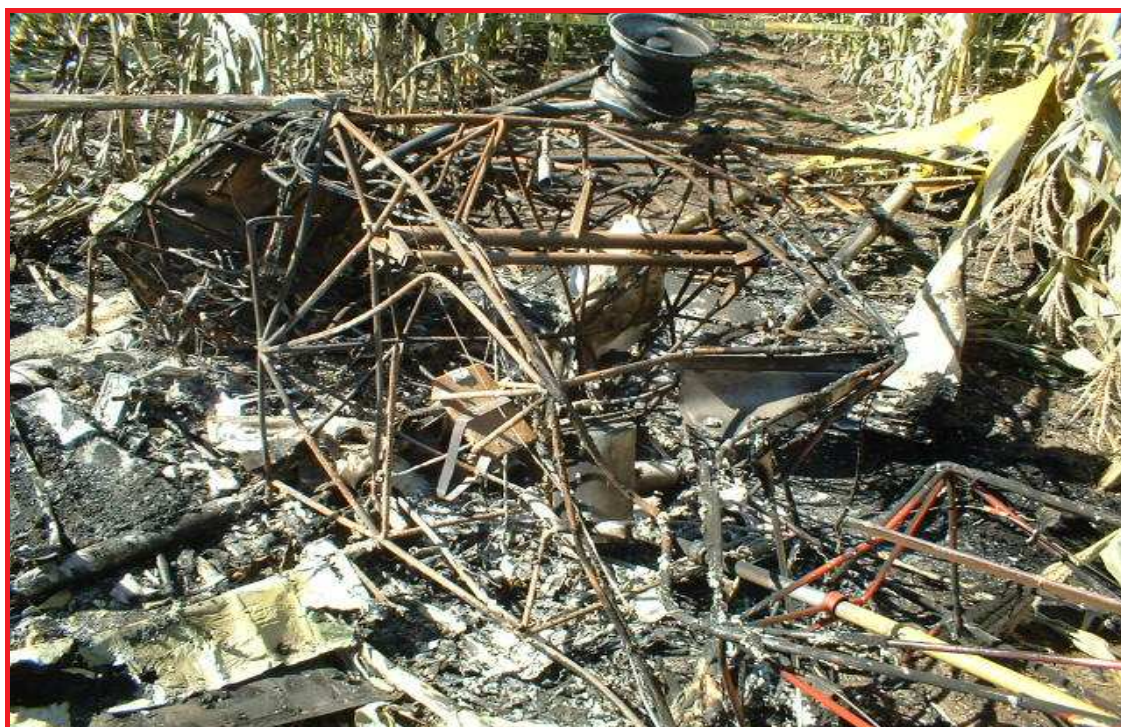
1.3.1 The aircraft was destroyed by the impact forces and the post-impact fire.

Fig 1: Above are the remains of the aircraft after the impact and the ensuing fire.

1.12.1 Evidence on the site indicated that the aircraft impacted with the terrain on a heading of 102°M in a steep nose-down configuration with the right wing low. This is indicative of entering a spin manoeuvre from which the pilot was unable to recover.

1.12.2 A post-impact fire erupted, destroying the aircraft and causing minor damage to the immediate vegetation around the initial impact point.

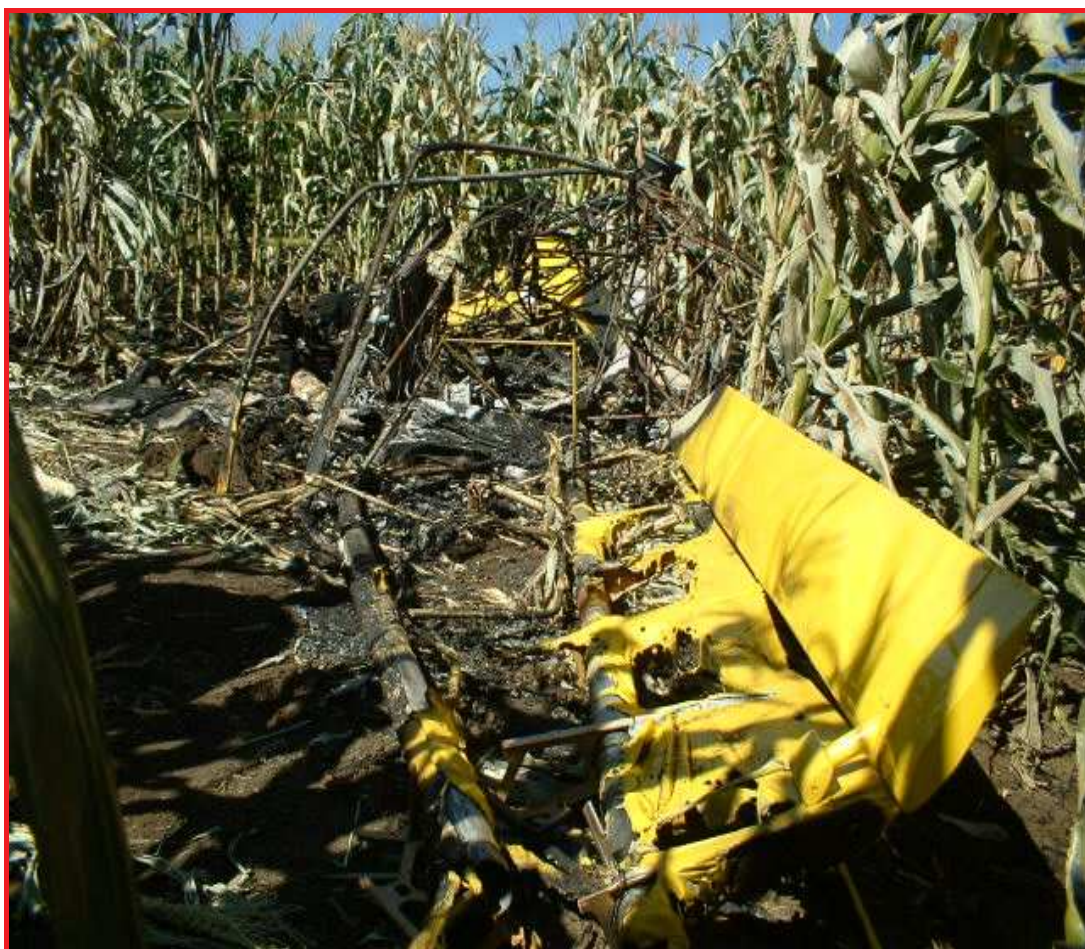
**Fig 3:**  
*Minor damage was caused to the immediate vegetation around the initial impact point.*
