# THE DUTCH SAFETY BOARD

**Occurrence number:** 2006062

**Classification:** Serious incident

| Sort of occurrence: | Wing tip strike during landing | Cockpit crew: | 2 |

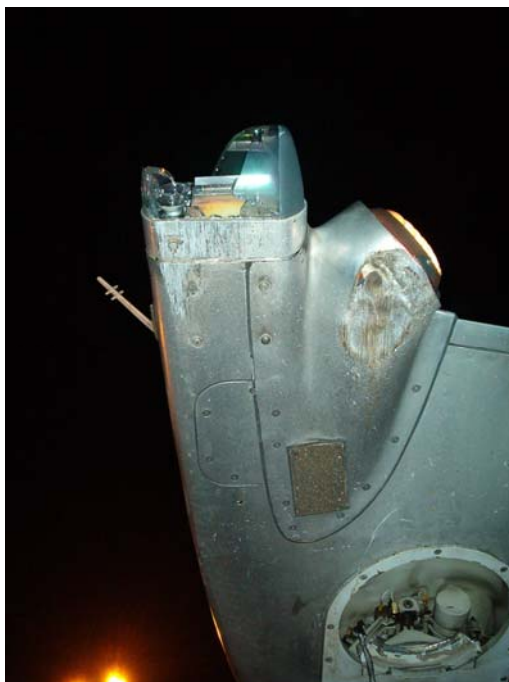
Post flight inspection of the aircraft by the Alitalia ground technician on the apron revealed that the left wing tip of the MD-80 was damaged.

*Damage of the left wing tip*

The data of the FDR confirmed the statement of the PF. During the last 20 seconds of the approach the aircraft flew with a side slip and had a roll angle between approximately 1° and 6° to the right and a corresponding aileron and rudder position (left aileron down, left rudder). The data showed also that during the landing manoeuvre (3 seconds before touchdown) left rudder input increased and left aileron went to neutral. As a result the aircraft rolled to the left. Left rudder input was probably applied to align the aircraft with the runway direction. Such an alignment introduces a positive sideslip angle to the right and corresponding rolling moment to the left which results in a roll acceleration and roll angle to the left if not adequately compensated for through an aileron deflection. The tendency to roll to the left may have been amplified by a wind gust from the right, increasing the side slip angle and the rolling moment to the left. The maximum left roll angle reached was 10,6°. At the same time during the landing flare the pitch angle reached a maximum value of 5° ANU attitude. The FDR data show that the left roll attitude was corrected by a right deflection of the ailerons. Flight manual data confirmed that this combination of pitch and bank angles during the landing flare will lead to wingtip contact with the runway.
