AIRCRAFT ACCIDENT REPORT AND EXECUTIVE SUMMARY

| | | | | Reference: | CA18/2/3/8147 | |
| Aircraft Registration | ZS-EVB | Date of Accident | 20 June 2006 | Time of Accident | 1650Z | |
| Type of Aircraft | Piper Comanche | | Type of Operation | Test flight | | |

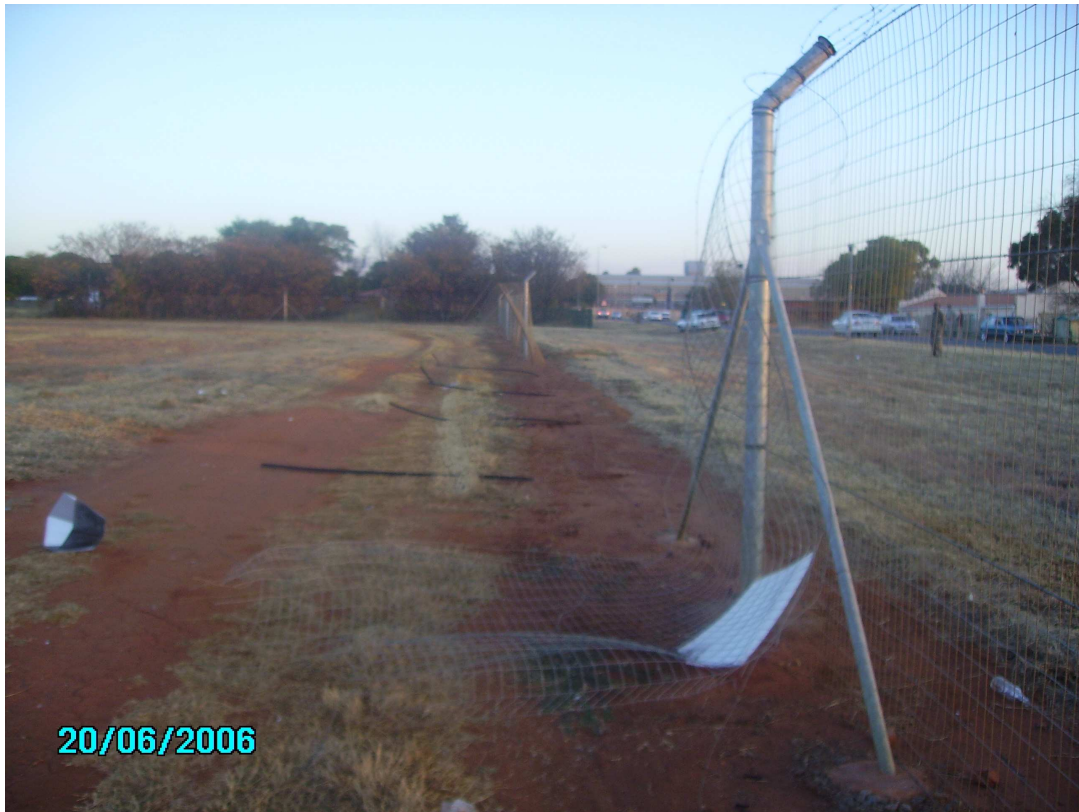
- 1.12.1 On final approach the right-hand engine lost power, followed by the left-hand engine. The pilot elected to execute a forced landing. On approach for landing on Runway 11, the aircraft struck a streetlight which was approximately 25m from the initial mark. The aircraft continued on its flight path and the main landing gears impacted a fence and the aircraft turned 180 degrees and continued skidding for some 35 meters before coming to a halt. The aircraft sustained extensive damages to the propellers, wings and the undercarriage.

Figure 1. Damage to the boundary fence of the airport.

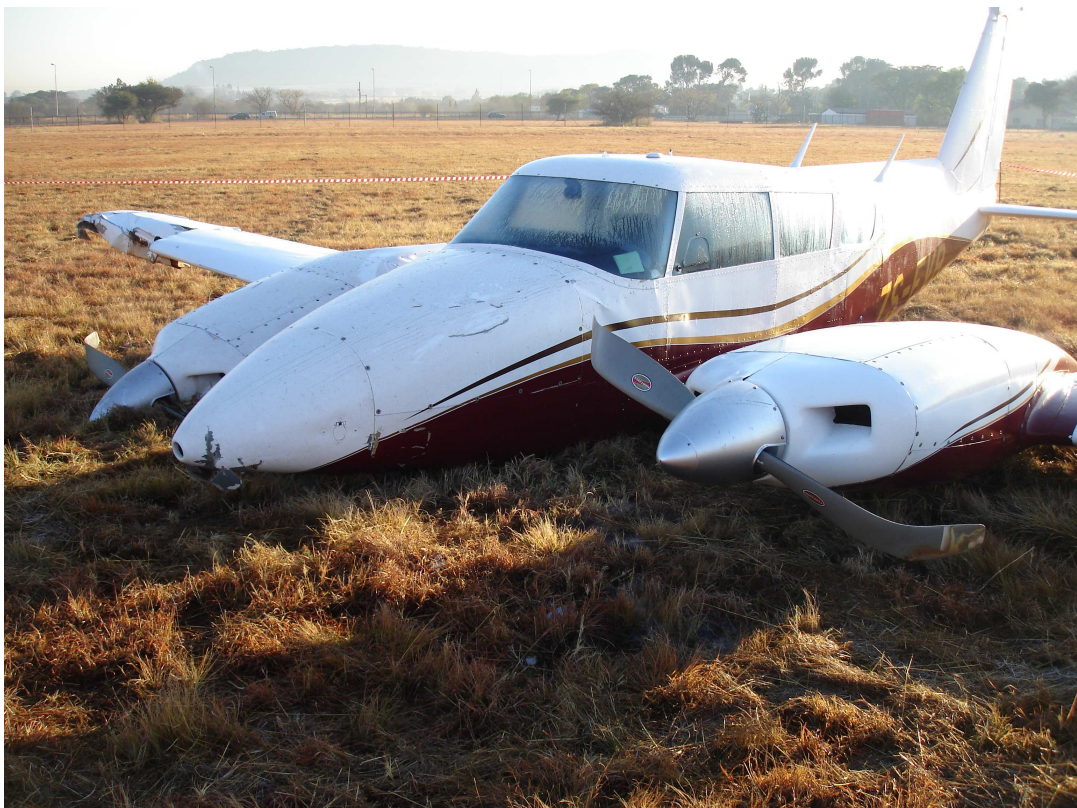
1.3.1 The aircraft sustained extensive damage to the propellers, wings and undercarriage.

Figure 2. The aircraft after the accident.

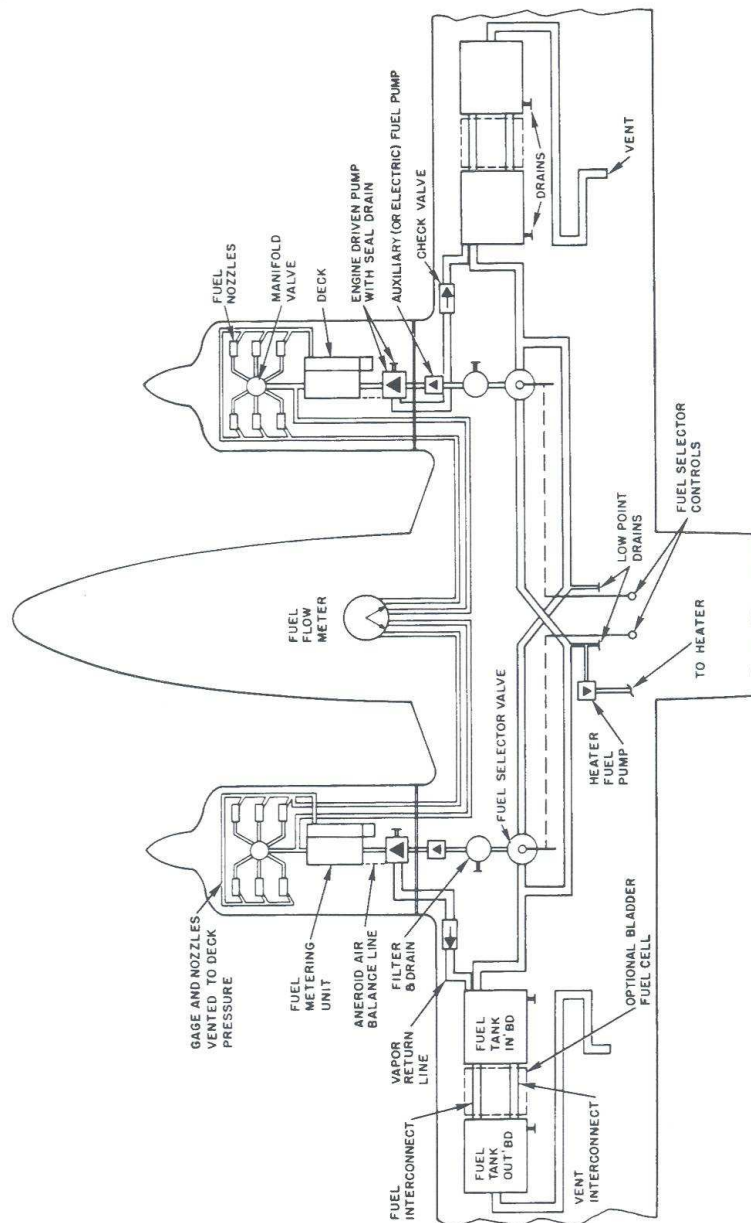
1.16.1 According to the report from the aircraft maintenance organisation suggest that during the repairs it was found that both selectors were leaking between the main and auxiliary positions, even when the selectors were in the OFF position. It was discovered that a previous aircraft maintenance engineer had adjusted the timing of the selectors, causing "CAM" of the selector to push against two ball bearings at the same time. Each selector has got one of these balls that spring loaded sealing the hole in the selector when selecting the main, the "CAM" push against the ball and opens the fuel. By changing the timing of the selector it caused to open both main and auxiliary simultaneously.

Figure 3. Schematic diagram of the fuel system.
