AIRCRAFT ACCIDENT REPORT AND EXECUTIVE SUMMARY

Reference:	CA18/2/3/8154	
Aircraft Registration	ZS-CKH	Date of Accident	23 July 2006		Time of Accident	1500Z
Type of Aircraft	Piper PA24-250		Type of Operation	Private		
Pilot-in-command Licence Type	Private	Age	48	Licence Valid	Yes	
Pilot-in-command Flying Experience	Total Flying Hours	816.47		Hours on Type	Unknown	
Last point of departure	Worcester Aerodrome, Western Cape (FAWC)					
Next point of intended landing	Grabouw Private Aerodrome, Western Cape					
Location of the accident site with reference to easily defined geographical points (GPS readings if possible)						
Mountainous terrain in Grabouw, GPS co-ordinates: S 34 ^o 07.877' E 019 ^o 05.882', elevation 2513 ft						
Meteorological Information	Rain, Cloud base: 500ft and misty.					
Number of people on board	1 + 0	No. of people injured	0	No. of people killed	1	
Synopsis	<p>On 23 July 2006, the aircraft took off from Worcester Aerodrome on a private flight to Grabouw Private Aerodrome. When the aircraft did not land as planned, a search mission was launched. The wreckage of the aircraft was found in the mountains the next day. The pilot was fatally injured in the accident.

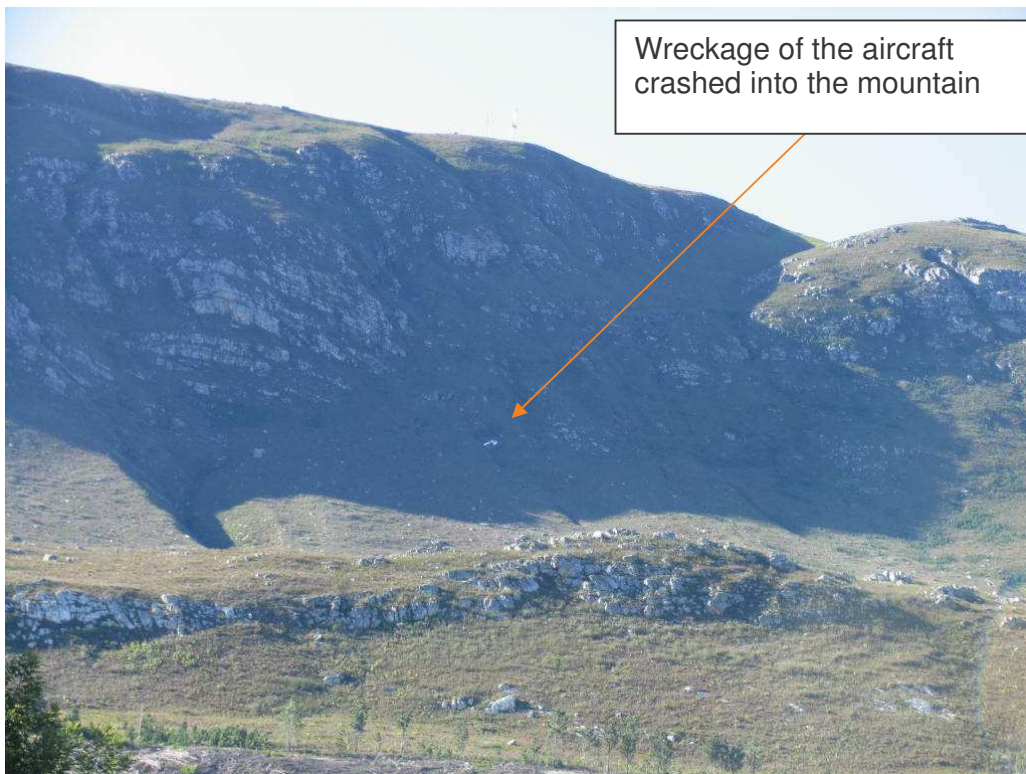
1.1.4 The next morning, when the weather had cleared, wreckage of the aircraft was found crashed into the mountain. The pilot was fatally injured in the accident. The GPS co-ordinates of the accident site were determined to be S 34° 07.877' E 019° 05.882', at an elevation of 2519 ft.

Figure 1: The accident site

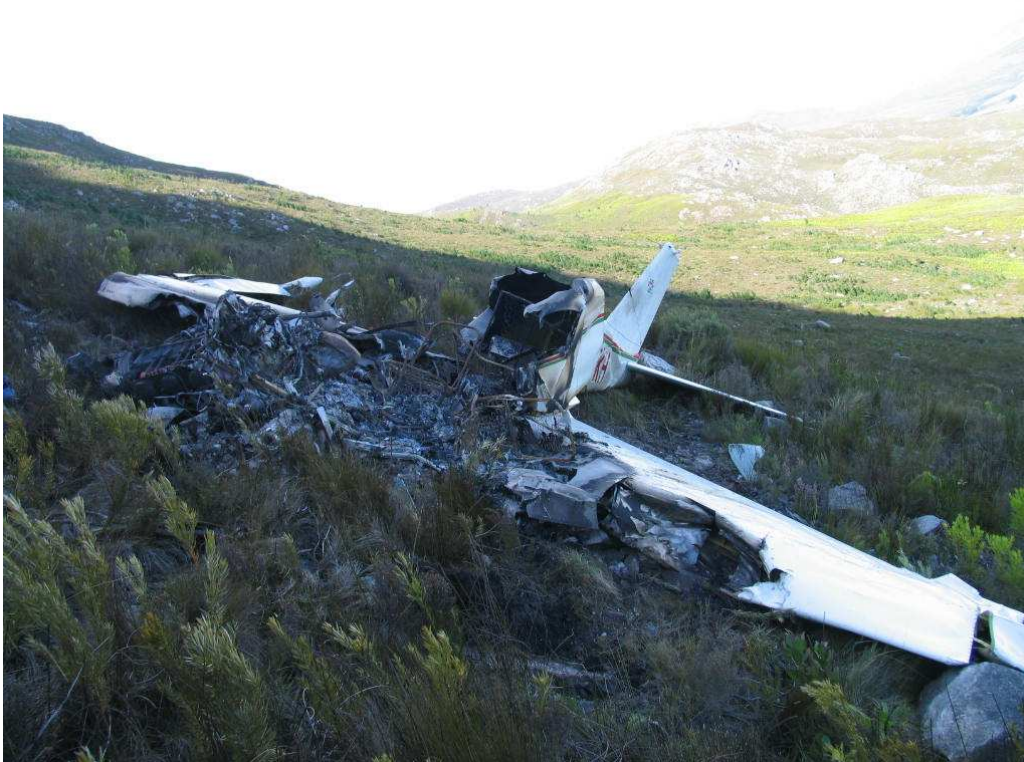
1.3.1 The aircraft was destroyed by post-impact fire.

Figure 2: Damage to the aircraft

1.12. The aircraft impacted the mountainside in a straight and level attitude. The nose section impacted first, then both wings collided with rocks, followed by eruption of a post-impact fire. The aircraft was consumed by the fire.

1.14.1 A post-impact fire erupted. The source of the fire was determined to be the fuel tank rupturing and fuel coming into contact with the hot engine, resulting in fire ignition.

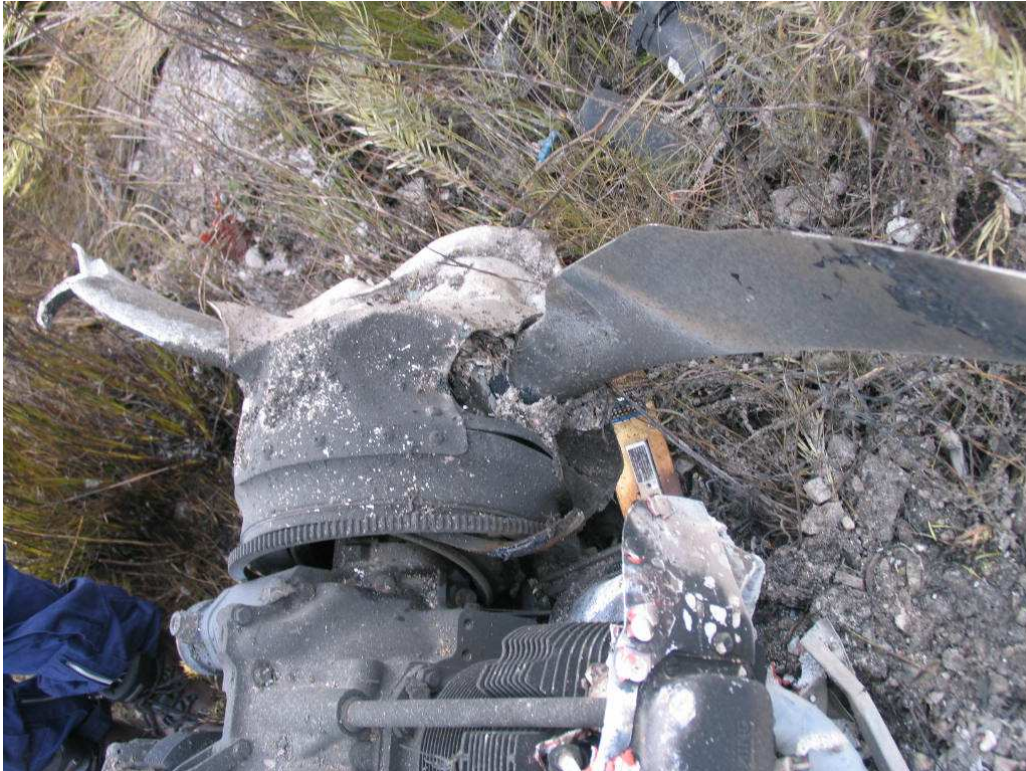
1.16.2 An assessment of the propeller indicated that the aircraft engine had full power when it collided with the mountain.

Figure 3: The propeller damage
