AIRCRAFT ACCIDENT REPORT AND EXECUTIVE SUMMARY

| | | | | Reference: | CA18/2/3/8179 | |
| Aircraft Registration | ZU-CYI | Date of Accident | 22 September 2006 | | Time of Accident | 1452Z |
| Type of Aircraft | L-29 Delphin (Aeroplane) | | Type of Operation | | Private | |

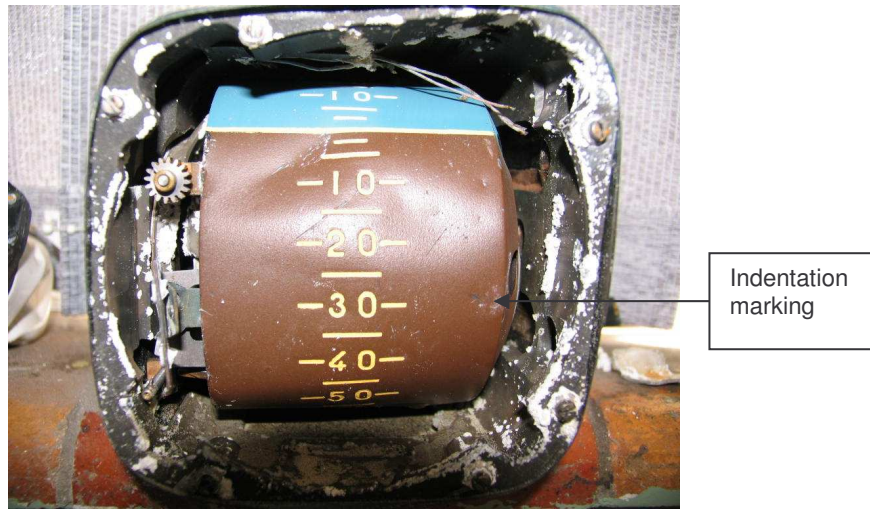
Figure 1: Artificial horizon indicator that was recovered from the sea.

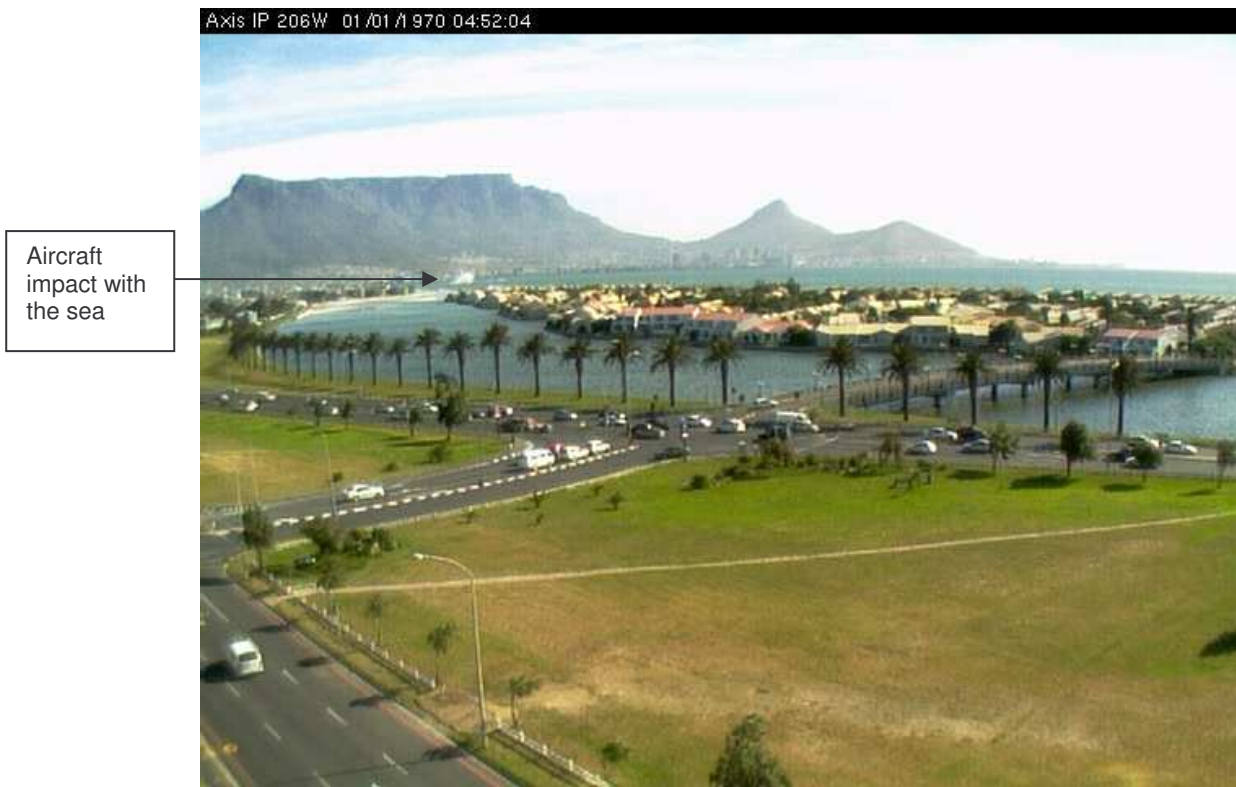
The only piece of video footage that was gathered in this investigation displaying the impact was obtained from a security surveillance camera, which recorded low-resolution colour images in a timed sequence. The camera was located on top of a building in Milnerton, which was a considerable distance away. Apart from the actual impact with the sea, seen as a massive water splash, it was not possible to draw any conclusions from the footage.

Figure 2: A surveillance video camera located on top of a building in Milnerton recorded the impact.

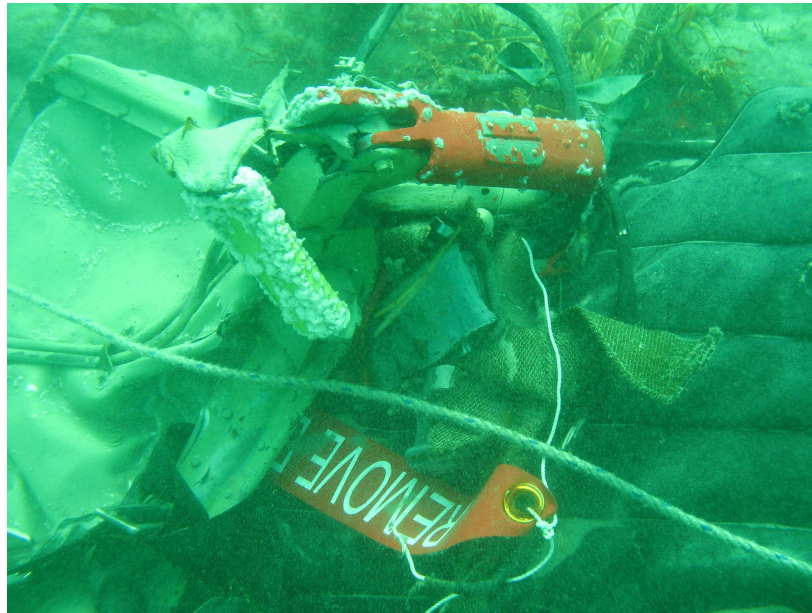
1.12.3 The pilot's ejection seat was armed for the flight, which imposed a hazard for any person who might have wanted to disturb the seat following impact, as the pilot did not eject from the aircraft prior to impact. The assistance of a special dive unit from the South African Navy was acquired to disarm both ejection seats prior to the continuation of any underwater recovery work.

Figure 4: Underwater photo of the aft cockpit ejection seat with some of the pins still secure.

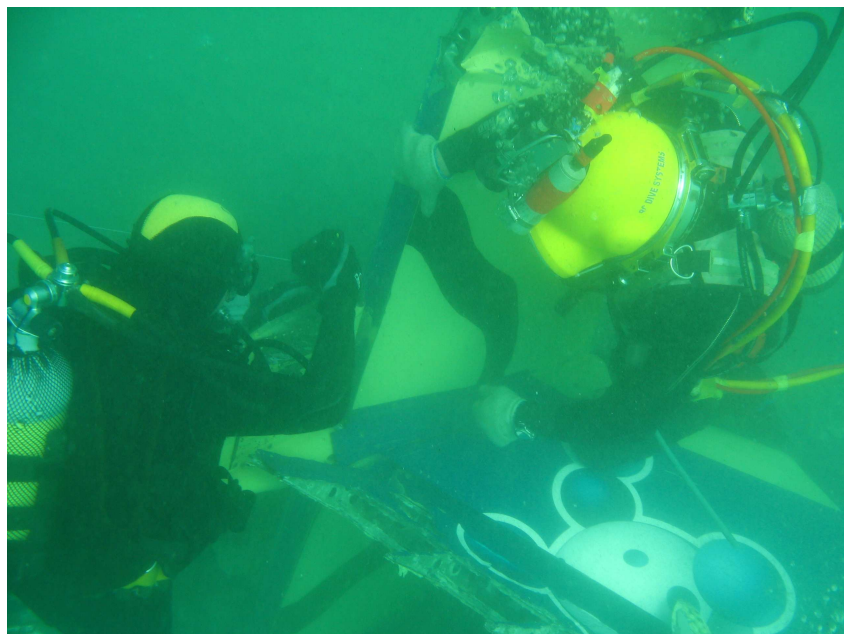
Figure 5: Divers preparing the empennage section for recovery.

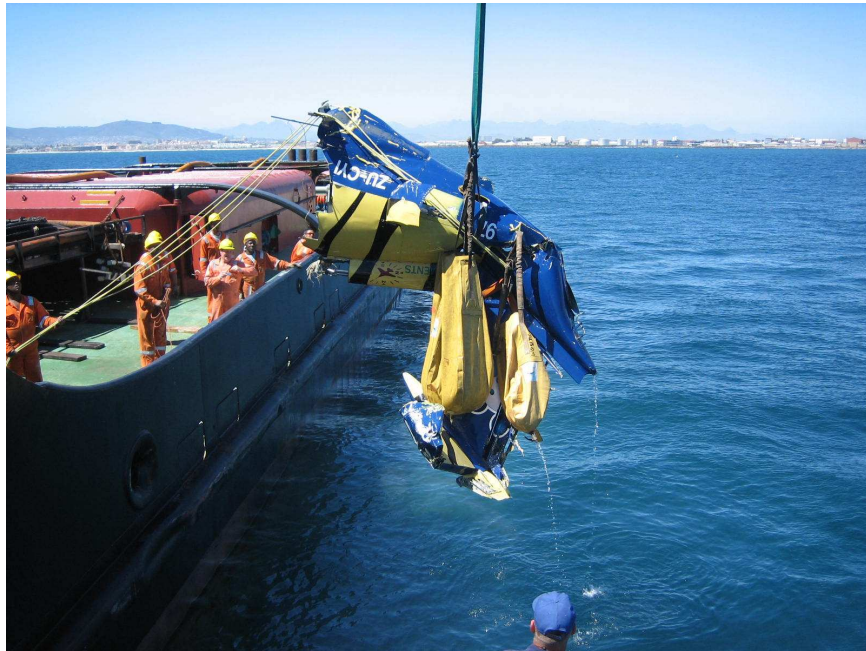
Figure 6: Recovery of the empennage section from the water onto the support vessel.

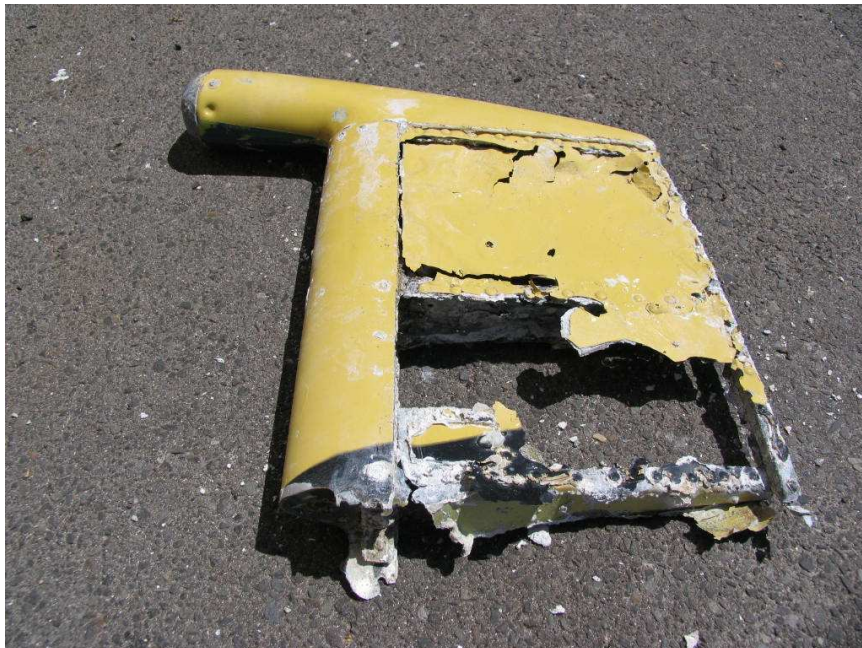
1.12.5 Following recovery of the debris, everything was rinsed with fresh water and allowed to dry properly before it was secured in a demarcated area. Approximately 90% of the aircraft was recovered, with the majority of missing pieces originating from the nose and cockpit areas. All the flight control surfaces as well the dive breaks/spoilers were accounted for, although they were severely distorted and compressed due to impact and subsequent corrosion.

Figure 7: The outer section of the left elevator distorted by corrosion.

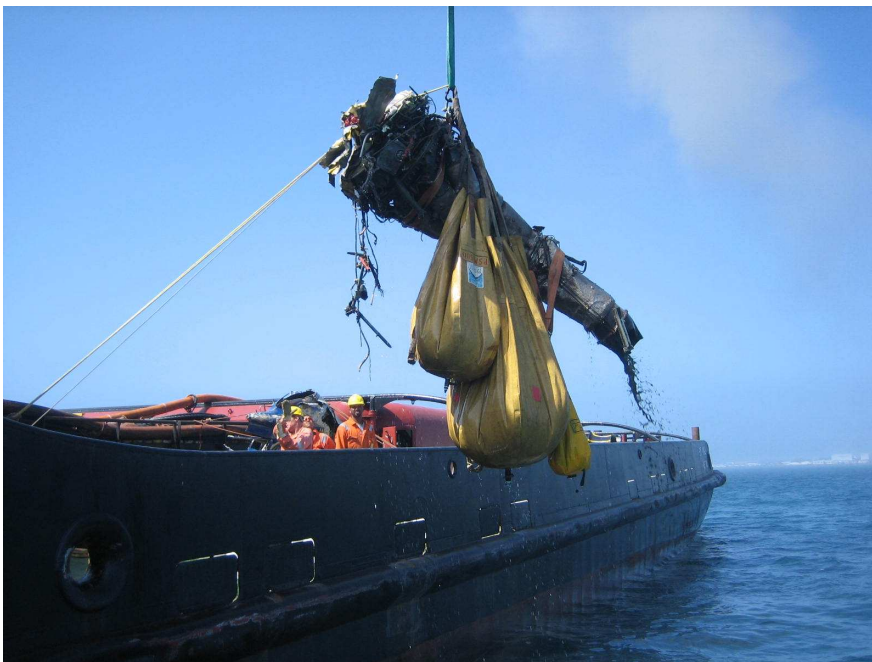
Figure 8: The engine being lifted by crane from the sea onto a special recovery vessel (ZTUG).

The engine teardown procedure did not reveal any mechanical defect that could be

associated with an engine malfunction inflight that would result in this accident.
