AIRCRAFT ACCIDENT REPORT AND EXECUTIVE SUMMARY

Reference:	CA18/3/2/0521	
Aircraft Registration	ZS-MNJ	Date of Incident	30 September 2006		Time of Incident	0930Z
Type of Aircraft	Piper PA 34		Type of Operation	Private Flight		
Pilot-in-command Licence Type		Private Pilot	Age	55	Licence Valid	Yes
Pilot-in-command Flying Experience		Total Flying Hours	256.8		Hours on Type	130.4
Last point of departure		Rand Aerodrome (FAGM)				
Next point of intended landing		Lanseria Aerodrome (FALA)				
Location of the incident site with reference to easily defined geographical points (GPS readings if possible)						
At Lanseria Aerodrome, on the grass to the left side of Runway, S 25°56.451 E 027°55.416						
Meteorological Information		Wind direction: 360°/8 kts, Visibility: Clear Skies, Temperature: 20°C.				
Number of people on board	1 + 3	No. of people injured	0		No. of people killed	0
Synopsis						
<p>The pilot was engaged on a private flight in daylight conditions from Rand Aerodrome to Lanseria Aerodrome. After take-off, the pilot retracted the undercarriage, but the right hand main gear failed to retract. The pilot then recycled the undercarriage with the normal system and extended it aga

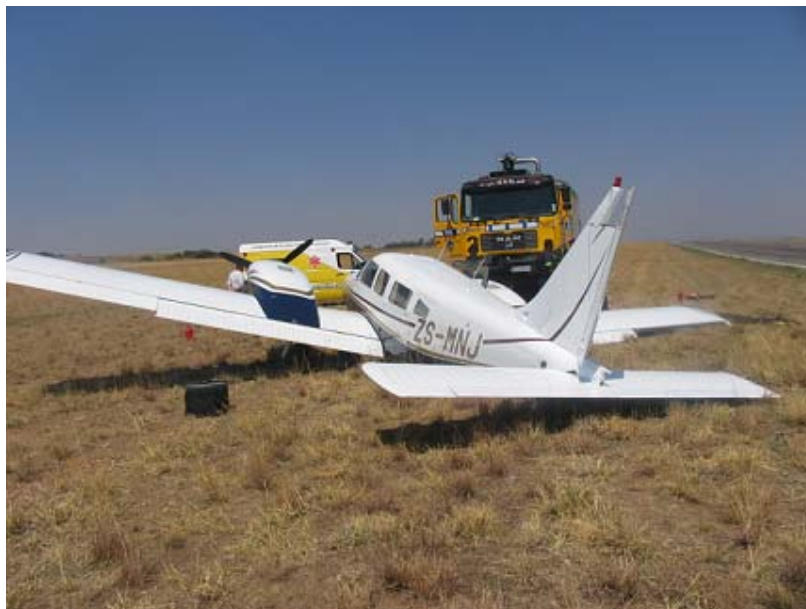
R/H main gear collapsed after landing

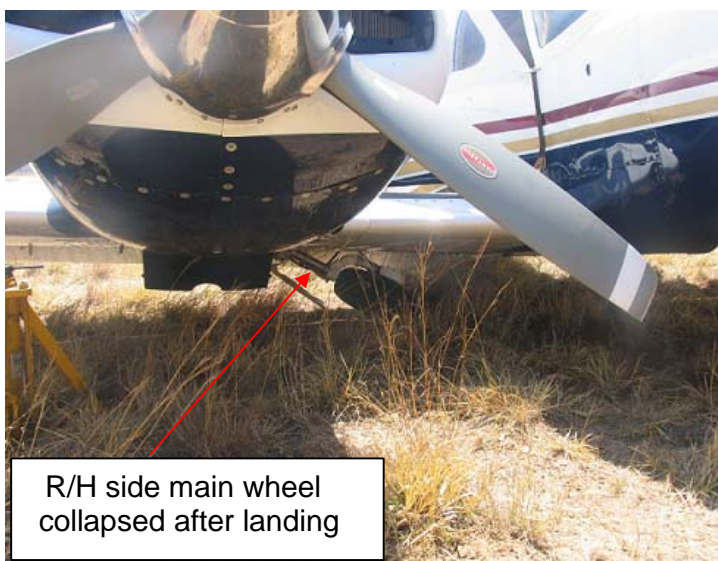
1.12.1 When the aircraft landed on Runway 06L, the right-hand side main gear collapsed and the aircraft veered off the runway onto the grass. The location of the wreckage was found at Lanseria Aerodrome, GPS co-ordinates reading: S 25°56.451 E 027°55.416. The aircraft was still intact at the accident site. The damage caused was to the bottom skin of the right-hand side wing and main gear.

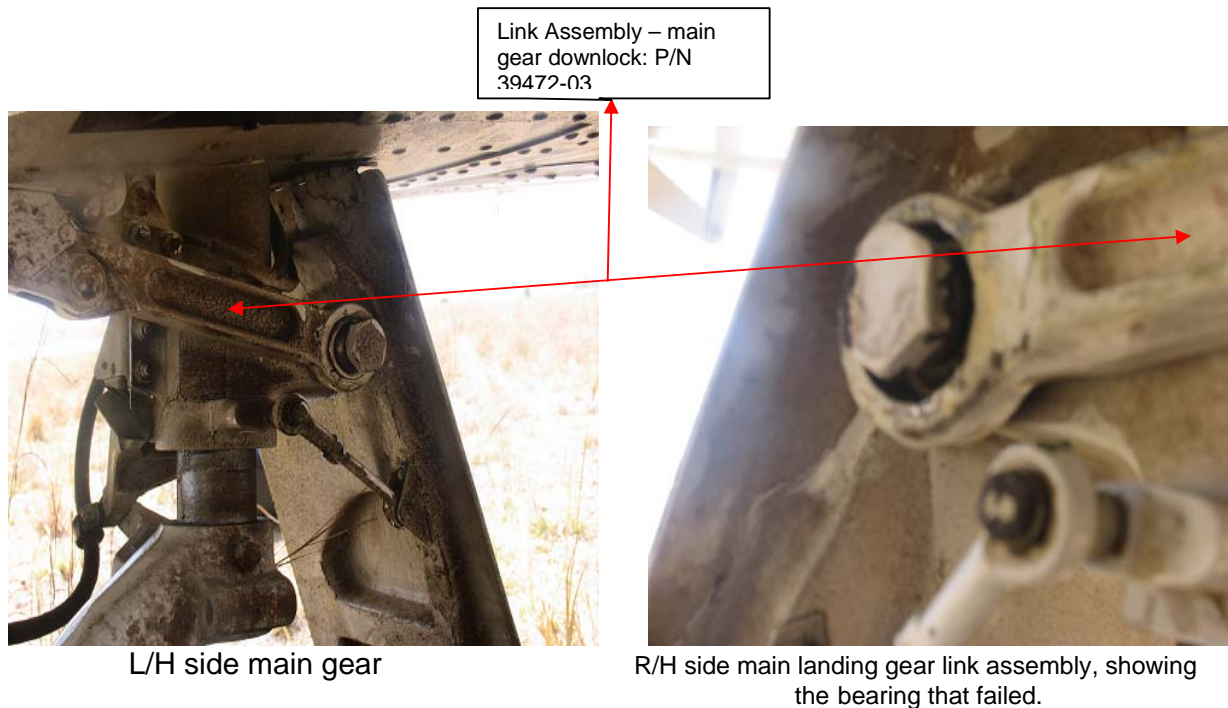
1.16.1 The aircraft was lifted on jacks and the undercarriage was examined. The evidence found showed that the following parts; Bearing: P/N 452793, x2 Bushings – tapered, truss assembly: P/N 39487-02 of the Link Assembly were worn to the limit, which resulted in the Link Assembly installation of the Gear Assembly – main, right: P/N 39484-09 to move over the Bolt: P/N 402978. (See photo below)

1.6.3 1.16.2 The maintenance requirement of the identified parts was determined to be “on condition”. Such a categorization would only require a visual inspection of the part during the inspection. Corrective action would then only be taken if mechanical defect or malfunction was detected. However, it appears as if the fact that the bearing had worn to beyond safe limits, was not noticed. It is also a normal practise to expect pilots to check undercarriage linkages during the preflight inspection.

- 2.2 During the onsite investigation and recovery of the wreckage, evidence showed that the Link Assembly – main gear downlock mechanism of the right-hand side main gear had failed; due to the link assembly bearing that was worn beyond safe limits. The link assembly installation became inoperative, resulting in the right-hand side main gear not retracting and extending properly.

4.1 Commissioner should require the Airworthiness Department of the SACAA to review the adequacy of the current inspection requirements and guidance material in respect of on condition parts to Aircraft Maintenance Organizations

4.2 It is recommended that the SACAA publish an article in the Safety Link magazine stressing the importance of verifying the servicability of undercarriage on condition items, such as linkages, during inspections, as well as during a preflight
