AIRCRAFT ACCIDENT REPORT AND EXECUTIVE SUMMARY

Reference:	CA18/2/3/8203	
Aircraft Registration	ZS-RKF	Date of Accident	3 November 2006	Time of Accident	0400Z	
Type of Aircraft	Robinson R22 (helicopter)		Type of Operation	Private		
Pilot-in-command Licence Type		Private	Age	31	Licence Valid	Yes
Pilot-in-command Flying Experience		Total Flying Hours	480		Hours on Type	480
Last point of departure		McRest camp (private farm) near Kuruman, North West Province				
Next point of intended landing		McRest camp (private farm) near Kuruman, North West Province				
Location of the accident site with reference to easily defined geographical points (GPS readings if possible)						
McRest camp at the following GPS coordinates: S26° 10' 396" E022° 35' 267"						
Meteorological Information		Surface wind: 090° @ 5kts; Temperature: 15°C; Visibility: CAVOK				
Number of people on board	1 + 1	No. of people injured	1	No. of people killed	0	
Synopsis		<p>The pilot, accompanied by his wife, took off from McRest Camp on a local flight to take aerial photographs of kudu. After takeoff the helicopter collided with power lines spanned across its flight path. The power lines were approximately 6.3m above grou

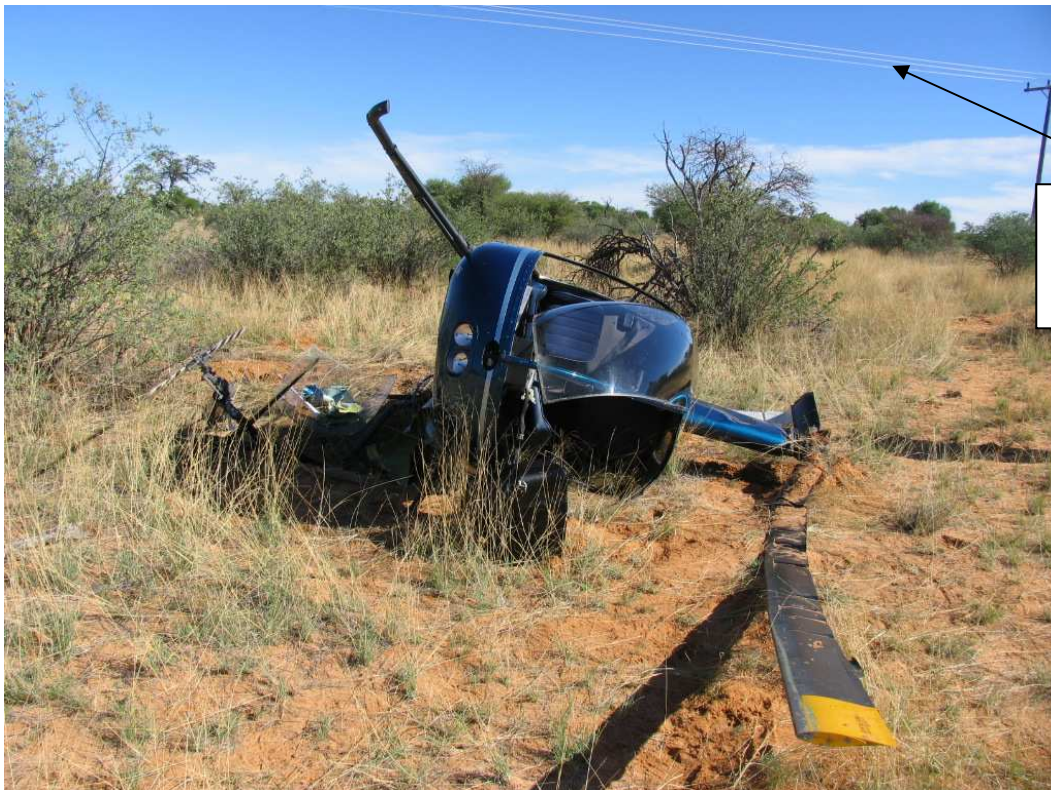
1.12.1 The helicopter collided with power lines after take off and as the main rotor blades struck the ground, the helicopter rolled onto its left side, sustaining substantial damage to the fuselage, tail boom assembly, and main and tail rotor drive system.

1.12.4 The tail boom exhibited evidence of severe impact on its left side.

1.12.5 The tail rotor drive shaft showed signs of tensional twisting. There was also rotational scoring on the inside of the tail boom consistent with tail rotor rotation on impact.

Figure 1. Front view of the helicopter, showing the considerable damage.
