Aircraft Accident Investigation Report

KNKT/07.01/08.01.36

BOEING 737-4Q8

PK-KKW

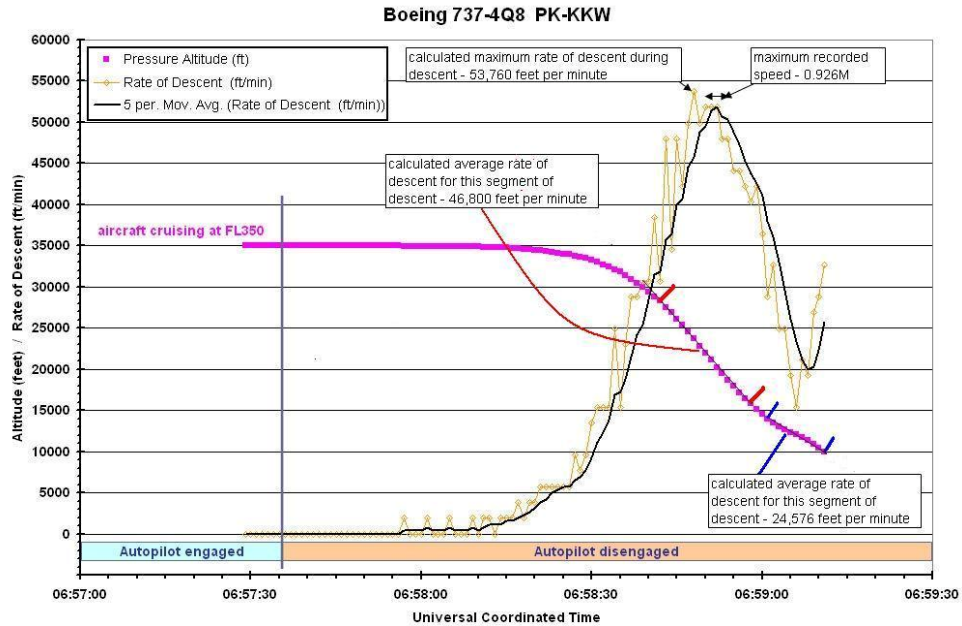
The maximum recorded Mach number reached was 0.926, at 06:58:51. Airspeed exceeded Vdive (400 kcas), and reached a maximum of approximately 490 kcas just prior to the end of recorded data. The descent between recorded data altitudes of 35,008 feet and 9,920 feet took 75 seconds, giving an average vertical speed (rate of sink) of 20,070 feet per minute. The maximum recorded rate of descent was 53,760 feet per minute at 06:58:48. Between 06:58:42 and 06:58:57, the average rate of descent was 46,88 feet per minute, and between 06:59:01 and 06:59:12 was 24,576 feet per minute. (See Figure 7.)

The g forces eventually reached about 3.5gs as the Mach number reached a maximum of 0.926. The 3.5 g force and Mach 0.926 airspeed are beyond the designed limitations of the aircraft. Federal Aviation Regulation (FAR) 25.333 covers maneuver envelopes for structure design. FAR 25.333 shows the v-vs-n maneuvering envelope. At dive speeds, structures are required to maintain integrity 0-2.5g's.

Figure 7: Calculated rate of descent

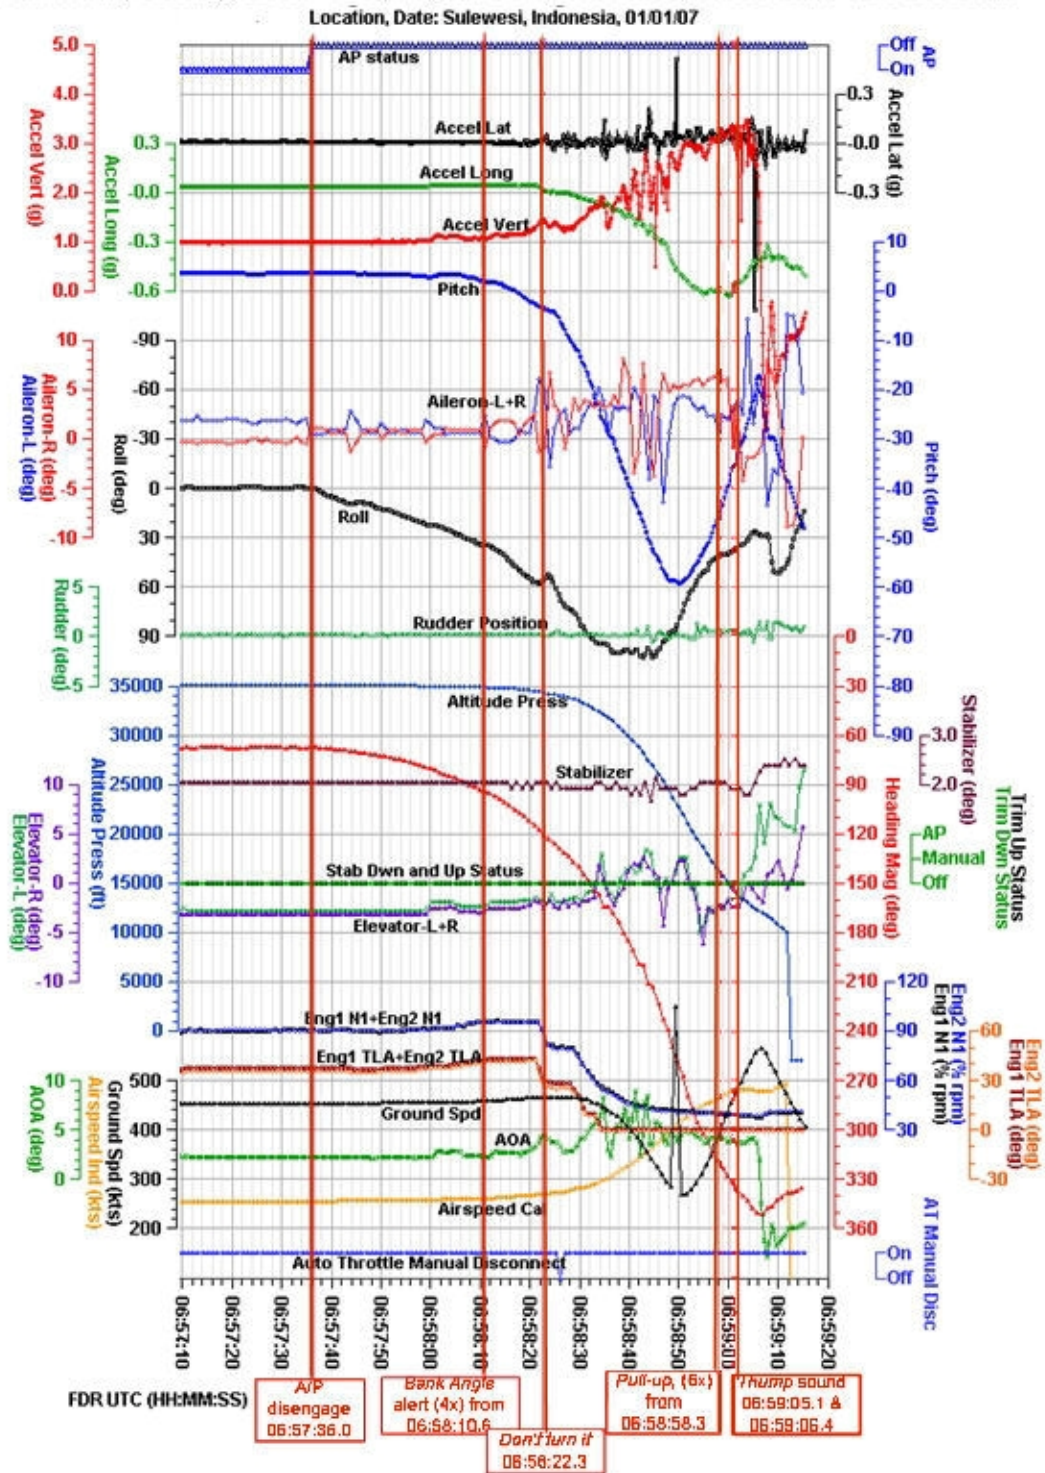
At 06:59:06, the normal load factor reversed from a positive 3 to 3.5g to a negative 2.8g, and the pitch rate reversed from a positive 4 deg/sec to a negative 6 deg/sec.

Flight recorder data indicated that a significant aerodynamic structural failure occurred when the aircraft was at a speed of Mach 0.926 and the flight load suddenly and rapidly reversed from 3.5g to negative 2.8 g. A *thump, thump* sound, which coincided with the time of the sudden flight load reversal, was evident on the CVR about 20 seconds from the end of the recorded data. At the time of the *thump, thump* sound, the aircraft was already in a critically uncontrollable state.

Figure 8: DFDR plot showing last 130 seconds of recorded data

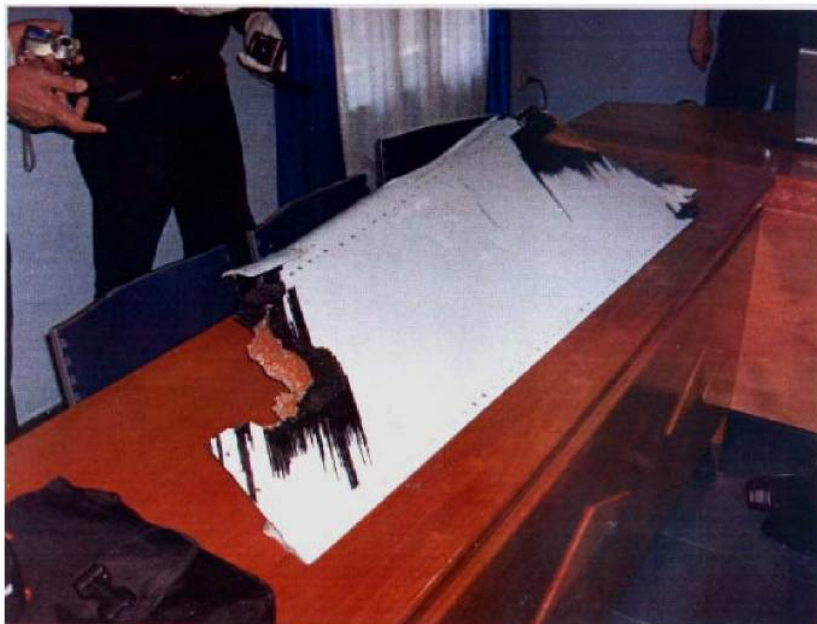
- The outboard section of the right elevator, left elevator, and two pieces of elevator tabs.
- One spoiler panel.
- Several fragmented composite panels probably from a horizontal stabilizer, one cabin floor panel.
- One passenger seat cushion with a fabric pattern that matched the passenger seat on other AdamAir aircraft, and several additional seat cushions without fabric covers.
- Several mangled and crushed seat trays from the backs of passenger seats.
- A small amount of personal effects; an empty briefcase and a passenger's personal identity card.

Figure 12: Outboard section of right elevator

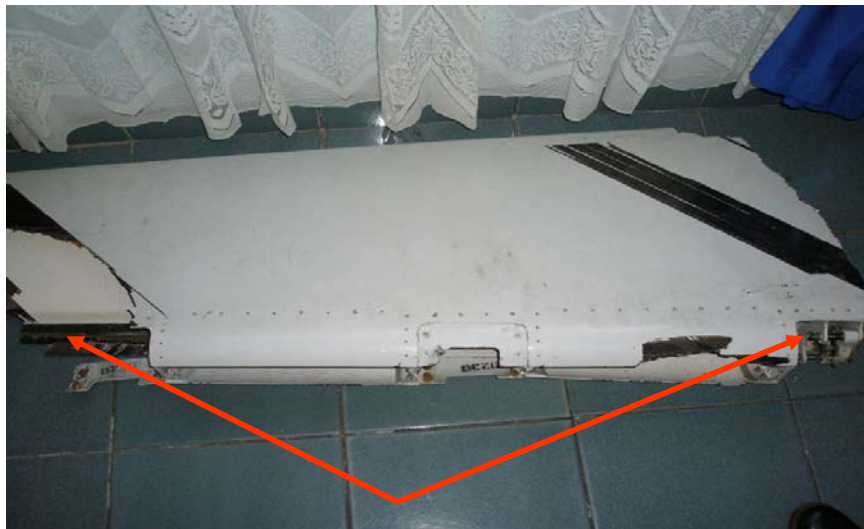
Figure A2 : Part of right elevator showing upper surface (Red arrows point to hinges). Found floating in the sea close to Sulawesi island (between Pare-pare and Baru, South Sulawesi) Makassar Strait

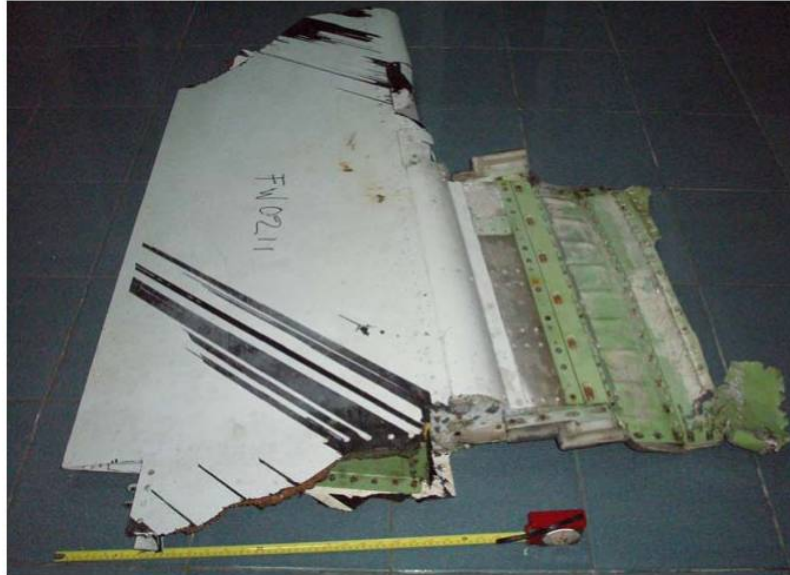
Figure A3: Part of Left Elevator showing upper surface. Found floating in the sea off the coast near Pare-Pare

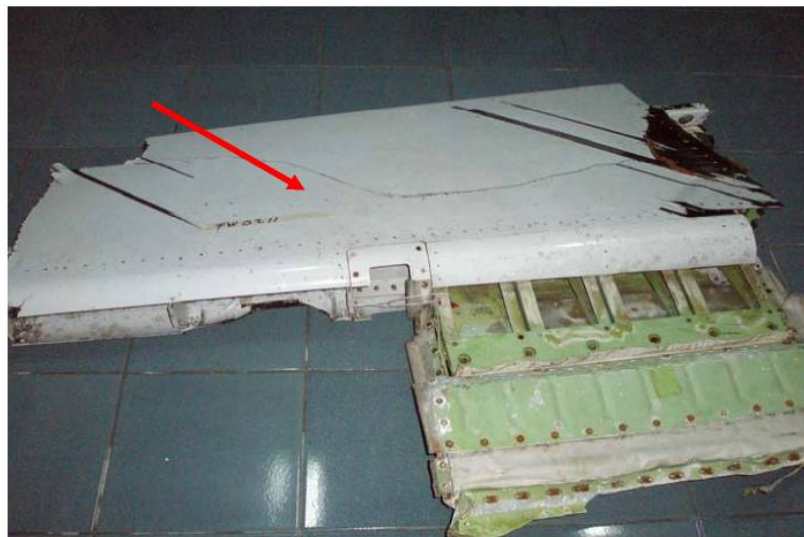
Figure A4 : Part of left elevator showing lower surface. Found floating in the sea off the coast near Pare-Pare

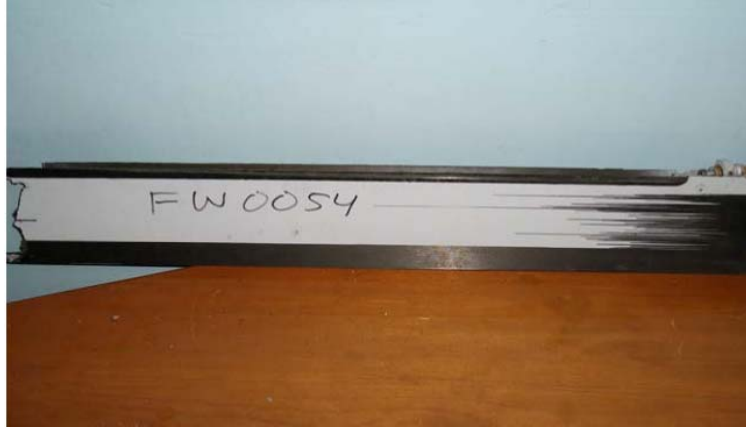
Figure A5 : Part of elevator tab. Found floating in the sea off the coast near Pare-Pare

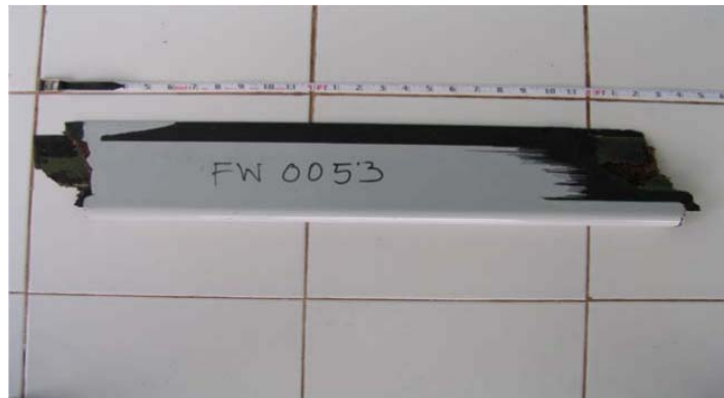
Figure A6 : Part of elevator tab. Found floating in the sea around Pare-pare

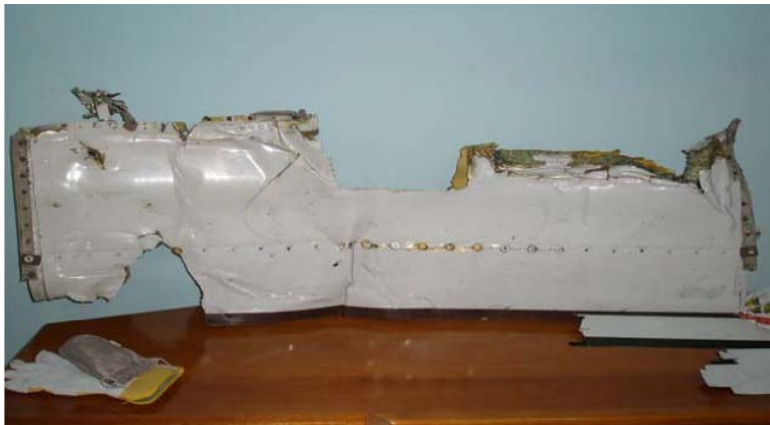
Figure A7 : Flight spoiler (showing lower surface) found floating in the sea off the coast of Pare-pare

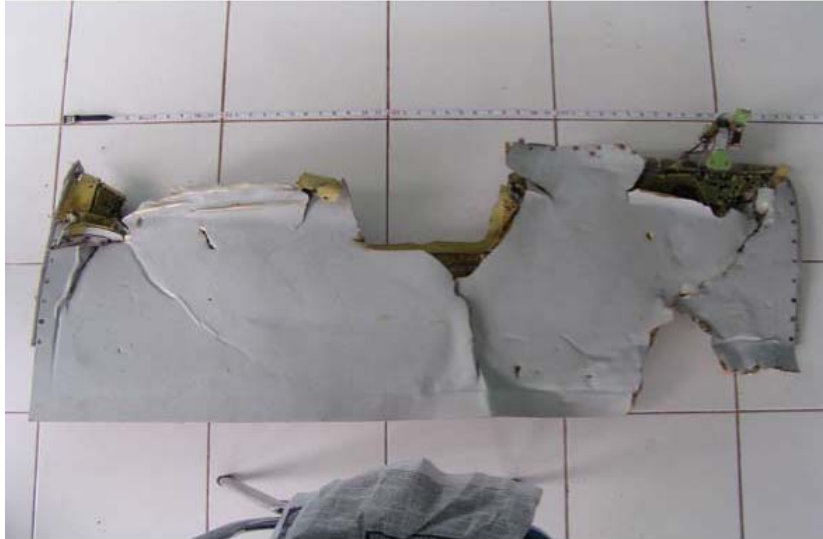
Figure A8 : Flight spoiler as in figure A7
