CA 18/3/2/8234

SOUTH AFRICAN CIVIL AVIATION AUTHORITY

AIRCRAFT ACCIDENT REPORT AND EXECUTIVE SUMMARY

Name of Owner/Operator : A P Burger
Manufacturer : Canadian Home Rotors
Model : Safari
Nationality : South African
Registration Marks : ZU-DVY
Place : Lethlabile – Rabukalo Village
Date : 12 January 2007
Time : 0630Z

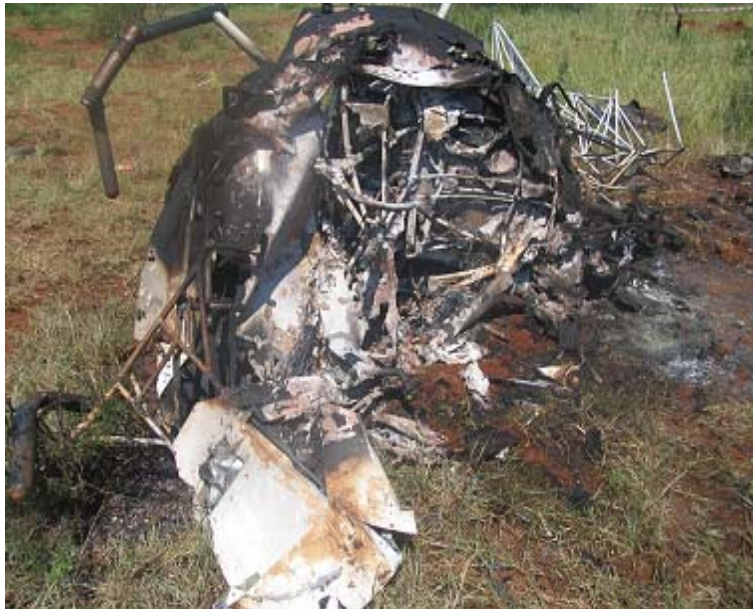
Photo 1, showing damage caused to the helicopter.

1.3.1 The helicopter was destroyed in the accident.

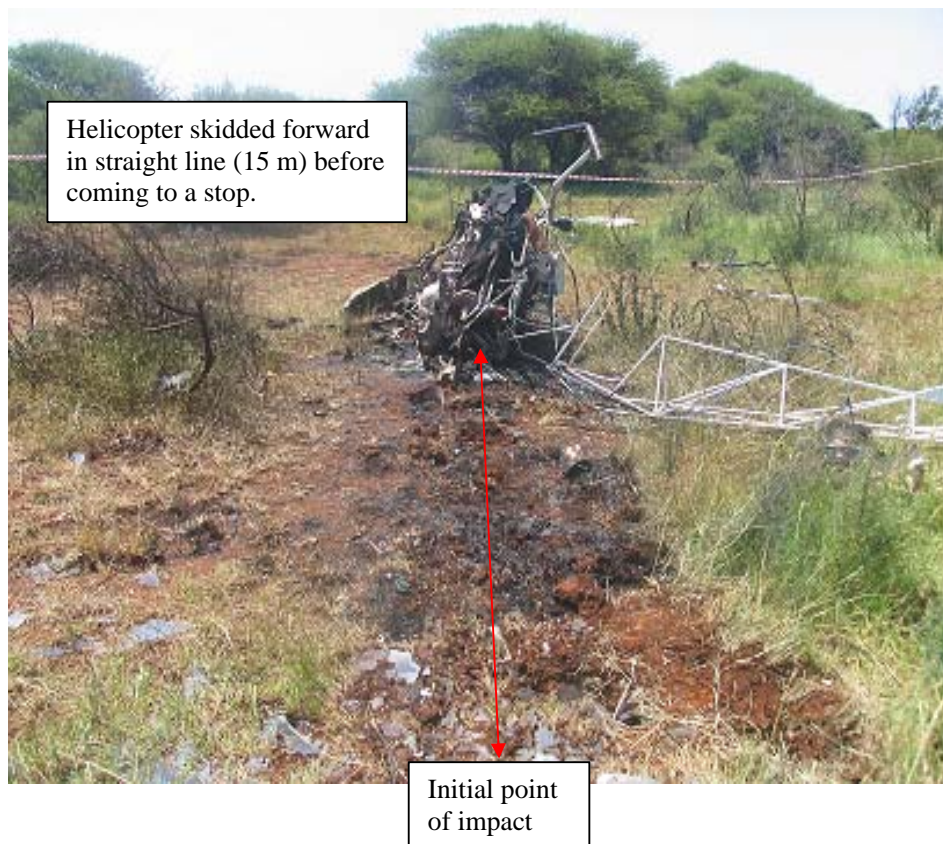
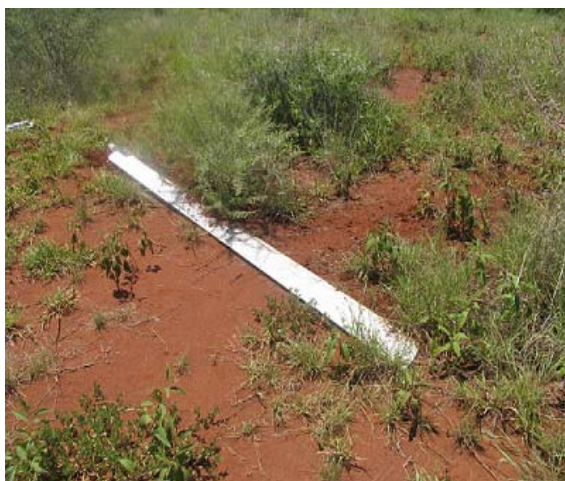
Main Rotor Blade: S/N 2040
(GPS co-ordinates: S25°32.4444' E027°54.237')

- (i) The helicopter first impacted with the ground with its nose section. The wreckage then skidded forward for approximately 15 metres before stopping.
- (ii) Several airframe structural parts and components broke off and separated from the main wreckage. (see pictures and information below)

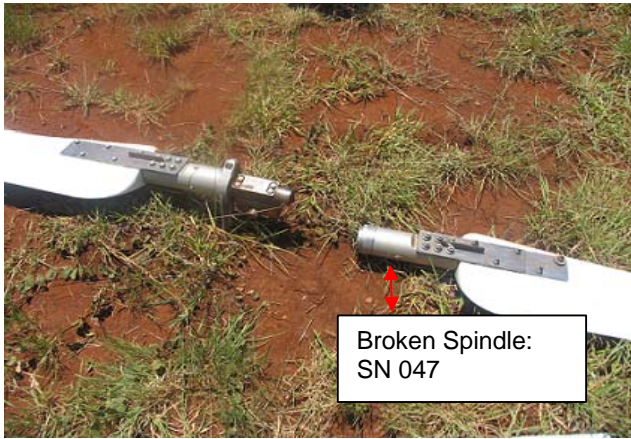
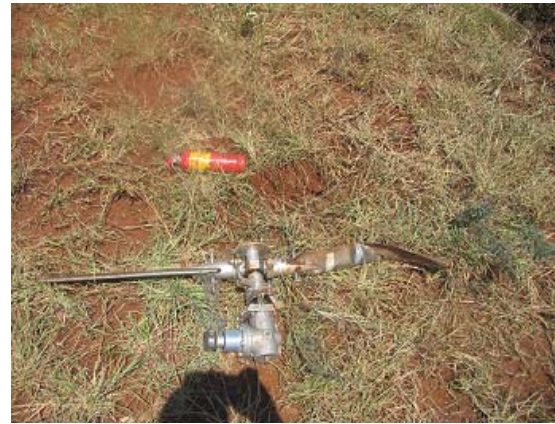
Tail Rotor Assembly

1.12.2 When the helicopter impacted with the ground, the tail rotor and tail boom broke off and then separated from the fuselage. The tail boom was found on the right side of the main wreckage, approximately 5 metres away. The tail rotor drive shaft installation was still secured to the main wreckage. The tail boom and drive shaft were twisted and were bent. There was also no evidence of fire damage sustained to the parts.

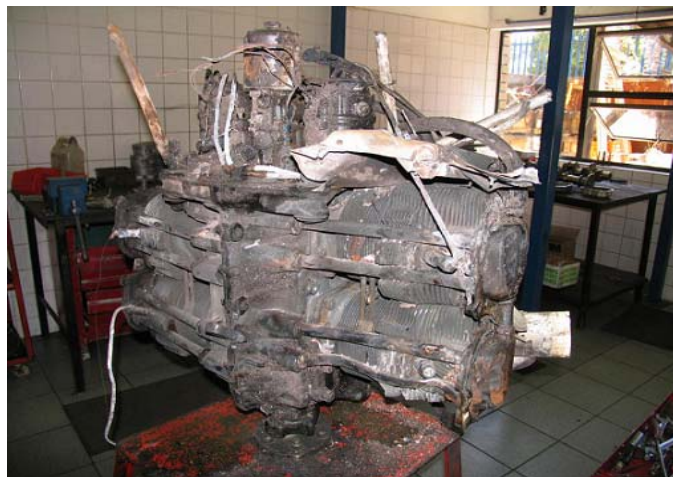
Engine of the helicopter

- 1.16.1 The engine of the helicopter was removed from the wreckage and recovered to an AMO for examination. Due to the impact and fire damage sustained, the engine could not be bench-tested for performance evaluation. An engine “tear-down” inspection was performed. The engine was completely disassembled and no anomalies were identified with the parts and components of the engine.

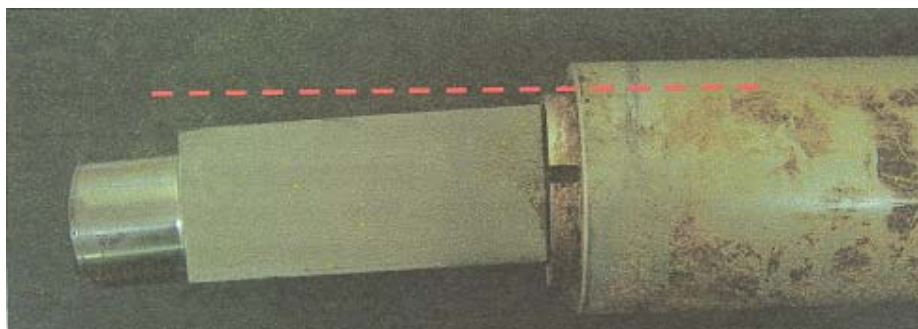
Main Rotor spindle

1.16.3 A visual and stereo – microscope investigation was performed on the tested parts. The visual inspection of the spindle indicated evidence of fracture surface which revealed clear indications of fatigue. (See below, evidence of fatigue failure caused to the

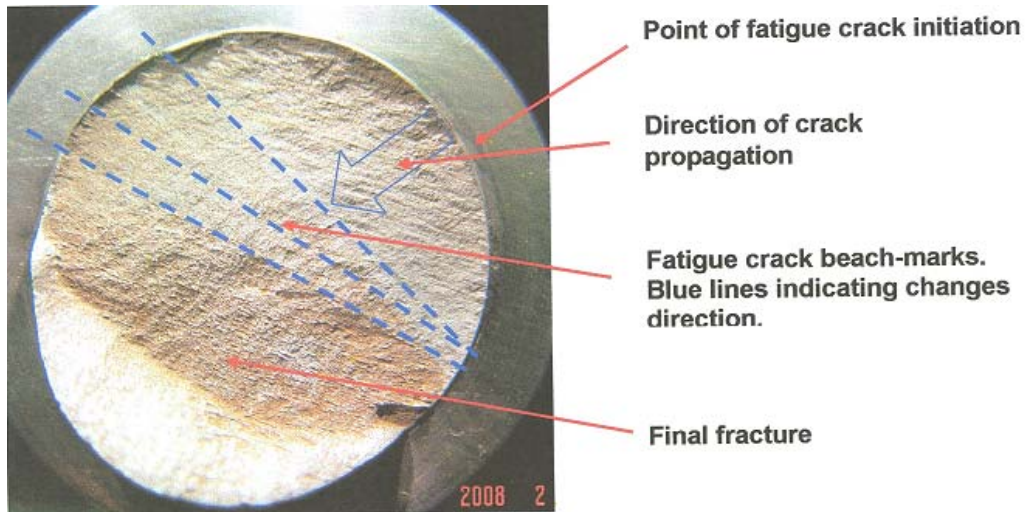
1.16.4 The picture above shows evidence of fatigue crack which propagated to approximately 55% of the spindle thickness, before the final fracture occurred. The directional changes in the fatigue crack, as presented by the blue lines, can be attributed to the effect of resultant strain combined with the varying operating position of the spindle relative to the rotor blade.

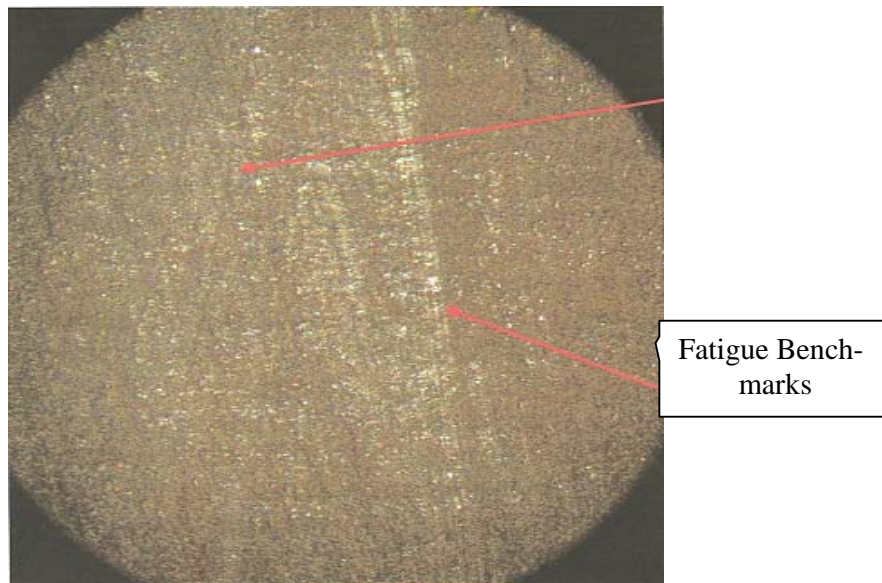
Main Rotor Spindle fracture surface showing clear fatigue bench-marks

1.16.5 The stereograph had clear indications that the fatigue crack originated in the sharp machined edge at the position indicated above with red lines. However, no clear signs of possible stress raisers i.e. nick or machine marks, could be detected in the vicinity of the crack point of initiation.

- (ii) The most probable cause for the initiation of the fatigue crack may be one or more of the following:
 - (a) The main rotor spindle was manufactured with a sharp corner without any radius at the point of crack initiation, leading to a higher surface stress.
 - (b) Shock overload, i.e. rotor strike or others.
 - (c) Over-torque of the castle nut during assembly.

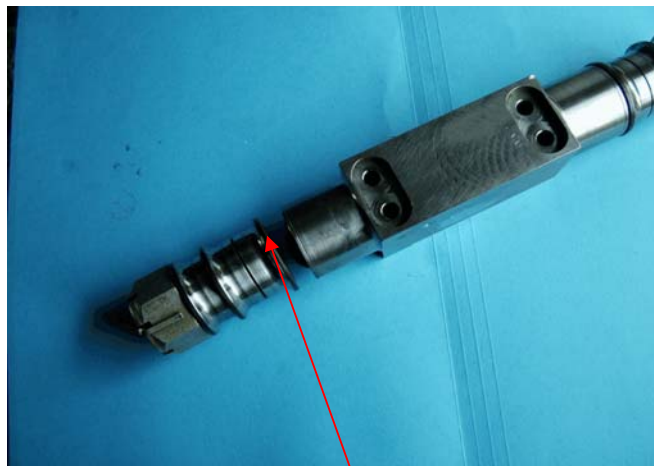
- (i) The rotor head has failed in fatigue, with the cracking most probably being initiated in the sharp radius as the result of an impact-loading event some time in the past. This impact also damaged the rolling element bearings on which the blade turns to change the pitch angle. It is considered that the lack of a sufficiently large radius at the point of failure contributed significantly to the failure by acting as a stress raiser.

The rotor head showing the position of the fracture in the radius between the bearing diameter and oil seal diameter.

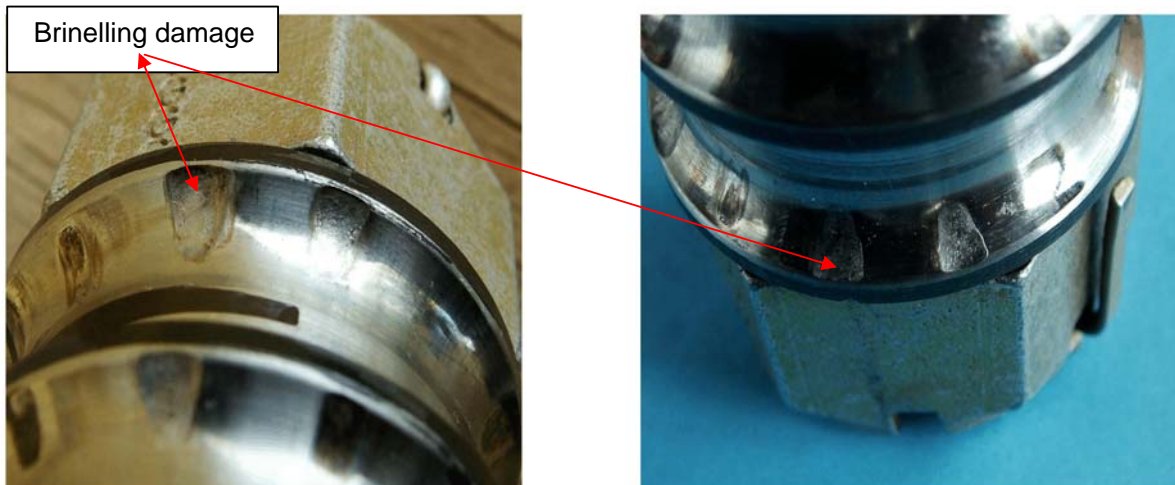
Main Rotor Bearing Assembly

- (iii) There are two forms of brinelling, or indentation, of rolling element bearing raceway surfaces. “True” brinelling is defined as the result of an impact loading on the bearing, causing the rolling elements, in this case spherical, into the raceway surface. This results, in severe cases, of “piling” or bulging of the raceway material around the damage. This form of damage is clearly visible in the bearings from this component, indicating clearly that it had been subjected to impact loading. A second form of brinelling, known as “false” brinelling results from the bearing being subjected to oscillating loading over a small range of angular displacement. This form of damage results in a form of wear similar to fretting, which is also clearly visible in the bearings from this component, indicating that it has been operated for a considerable period of time after the initial damage was incurred.

- (iv) It can therefore be presumed that the bearings were damaged by some form of impact loading at some significantly long time in the past, and had continued being operated with this damage present. Operation of the rotor head in this condition would have resulted in irregular movement of the blade when the pitch angle was changed. It is probable that the fatigue crack was initiated by the impact loading, and then propagated slowly in operation. The rotational speed of the rotor and the centrifugal forces on the hub is more or less constant, and will not induce the cyclic loadings needed for fatigue propagation. It is more probable that the fatigue crack propagation was controlled by the lifting forces generated by the rotor blade, inducing bending forces in the head. The evidence shows that the fatigue initiated on the bottom surface. Brinelling damage to the bearing raceways was evident on the failed side of the rotor head. The raised ridge due to “piling” is visible. Note that the indented surface shows signs of wear.

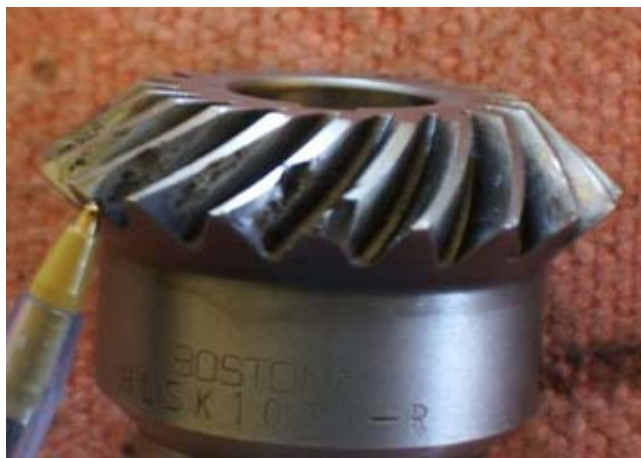
Tail Rotor Drive Shaft Gear

- (i) The identified gear was replaced on 10 June 2006 after the helicopter had been operational for 182.8 hours. It is possible that the drive shaft had sustained damage in the reported incident and was also replaced with a serviceable part from the other kit. That is the damaged part that was subsequently installed in ZU-DVY.

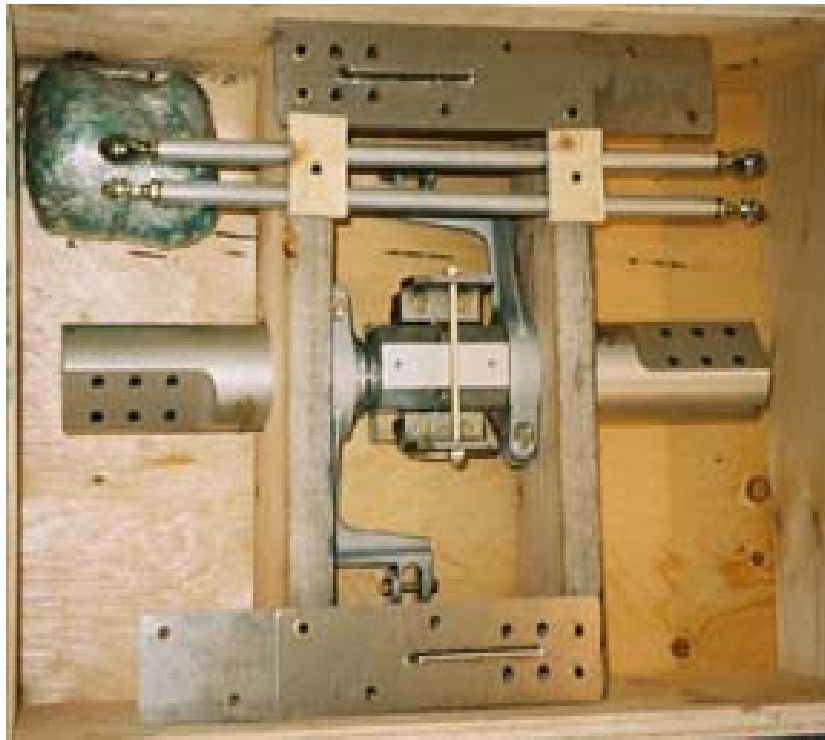
Photo, showing Main Rotor Head Assembly

- (i) No evidence could be found of maintenance done on the main rotor assembly, which required that the castle nut be torqued. According to the aircraft manufacturer, each component comes in a crate and in boxes. The components are not allocated to any specific frame. There would have been enough parts to make up the two helicopters. As a result, there is no requirement for the owners of the helicopters to fasten or torque the castle nut of the rotor head bearing assembly during the build process. The Hub and spindles come pre-assembled. In the light of the evidence, the probable cause identified in 1.16.6 (ii)(c) above was eliminated in the investigation. (See photo of main rotor head assembly packed for shipment.)
