AIRCRAFT ACCIDENT REPORT AND EXECUTIVE SUMMARY

Reference:	CA18/2/3/8241	
Aircraft Registration	ZS-GWG	Date of Accident	13 January 2007		Time of Accident	1500Z
Type of Aircraft	Hoffman H38 Dimona		Type of Operation		Private	
Pilot-in-command Licence Type		Glider	Age	62	Licence Valid	Yes
Pilot-in-command Flying Experience		Total Flying Hours	959.5		Hours on Type	754
Last point of departure		Uitenhage Aerodrome FAUH – Eastern Cape Province				
Next point of intended landing		Uitenhage Aerodrome FAUH – Eastern Cape Province				
Location of the accident site with reference to easily defined geographical points (GPS readings if possible)						
S33° 39' 29.46" E025° 07' 55.34" at an elevation of 1 600 ft AMSL						
Meteorological Information		Fine weather conditions prevailed at the time of the accident. There was no cloud, mild wind and moderate temperatures of approximately 23°C.				
Number of people on board	1 + 1	No. of people injured	1	No. of people killed	1

Name of Owner/Operator : Gous JP
Manufacturer : Hoffman
Model : H38 Dimona
Nationality : South Africa
Registration Marks : ZS-GWG
Place : Uitenhage
Date : 13 January 2007
Time : 1500Z

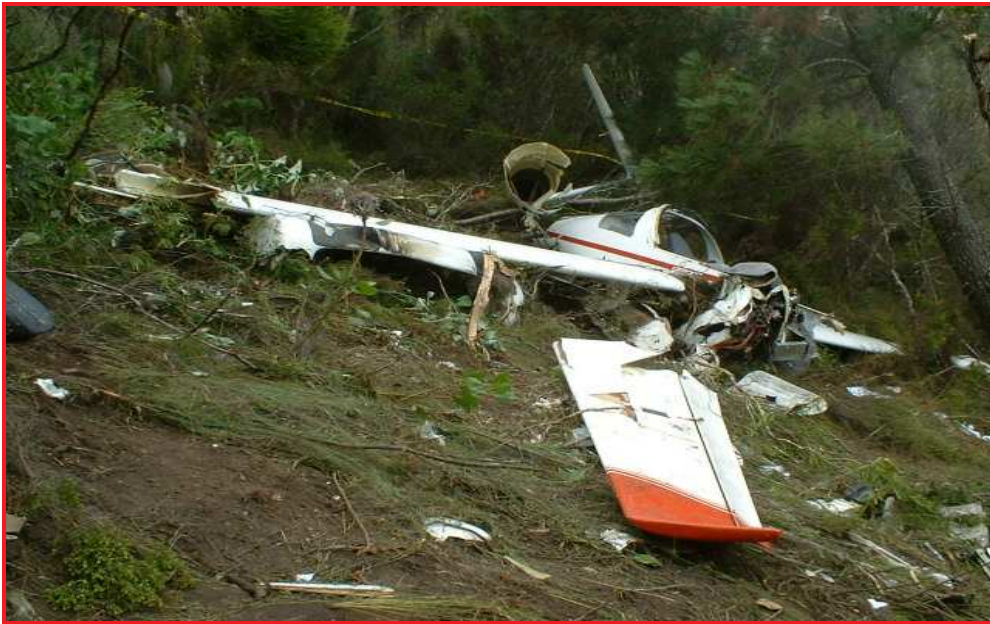
Figure 1. The wreckage of ZS-GWG.

1.12.1 The aircraft collided with the terrain in a nose-up, right-wing-low attitude.

1.12.2 Although the break-up was severe, all extremities of the aircraft were accounted for, and a midair breakup was excluded as the possible cause of the accident.

1.12.3 Evidence from the accident site suggested that the aircraft had been unable to outclimb the terrain which rises at an angle of approximately 20° - 25°.

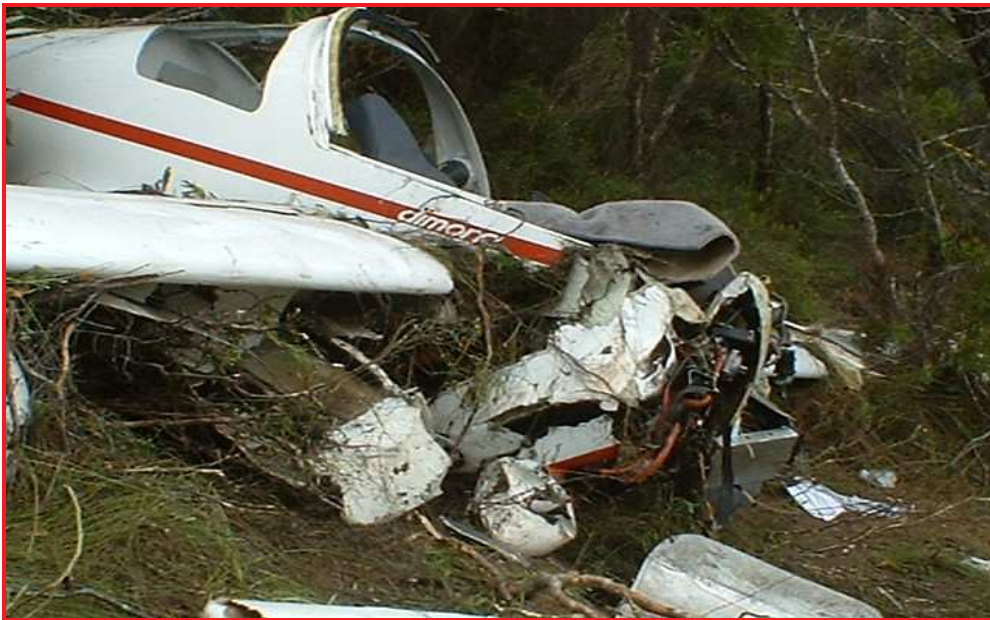
Figure 2. The extensive damage to the cockpit area.

- 1.15.1 The severity of the impact, as shown by the break-up of the cockpit area, rendered this accident non-survivable, although the pilot did survive.
- 1.15.2 A witness heard the aircraft but did not see it. He informed the flying school at the airfield (FAUH) who then launched a search party by foot and some micro-light aircraft. The accident aircraft was spotted later the day by one of the aircraft searching the area.

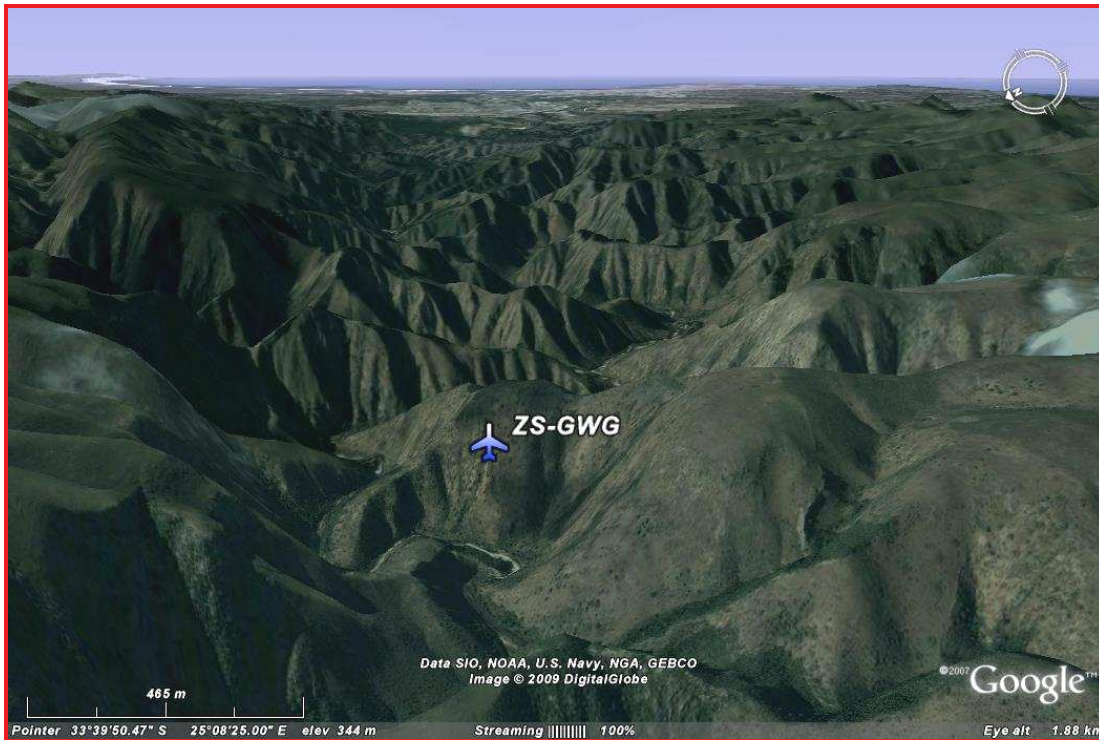
Figure 4. The accident occurred in a valley.

- 2.1 The pilot flew into a valley but the aircraft was unable to outclimb the terrain and collided with the mountainside in a nose-up, right-wing-low attitude.
- 2.2 The pilot sustained serious injuries and the passenger was fatally injured during the accident sequence. The aircraft was destroyed.
- 2.3 Fine weather conditions prevailed at the time of the accident.
- 2.4 The engine and fuel system of the aircraft were examined and, apart from accident-related damage, appeared to be in good condition.
