AIRCRAFT ACCIDENT REPORT AND EXECUTIVE SUMMARY

Reference:	CA18/2/3/8251	
Aircraft Registration	ZS-KSH	Date of Accident	9 February 2007		Time of Accident	1550Z
Type of Aircraft	Cessna 414 A		Type of Operation	Private		
Pilot-in-command Licence Type		Commercial	Age	32	Licence Valid	Yes
Pilot-in-command Flying Experience		Total Flying Hours	1 308		Hours on Type	27
Last point of departure		Lanseria Aerodrome (FALA)				
Next point of intended landing		Kitty Hawk Aerodrome (FAKT)				
Location of the accident site with reference to easily defined geographical points (GPS readings if possible)						
On the overshoot area past runway 01 at Kitty Hawk Aerodrome (GPS position: S25°50.929' E028°26.957')						
Meteorological Information		Surface wind: Light and Variable; Temperature: 25°C; Visibility: Good.				
Number of people on board	1 + 1	No. of people injured	0	No. of people killed	0	
Synopsis						
<p>The pilot stated that he undertook a private flight, accompanied by a passenger, from Lanseria Aerodrome to Kitty Hawk Aerodrome. .</p> <p>According to the pilot, he selected 45° of flaps on approach for landing on Runway 01 at Kitty Hawk. He landed at an IAS of 90kt too far down the runway

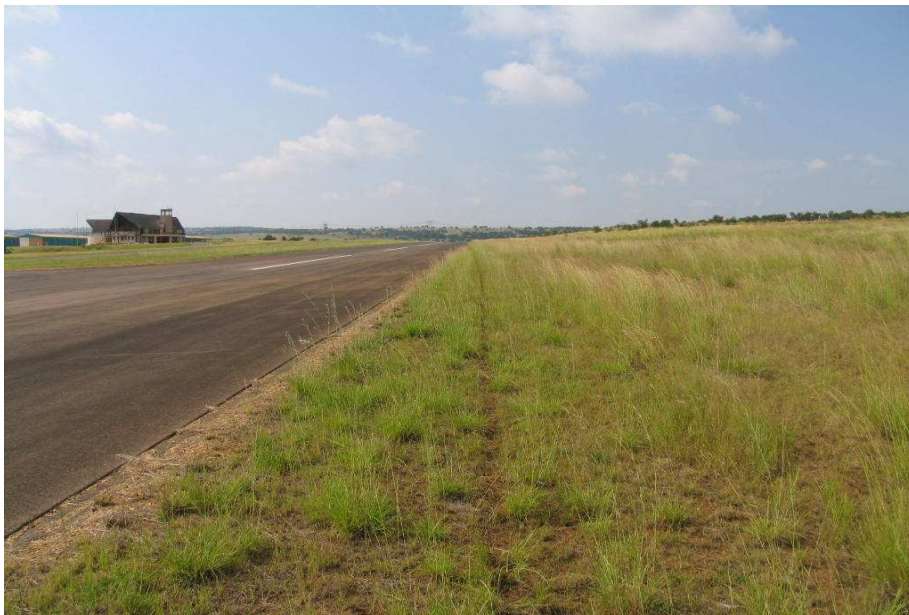
- 1.1.3 As he was unable to slow the aircraft sufficiently when he applied brakes, he manoeuvred the aircraft to the left and partly onto the grass in order to slow down more rapidly. He continued to apply maximum braking. The aircraft subsequently slowed down, but the pilot was unable to bring it to a complete stop and overran the runway.

Figure 1. Tyre marks showing how aircraft departed from runway onto grass.

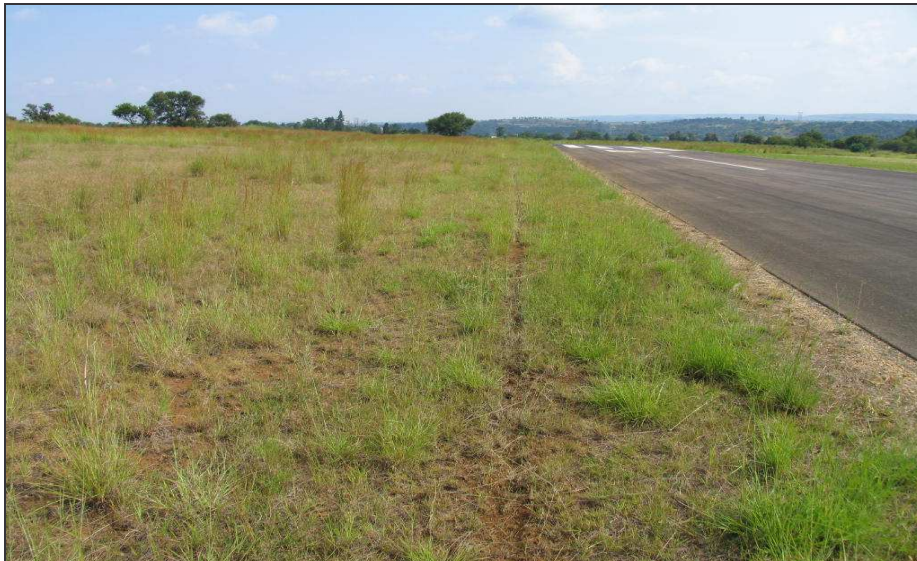
Figure 2. Tyre braking marks on grass near end of Runway 01.

1.12.1 The aircraft landed far down Runway 01 which sloped downhill and was 810 metres long. The aircraft subsequently started rolling partially onto the grass on the left-hand side, as indicated by brake marks approximately 230m before the end of the runway. It overran the end of the runway and went off the steep slope in the overshoot area.

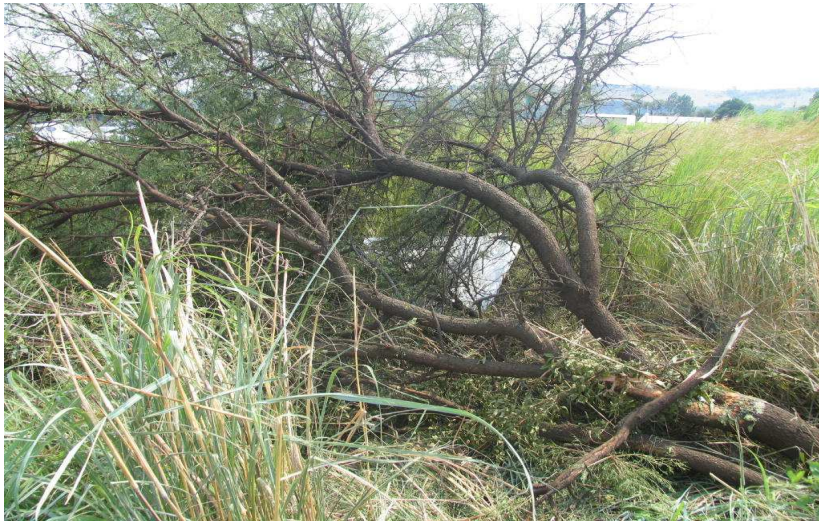
- 1.1.4 The right wing collided with a tree, causing the outboard section of the wing to separate. The main and nose landing gears collapsed after impact with the ground and the aircraft ground-looped through 45° to the right before coming to a rest.

Figure 3. Tree uprooted after impact by right wing.

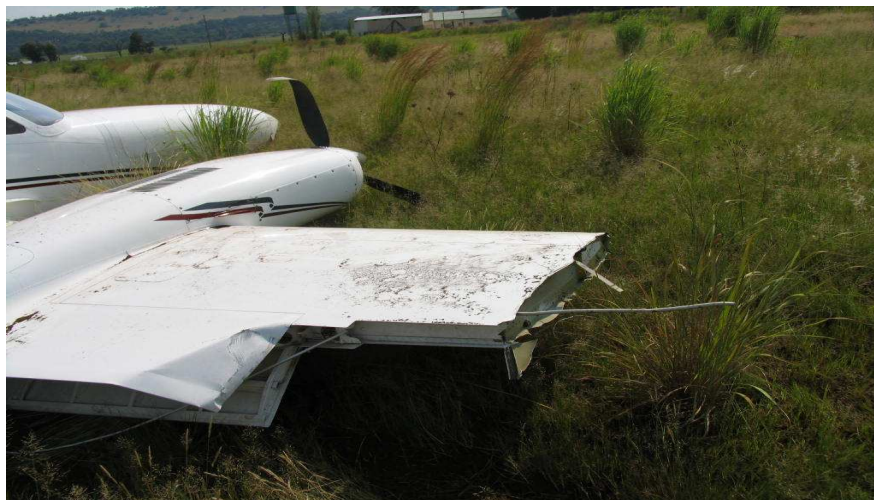
- 1.3.1 The aircraft sustained substantial damage to the left-hand and right-hand main and nose landing gears, the right wing and both propellers.

Figure 4. Main wreckage showing right wing outboard section missing.

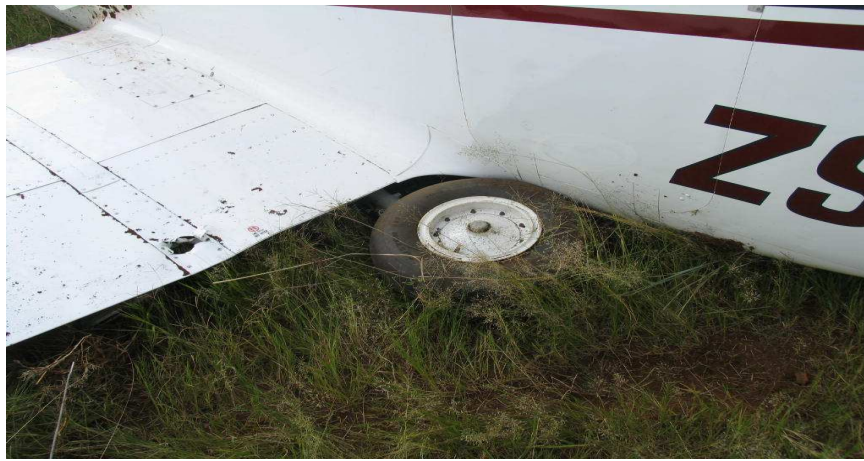
Figure 5. Left-hand main undercarriage collapsed during impact sequence.

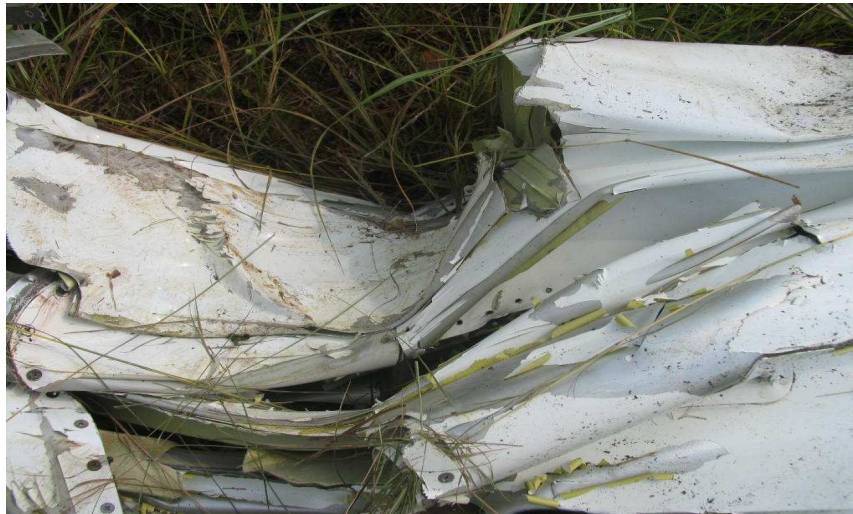
Figure 6. Right wing outboard section separated on impact with tree.

1.12.2 The right wing then collided with a tree, causing the outboard section to separate. The main and nose landing gears collapsed on impact with the ground and the aircraft ground-looped through 45° to the right before it came to rest approximately 100m beyond the end of the runway.

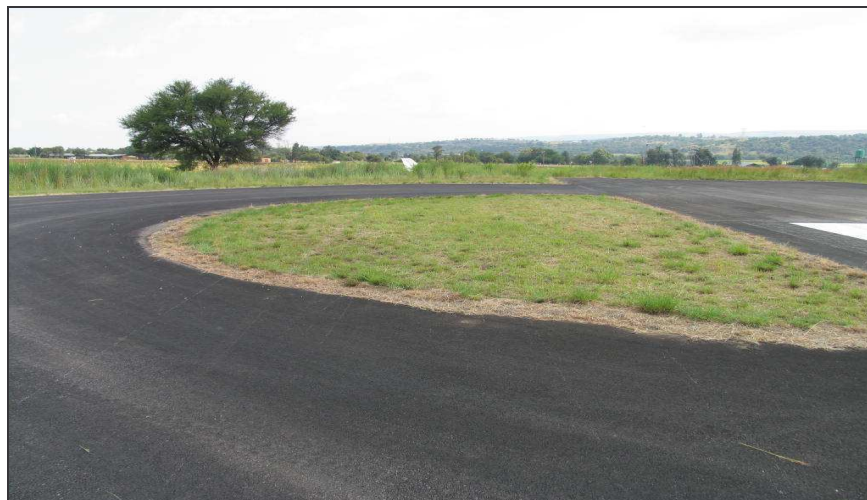
Figure 7. View of where the aircraft overran the end of the runway.

3.2.1 The pilot landed the aircraft too far down the downward-sloping runway, and was unable to stop it within the distance remaining.
