AIRCRAFT ACCIDENT REPORT AND EXECUTIVE SUMMARY

Reference:	CA18/2/3/8259	
Aircraft Registration	ZS-KFU	Date of Accident	19 February 2007		Time of Accident	1250Z
Type of Aircraft	Piper PA38 Tomahawk		Type of Operation	Training		
Pilot-in-command Licence Type	Commercial		Age	42	Licence Valid	Yes
Pilot-in-command Flying Experience	Total Flying Hours	8 127.35		Hours on Type	2.4	
Last point of departure	Pietersburg Civil Aerodrome (FAPI)					
Next point of intended landing	Springs Aerodrome (FASI)					
Location of the accident site with reference to easily defined geographical points (GPS readings if possible)						
Outside the perimeter of runway 26 at Pietersburg Civil Aerodrome (GPS position: S23° 55' 19" E29° 30' 39")						
Meteorological Information	Fine weather. Temperature: 28°C; Wind: 15-18 knots; Visibility: CAVOK					
Number of people on board	2 + 0	No. of people injured	2	No. of people killed	0	
Synopsis						
<p>The instructor, accompanied by a student, flew from Springs aerodrome to Pietersburg civil aerodrome, where they landed safely and viewed an aircraft for sale. Their aeroplane was then refuelled to its full capacity with 100 litres (26.42 US gallons) of avgas prior t

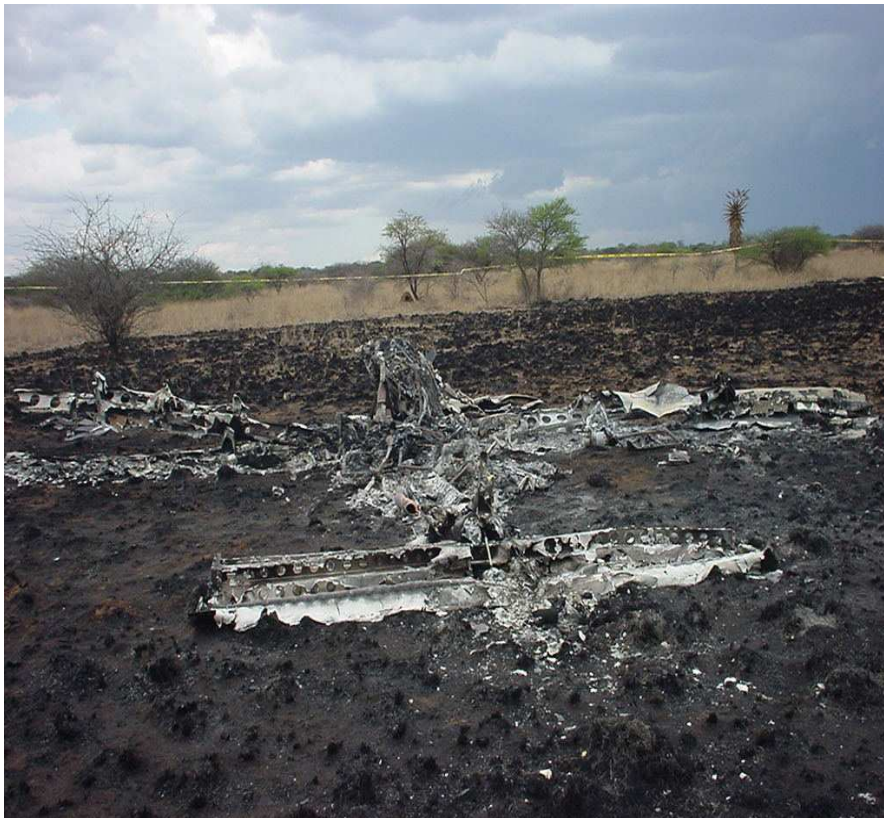
1.3.1 The aircraft was destroyed by post-impact fire.

Picture1. The remains of the wreckage

1.14.1 Post-impact fire erupted and destroyed the aircraft.

2.4 It is believed that in an attempt to recover from the stall, the instructor took control from the student but did not have enough height and time to recover. The aircraft stalled about 300 feet above ground level and struck the ground with the right wing tip first. Post-impact fire broke out, destroying the aircraft.
