AIRCRAFT ACCIDENT REPORT AND EXECUTIVE SUMMARY

Reference:	CA18/2/3/8280	
Aircraft Registration	ZS-RMI	Date of Accident	5 April 2007		Time of Accident	0745Z
Type of Aircraft	Robinson R22 helicopter		Type of Operation	Training		
Pilot-in-command Licence Type		Commercial	Age	36	Licence Valid	Yes
Pilot-in-command Flying Experience		Total Flying Hours	6 782,3		Hours on Type	2,9
Last point of departure		Grand Central Aerodrome (FAGC)				
Next point of intended landing		Grand Central Aerodrome (FAGC)				
Location of the accident site with reference to easily defined geographical points (GPS readings if possible)						
The garden of a private home: 100 East Hertford Road, Morningside, Johannesburg. The GPS position S26°04.008' E028° 03.081' at an elevation of 4 668 ft.						
Meteorological Information		Temperature: 21°C; Wind: 3 kt / 260°; Cloud: SCT at 4 000 ft; Visibility: 10 km				
Number of people on board	1 + 1	No. of people injured	0	No. of people killed	2

Name of Owner/Operator : Helicopter Training Services
Manufacturer : Robinson Helicopter Company
Model : R22 Beta II
Nationality : South African
Registration Marks : ZS-RMI
Place : Morningside, Johannesburg
Date : 5 April 2007
Ti

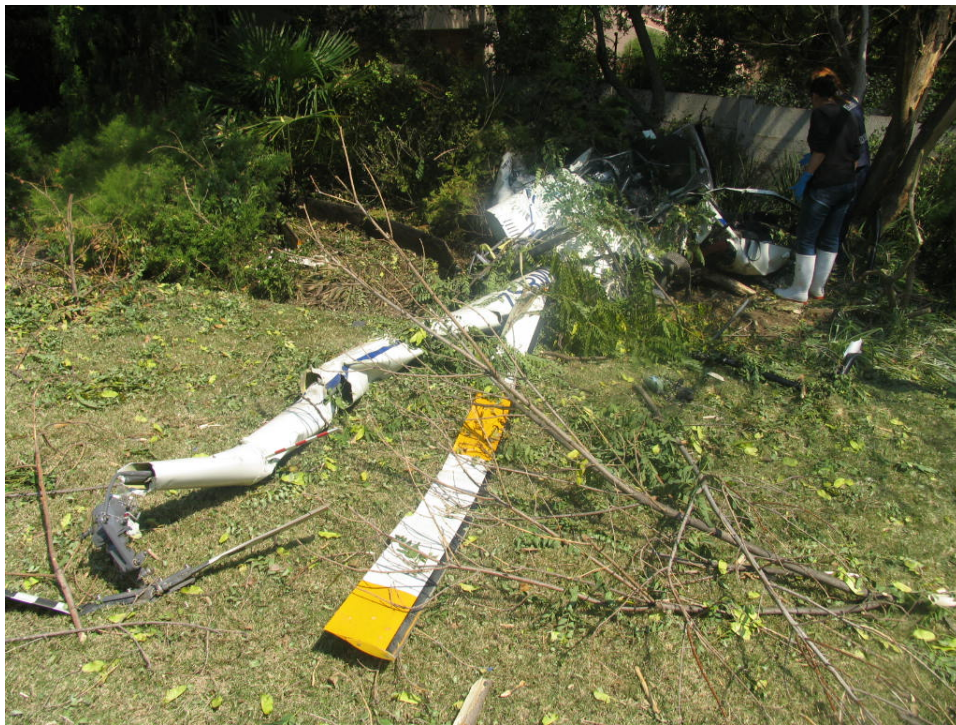
1.3.1 The helicopter was destroyed in the accident.
Refer Figure 2 on following page.

Figure 2. The wreckage of the helicopter.

1.12.1 The helicopter fell in a nose-down attitude and crashed between trees before hitting the ground. It was destroyed on impact. During the on-site investigation, it was found that the windshield had separated from the helicopter before the crash. The windshield was found at GPS position S26° 03.953' E028° 03.161', 170 m from the wreckage..

1.12.2 The wreckage, with the exception of the windshield, was contained within a small impact area.

1.12.3 The fuel tank was found ruptured, and damage to the grass at the impact site indicated a significant amount of fuel spillage.

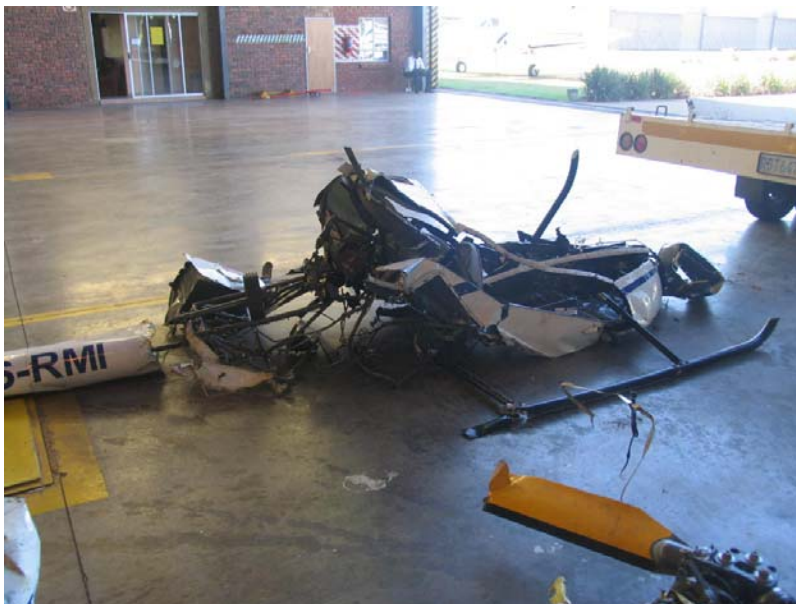
- The wreckage was removed from the accident site to the South African Police Services Air Wing hangar at Wonderboom Aerodrome for further investigation. A wreckage reconstruction (see Figures 3 and 4 below) was performed to account for all the components, determine the failure modes and ascertain whether there was any possibility of in-flight breakage of the helicopter.
- During on-site investigation one of the main rotor blades was found broken, and the witness marks on the trees suggested that the main rotor was turning on impact. Further wreckage examination also revealed that the drive belts were intact.
- The airframe and its systems were inspected and all failures observed showed evidence of damage due to the accident sequence. None of the systems inspected showed signs of any pre-existing failure prior to the accident.

Figure 3. The wreckage during reconstruction – side view.

2.4 The examination of the wreckage and engine did not disclose any evidence of a pre-existing airframe defect, engine malfunction or system deficiency which could have caused or contributed to the accident. All damages observed were the result of impact forces caused by the crash.

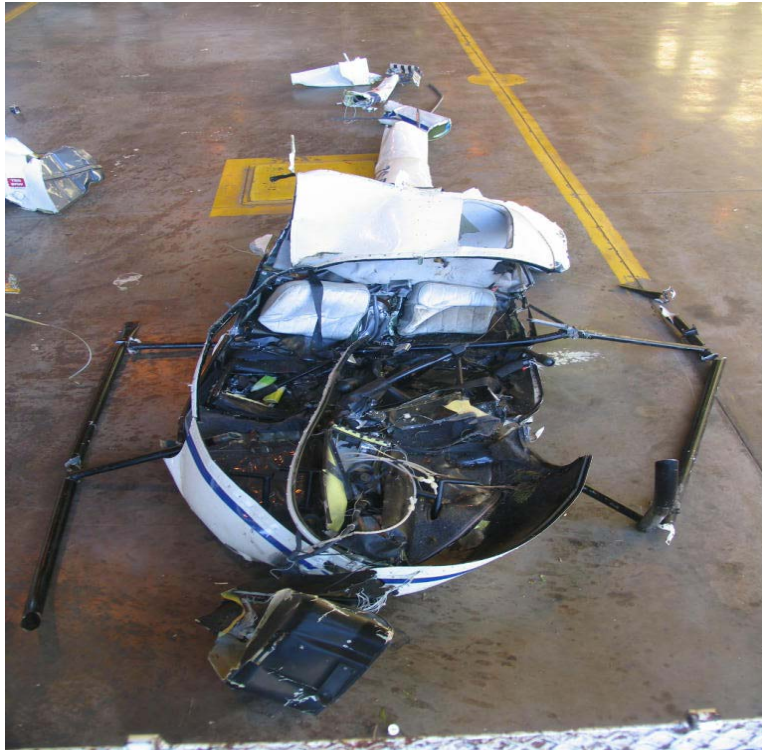
Figure 4. The wreckage during reconstruction – front view.

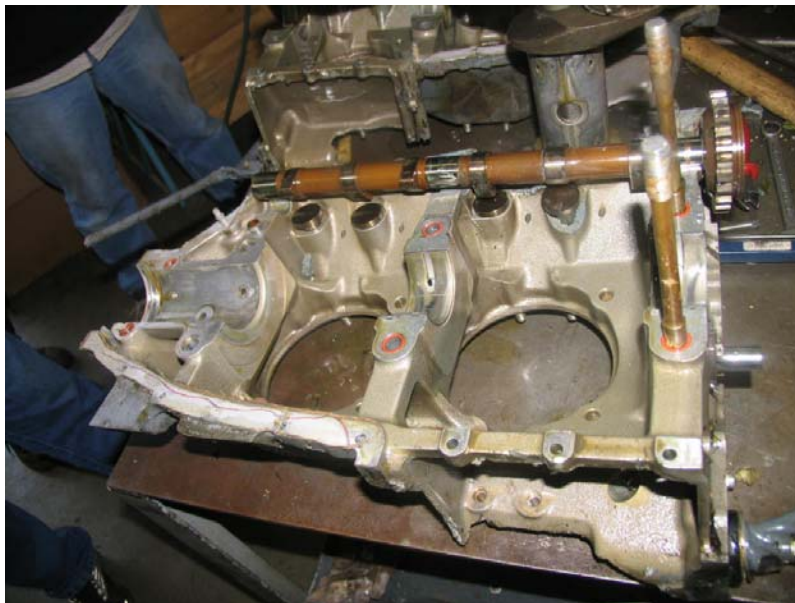
- The helicopter engine was removed and taken to an approved engine overhaul facility to determine whether there had been any engine malfunction or failure. A complete engine teardown inspection was conducted, and it was found that all noted damage was consistent with that of accident damage; there was no evidence to suggest that the engine might have failed or malfunctioned prior to the accident.

Figure 5. The engine parts during the teardown inspection.
