AIRCRAFT ACCIDENT REPORT AND EXECUTIVE SUMMARY

Reference:	CA18/2/3/8284	
Aircraft Registration	ZS-RTA	Date of Accident	10 April 2007		Time of Accident	1345Z
Type of Aircraft	Robinson R22 Beta		Type of Operation	Training		
Pilot-in-command Licence Type		Commercial	Age	64	Licence Valid	Yes
Pilot-in-command Flying Experience		Total Flying Hours	18503.6		Hours on Type	2333.2
Last point of departure		FAVG (Virginia – Durban; KZN)				
Next point of intended landing		FAVG (Virginia – Durban; KZN)				
Location of the accident site with reference to easily defined geographical points (GPS readings if possible)						
La Mercy – North of Durban; KZN @ a GPS position of S29° 35.805" E031° 7.099" @ Elevation +- 230 ft AMSL						
Meteorological Information	According to the official weather report, fine weather conditions prevailed at the time and place of the accident.					
Number of people on board	1+1	No. of people injured	0	No. of people killed	2	
Synopsis

Name of Owner/Operator : ORYX Trust / Starlite Aviation
Manufacturer : Robinson
Model : R22 Beta
Nationality : South Africa
Registration Marks : ZS-RTA
Place : La Mercy, KZN Province
Date : 10 April 2007
Time : 1345Z

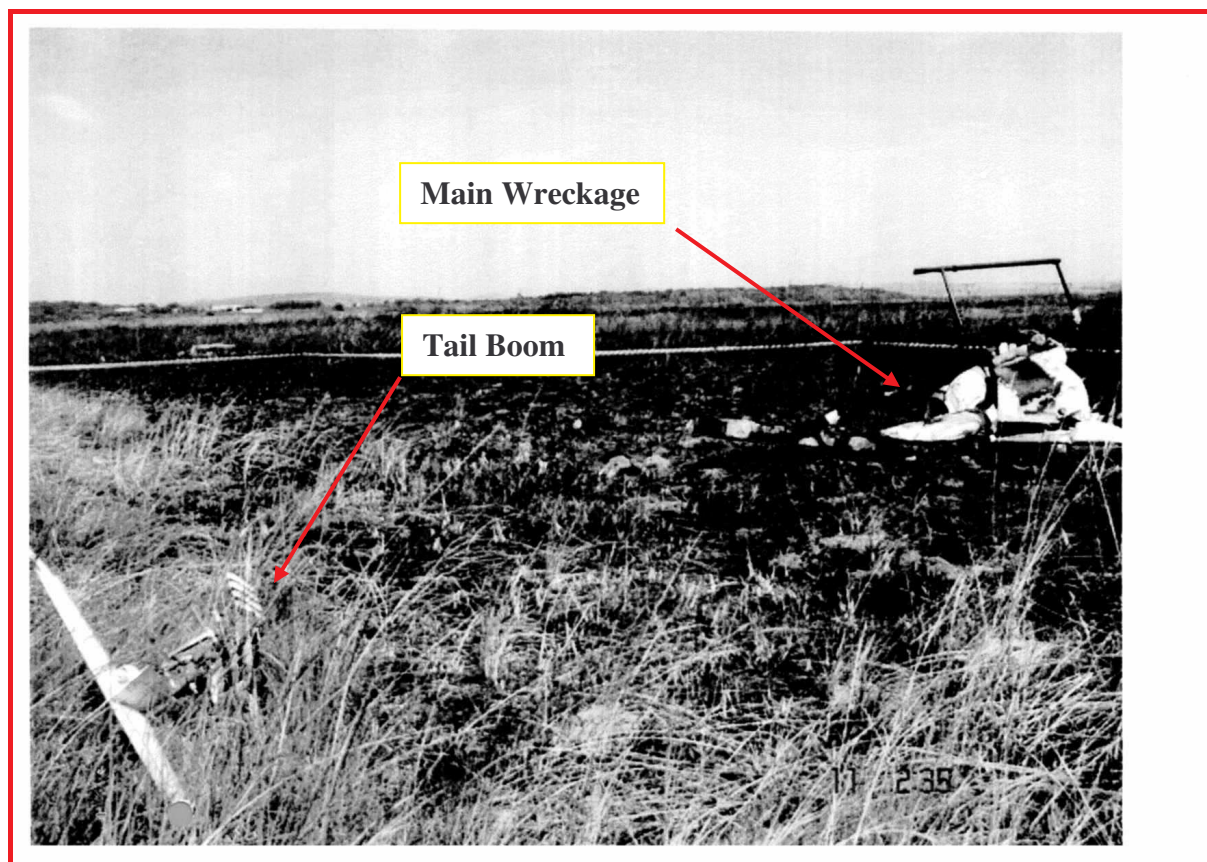
1.3.1 In addition to the impact damage, the aircraft also sustained substantial fire damage after the impact and was destroyed during the accident sequence.

Figure 1: General view of the accident site.

1.12.1 It would appear that the student was doing an auto-rotation exercise, but initiated the recovery too late. The instructor failed to intervene in time and the tail of the helicopter impacted with the terrain.

1.12.2 After the tail impacted with the terrain, the tail boom severed from the helicopter, the helicopter nosed over forward and the force of the impact caused the helicopter to burst into flames.
