AIRCRAFT ACCIDENT REPORT AND EXECUTIVE SUMMARY

Reference:	CA18/2/3/8285	
Aircraft Registration	ZS-OZF	Date of Accident	15 April 2007		Time of Accident	0530Z
Type of Aircraft	Cessna U206C		Type of Operation	Private		
Pilot-in-command Licence Type	Private (Validation)		Age	39	Licence Valid	Yes
Pilot-in-command Flying Experience	Total Flying Hours	676		Hours on Type	5,9	
Last point of departure	Barberton Aerodrome (FABN)					
Next point of intended landing	Barberton Aerodrome (FABN)					
Location of the accident site with reference to easily defined geographical points (GPS readings if possible)						
Runway 35 at Barberton Aerodrome. GPS coordinates: S25°42'52.2' E030°58'22'						
Meteorological Information	Surface wind: Calm; Visibility: CAVOK; Temperature: 14°C					
Number of people on board	1 + 1	No. of people injured	0	No. of people killed	0	
Synopsis	<p>The pilot, accompanied by a passenger, departed from Barberton aerodrome on a local private flight. According to the pilot, he returned to the aerodrome after a flight of approximately 30 minutes for a full-stop landing on runway 35. Full flaps were selected prior to touchdown, and he recalled his speed to be approximately 75 mp

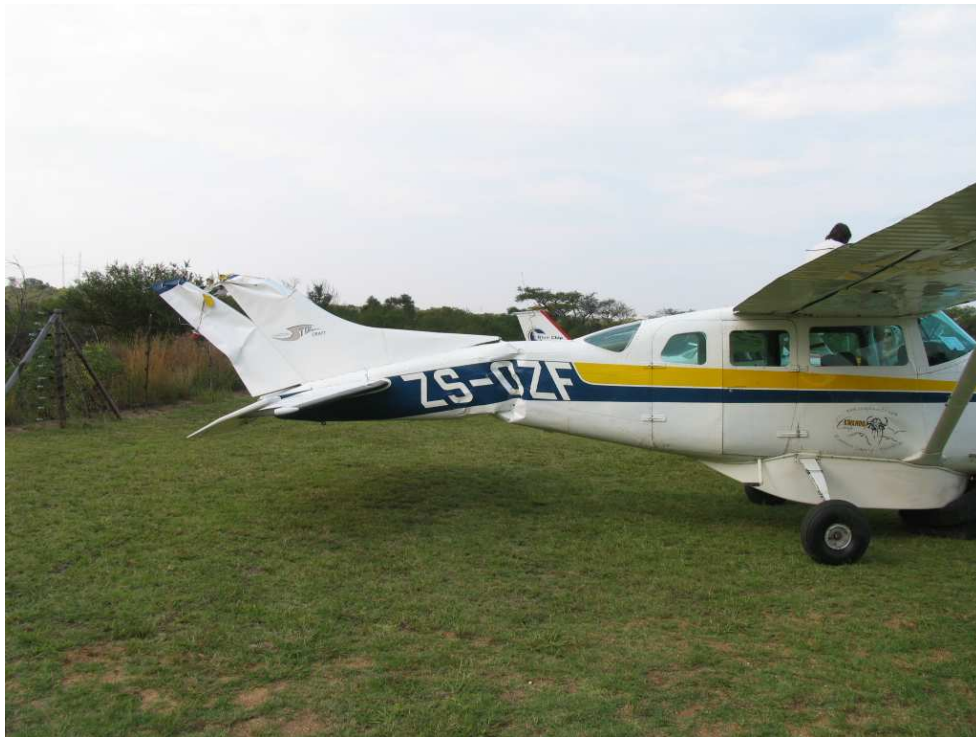
1.3.1 The aircraft sustained damage to the propeller, left wing, right-hand main wheel, and empennage and nose wheel.

1.12.1 During the landing, the aircraft bounced twice and came to rest in an inverted attitude.

Figure1. The damaged aircraft following the recovery.

The pilot had limited experience on the aircraft type and stalled the aircraft during the flare, resulting in a hard landing, which caused the aeroplane to bounce. As a result, the nose wheel separated and the aircraft nosed over.
