**Statens haverikommission**  
Swedish Accident Investigation Board

## ***Report RL 2008:07e***

### **Accident with helicopter SE-HPS at Sisjön, Västergötland county on 24 April 2007**

Case L-06/07

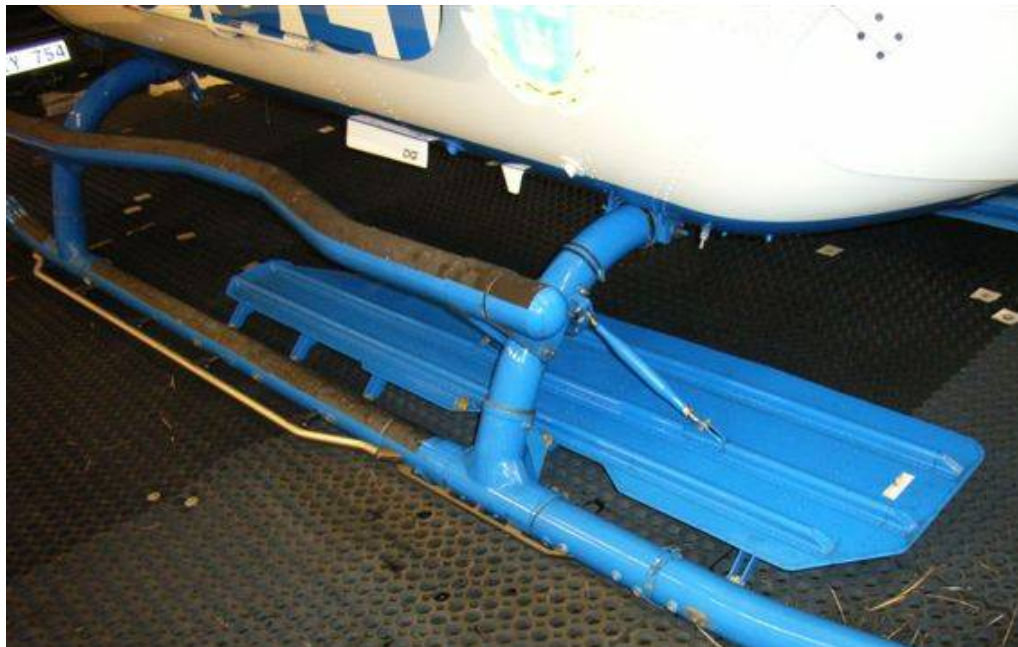
The helicopter had been relocated from the SPW base in Boden, where it had been stationed for a time, to Gothenburg on the day before the accident. While at Boden, it had been provided with snow skids to facilitate start and landing in snow-covered terrain. (See photo below).

Snow skids

- e) The snow skids installed can probably affect the manoeuvrability of the helicopter type in certain flying attitudes.
- f) Deficiencies have been noted in the direction of SPW, its inspection activities, routines and rules.

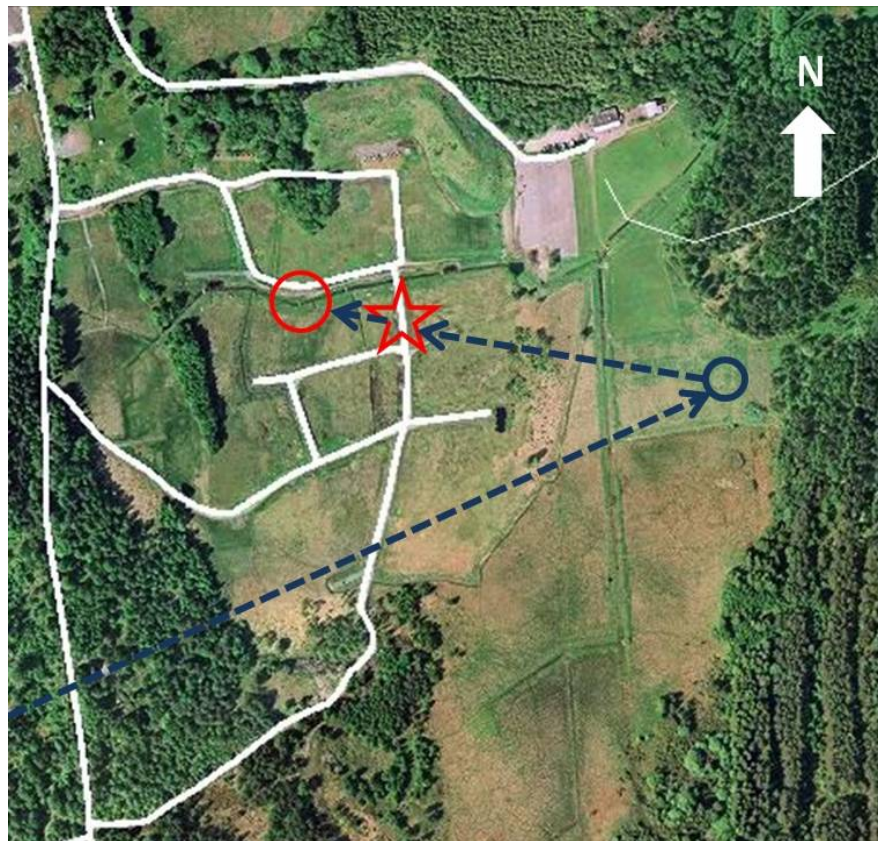
The helicopter struck the ground on the northern part of a roughly oval open exercise area of diameter approximately 500 metres. This area is surrounded by undulating forest terrain and is traversed by some narrow gravel roads and a water-filled ditch. At the time of the accident, the ground was uneven, saturated and covered with uncut vegetation. The approximate final flight path of the helicopter, the turn with elevated nose, the contact track, impact point and final resting place have been drawn in the following aerial photograph.

Final part of the flight path and impact area. The lesser circle indicates approximately the high point of the final manoeuvre.

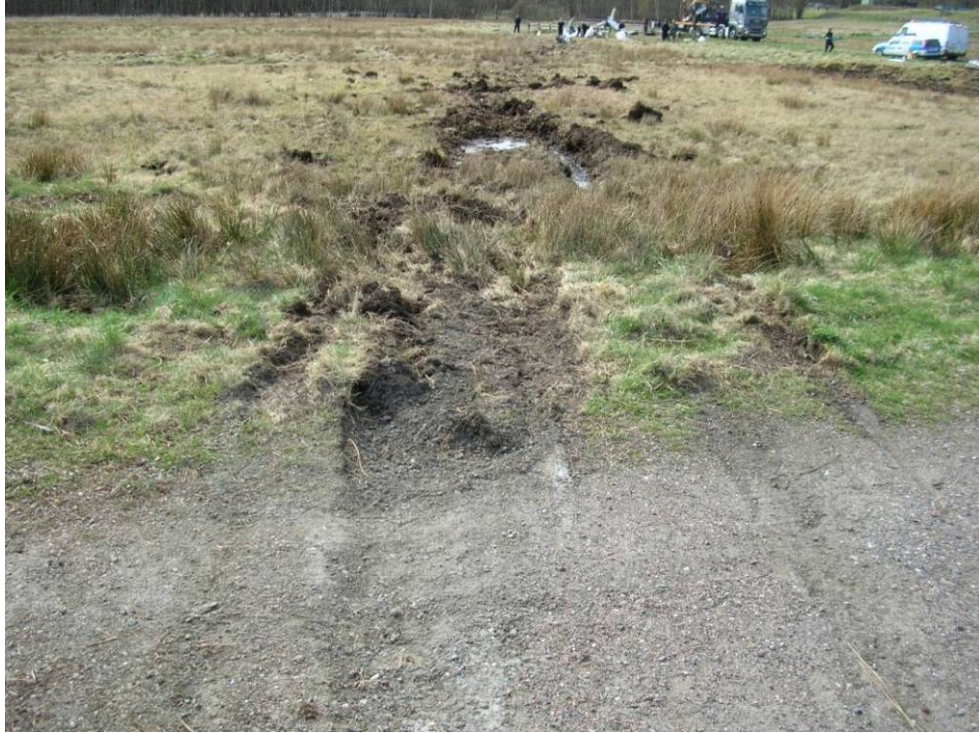
The markings on the ground indicate that the helicopter first touched the ground with the rear part of the tail boom approximately 10 metres east of a local gravel roadway. The port landing skid then struck the ground violently at the verge of the roadway, the starboard skid hit the ground and the helicopter swung to port.

Impact marks on the opposite side of the roadway and immediately west of the roadway show that the helicopter structure struck the ground violently there. Several other impact marks and scattered helicopter parts show that at this point, the helicopter rolled to starboard over the nose and then tumbled several times over a distance of 75 metres before finally stopping in a water-filled ditch.

Ground impact marks viewed in the direction of the impact

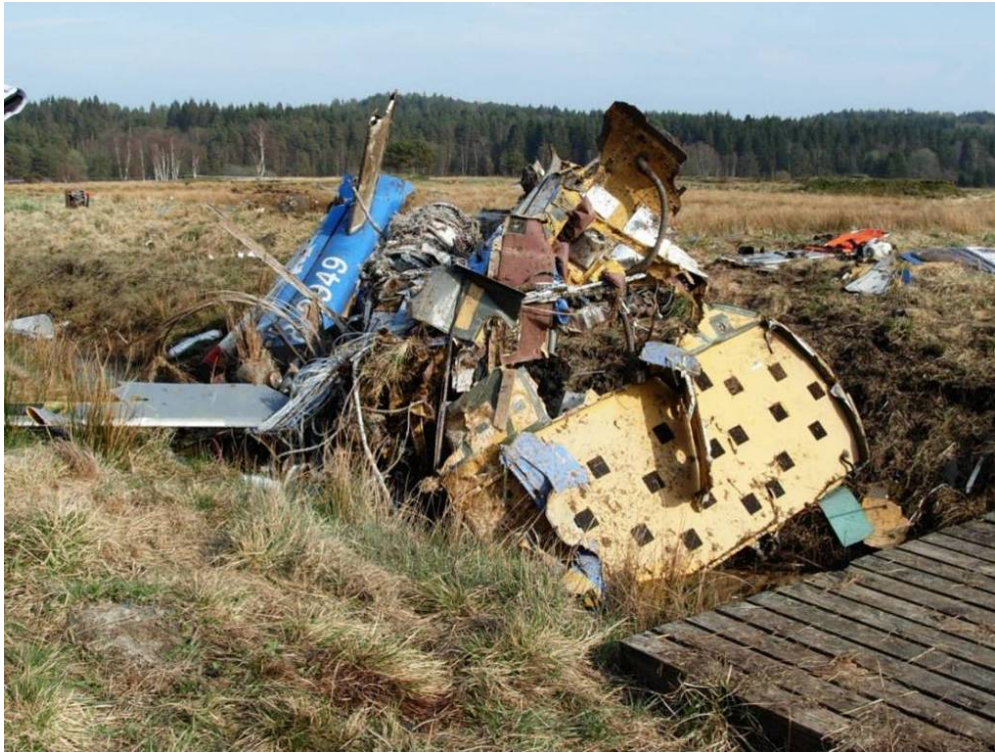
The helicopter was completely destroyed. The rear section of the tail boom, parts of the undercarriage, parts of the rotor blades and parts of the helicopter front separated from the helicopter during the first part of the tumbling. Other parts of the structure were crushed or torn loose and spread over an area approximately 110 x 25 m. The remnants of the wreckage consisted mainly of the central structure of the helicopter containing engines, transmission, electronic system etc. and the tail boom. See the photograph below.

Wreckage of the helicopter  
viewed in the direction of the impact with the ground
