## AIRCRAFT ACCIDENT REPORT AND EXECUTIVE SUMMARY

Reference:	CA18/2/3/8297	
<b>Aircraft Registration</b>	<b>ZS-RTZ</b>	<b>Date of Accident</b>	13 May 2007	<b>Time of Accident</b>	1400Z	
<b>Type of Aircraft</b>	Robinson R22 Beta II		<b>Type of Operation</b>	Private		
<b>Pilot-in-command Licence Type</b>		Private	<b>Age</b>	41	<b>Licence Valid</b>	Yes
<b>Pilot-in-command Flying Experience</b>		Total Flying Hours	195.4	Hours on Type	187	
<b>Last point of departure</b>		Wonderboom Aerodrome (FAWB)				
<b>Next point of intended landing</b>		Wonderboom Aerodrome (FAWB)				
<b>Location of the accident site with reference to easily defined geographical points (GPS readings if possible)</b>						
On a farm 5 nm north of the Carousel Casino at S25 15.423 E02817.723						
<b>Meteorological Information</b>		Surface wind: northerly and light; Visibility: CAVOK; Temperature: 26°C				
<b>Number of people on board</b>	1 + 1	<b>No. of people injured</b>	Nil	<b>No. of people killed</b>	Nil

**Name of Owner/Operator** : Private  
**Manufacturer** : Robinson  
**Model** : R22 Beta  
**Nationality** : South African  
**Registration Marks** : ZS-RTZ  
**Place** : Pienaarsrivier  
**Date** : 13 May 2007

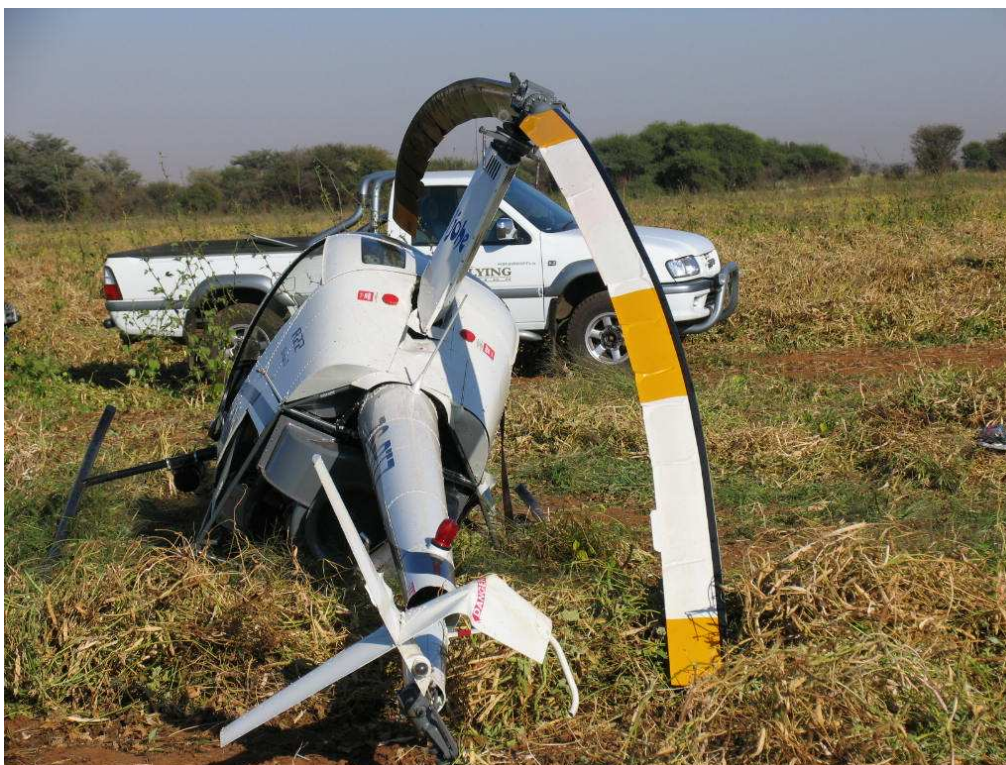
1.3.1 The helicopter was substantially damaged.

**Figure 1:** Rear view of the damaged helicopter at the crash site.

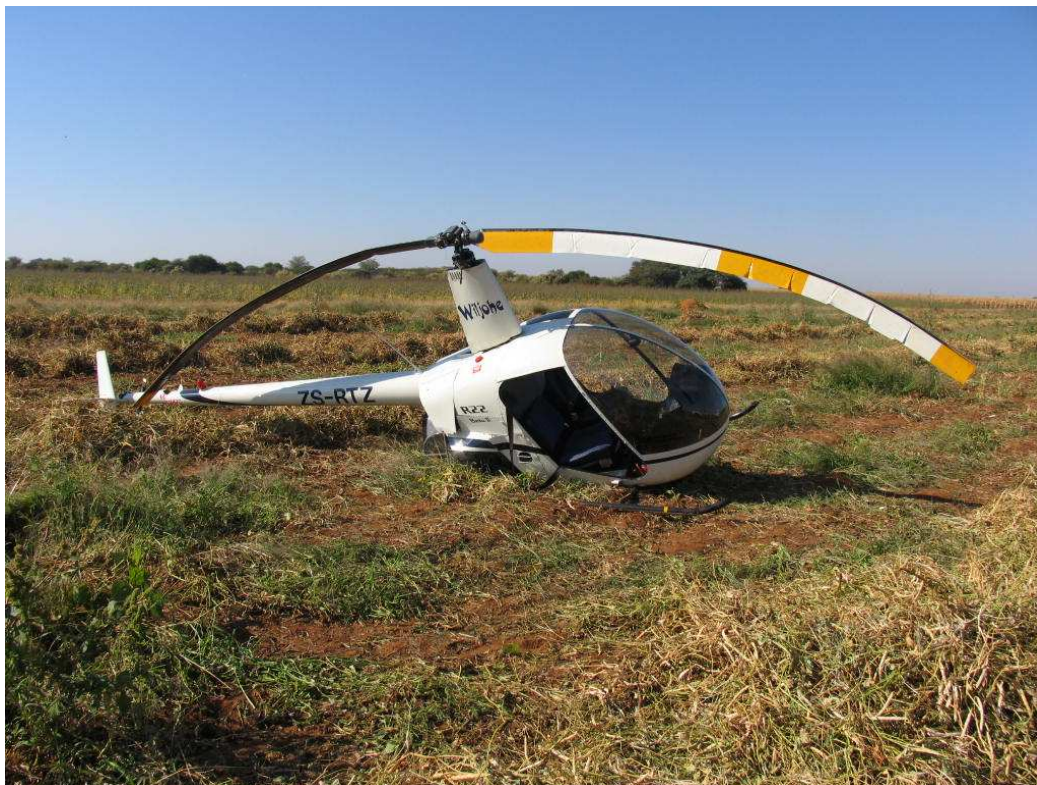
1.12.1 The tail section struck the ground first, followed by the right skid. The helicopter came to rest leaning to the right and facing in a westerly direction. It sustained damage to the main rotor blades, fuselage, skids, tail boom and tail rotor.

Figure 2. Right-hand side of the helicopter.
