AIRCRAFT ACCIDENT REPORT AND EXECUTIVE SUMMARY

Reference:	CA18/2/3/8301	
Aircraft Registration	ZS-RLY	Date of Accident	23 May 2007		Time of Accident	1410Z
Type of Aircraft	R22 Beta II helicopter		Type of Operation	Private		
Pilot-in-command Licence Type		Commercial pilot	Age	42	Licence Valid	Yes
Pilot-in-command Flying Experience		Total Flying Hours	1 553.4		Hours on Type	1 553.4
Last point of departure		Mpofu Safari Lodge, 60 km north of Lephalale, Northern Province				
Next point of intended landing		Mpofu Safari Lodge, 60 km north of Lephalale, Northern Province				
Location of the accident site with reference to easily defined geographical points (GPS readings if possible)						
Next to the Mogol River at Mpofu Safari Lodge, 60 km north of Lephalale						
Meteorological Information		Wind: 330°TN/10 kts; Temperature: 18°C; Visibility: 10 km				
Number of people on board	1 + 1	No. of people injured	0	No. of people killed	2	
Synopsis						
<p>At approximately 1400Z, the pilot, accompanied by a passenger, took off from Mpofu Safari Lodge to look for an antelope that had been injured the previous day.</p> <p>Whilst the helicopter was flying over the Mogol River in close proximity t

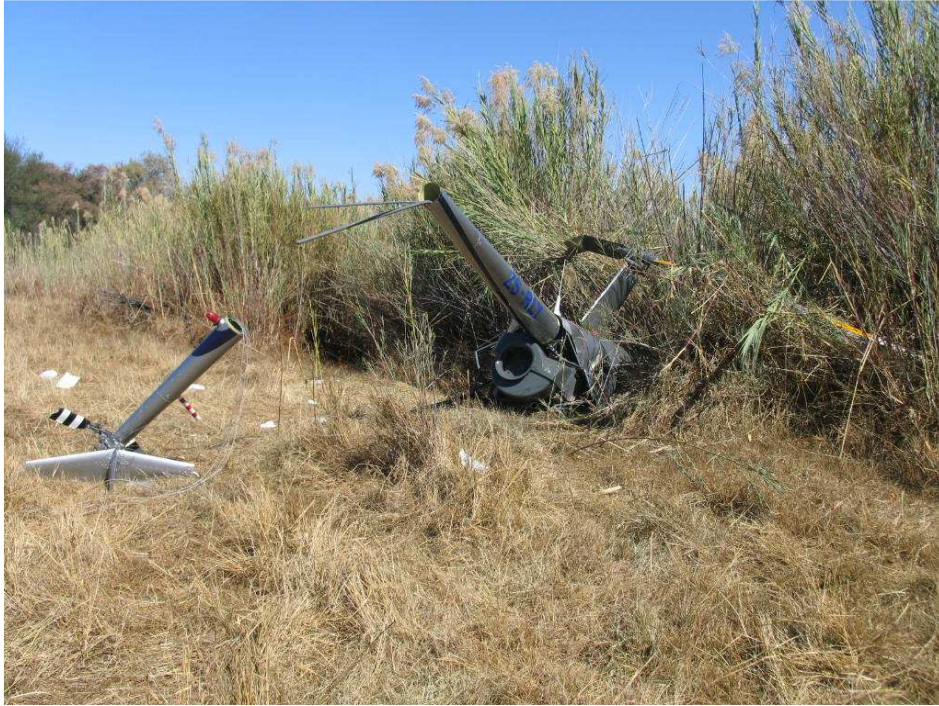
- 1.3.1 The helicopter sustained substantial damage to the main rotor blades, cabin, skids, tail boom and rotor.

Figure 1. Rear view of the wreckage.

- 1.12.2 The helicopter came to rest facing in a westerly direction with a nose-down attitude at the position S23° 25.003 E027° 42.074. The skids and the front lower fuselage area of the cabin collapsed on impact. The aft section of the tail boom separated from the helicopter and was found approximately 2 metres away from the main wreckage.

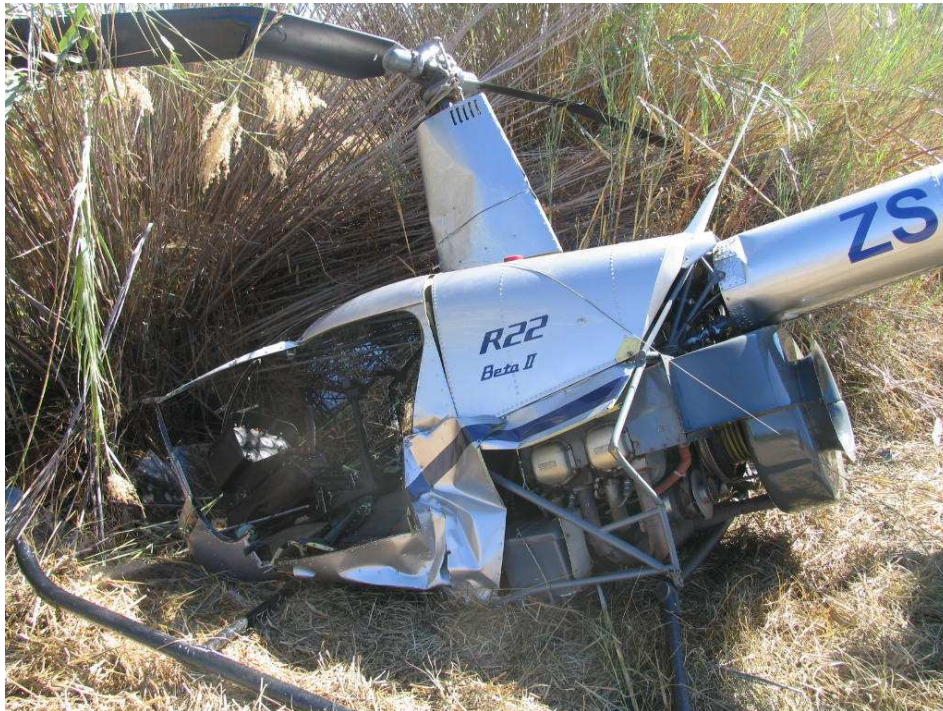
Figure 2. The extensive damage to the cabin.

1.15.1 The accident was considered non-survivable, due to the high impact forces. The cabin area caved in and both the pilot's and passenger's seats collapsed on impact with the ground. The occupants were found secured with three-point safety belts, which did not fail.

The cabin area had caved in, the skids had collapsed and the seats were badly damaged. The tail boom was severed and pieces of the tail rotor could not be found at the accident site. The main rotor blades were still attached to the helicopter but were bent in several places.

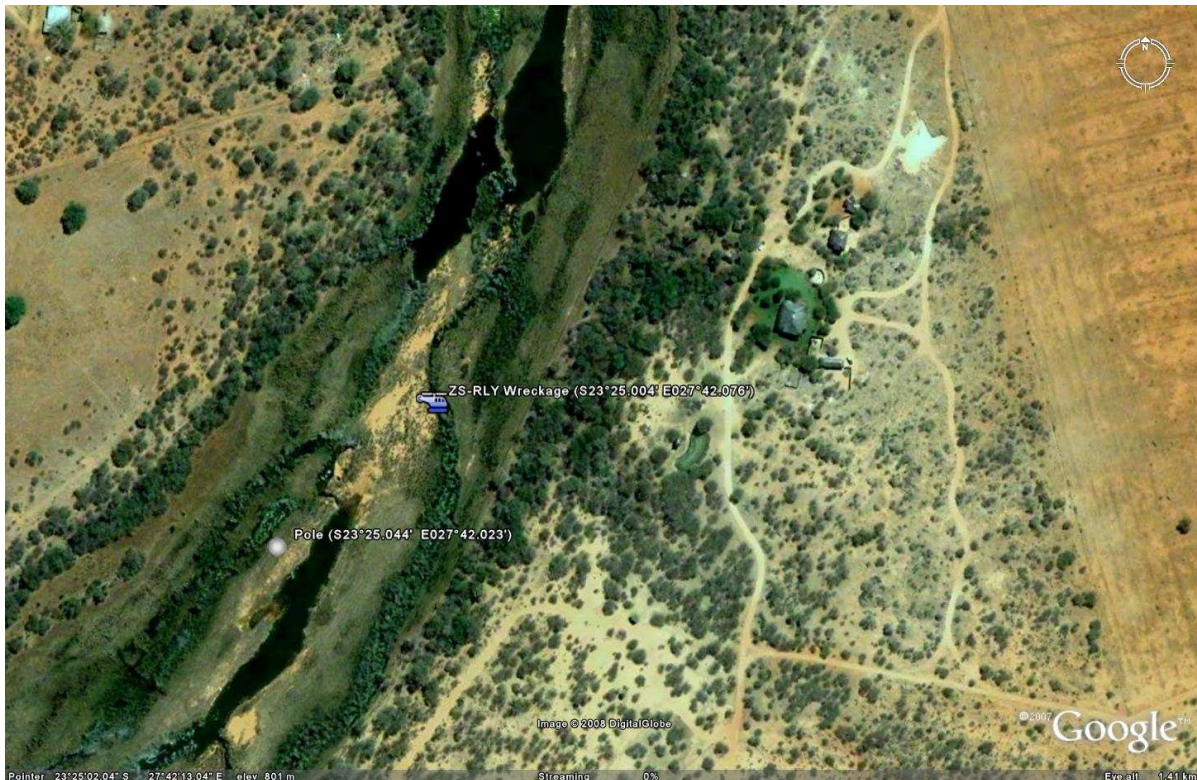
- 1.12.3 The helicopter impacted with a section of barbed wire fence at the position S23° 25 044 E27° 42 023 before pitching up into the air. The main wreckage was found 116 metres from where the helicopter struck the fence.

- 1.12.4 A piece of tail rotor blade was found at the position S23°25 021E027°42 043. A second piece of tail rotor was found at the position S23°25 025 E027°42 042. It was determined that the wreckage was in the direction 050.723° true north and 116 m from the fence.

Figure 3. The wreckage site in relation to where the helicopter struck the barbed wire fence.

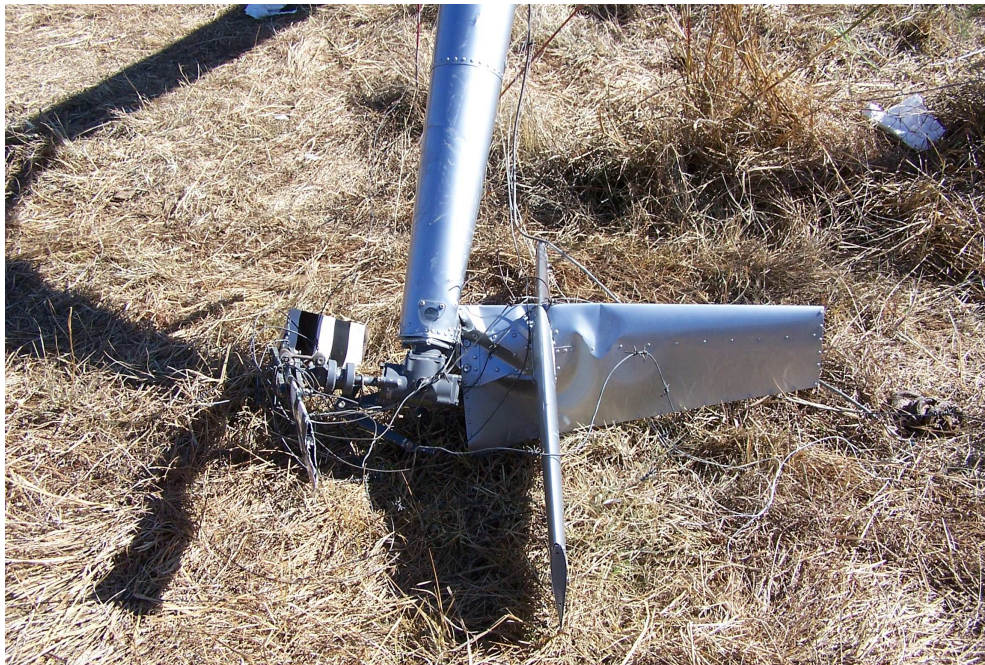
It was found that barbed wire had wound around the tail rotor. The helicopter had struck a 3-foot high barbed wire fence spanning the Mogol River.

Figure 4. The barbed wire entangled around the tail rotor.

- 3.2.1 The helicopter's tail rotor impacted with a 3-foot high barbed wire fence during a low-level flight, where after the helicopter impacted with the ground.
